#1 Roof Inspection at: 228 South Cave Creek Drive
Bloomington, IN 47403 1/11/2024 House faces slightly S/E.

*Inspection performed by: Mark Walcott Roofing Contractor
263 St. Rd. 135 South Nashville, IN 47448 Ph: 812-322-6532

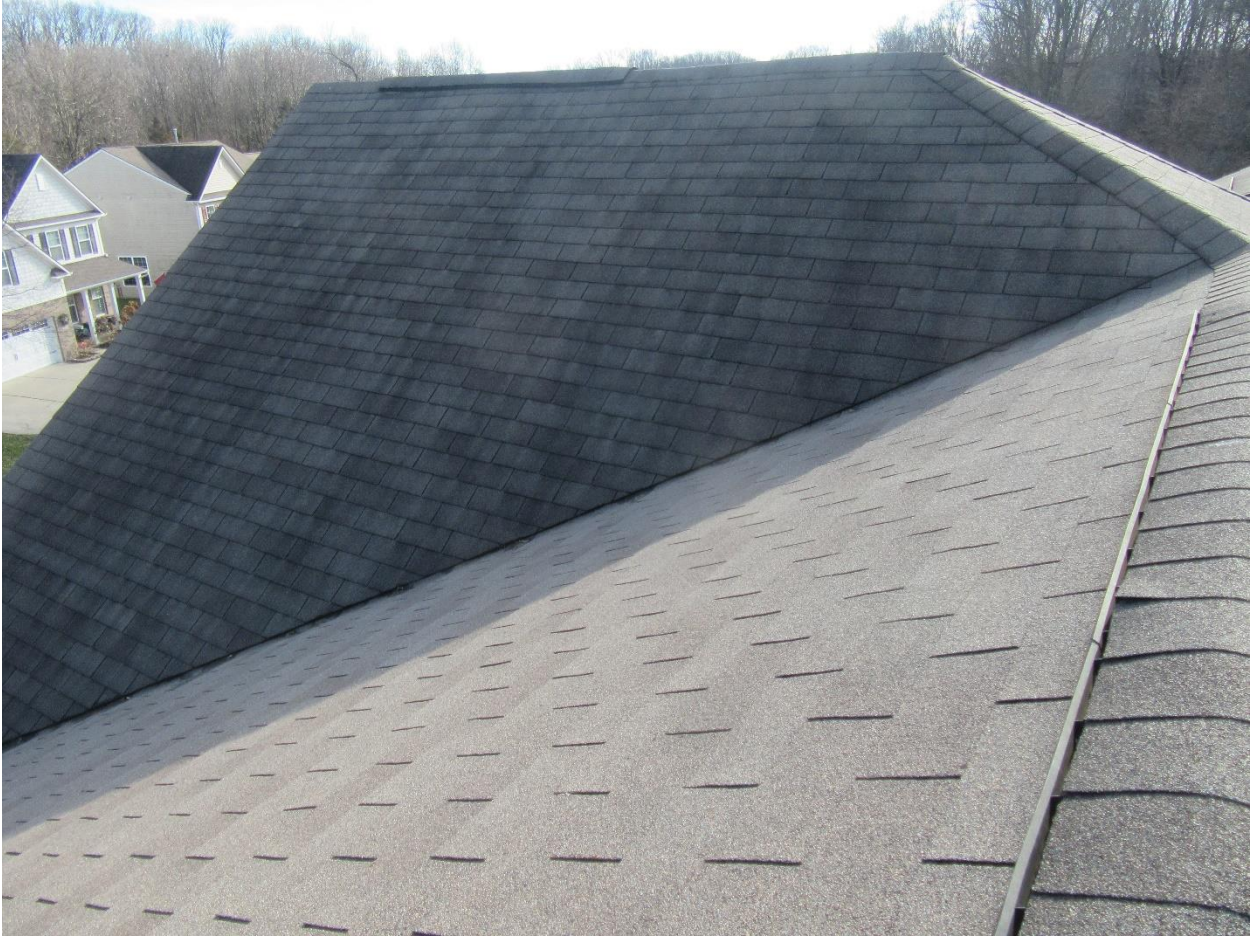
#9 View of the upper front center area.
Some algae is growing on the steep roof area.

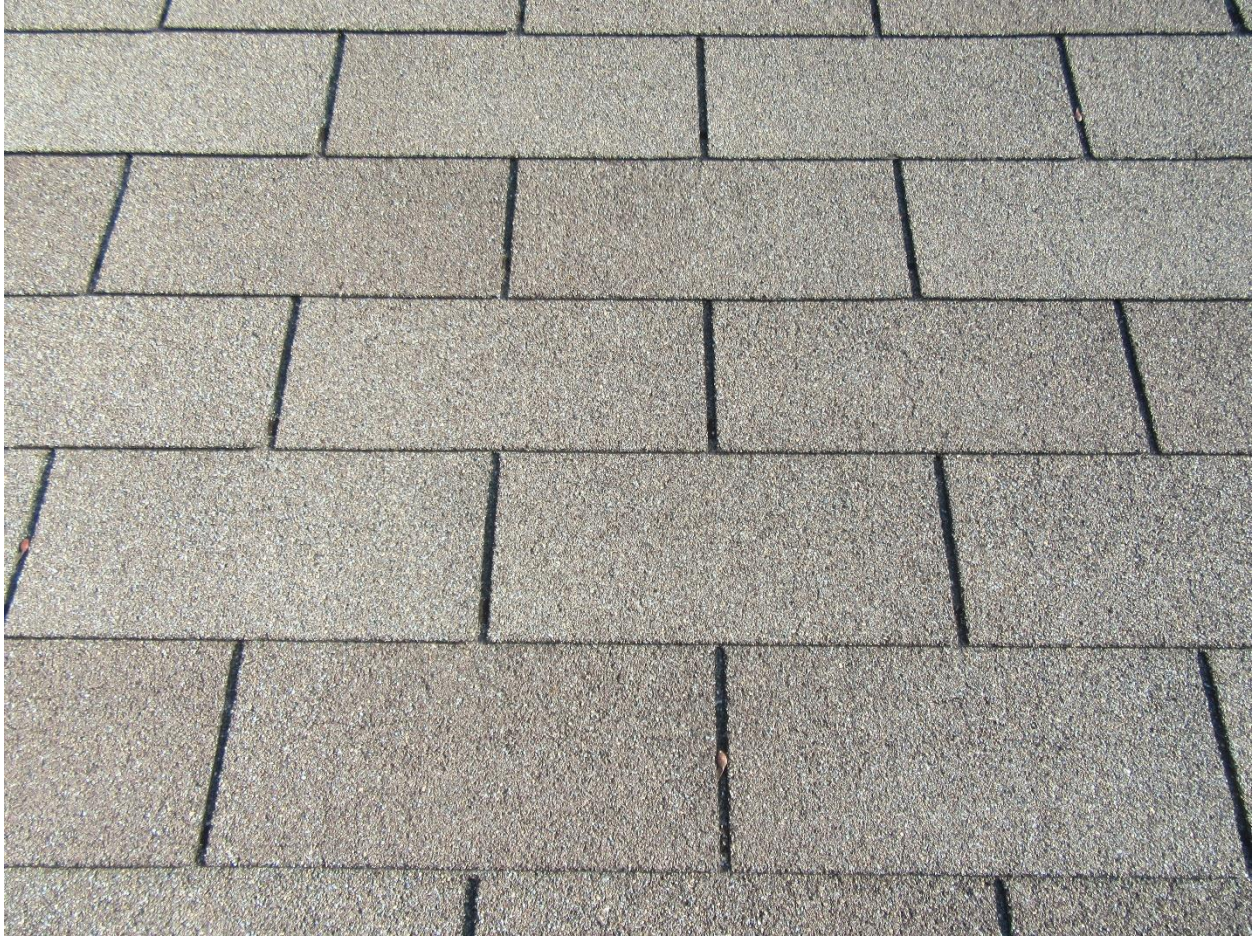
#15 Close-up view of some shingles. Shingles appear to be in satisfactory condition for their age.

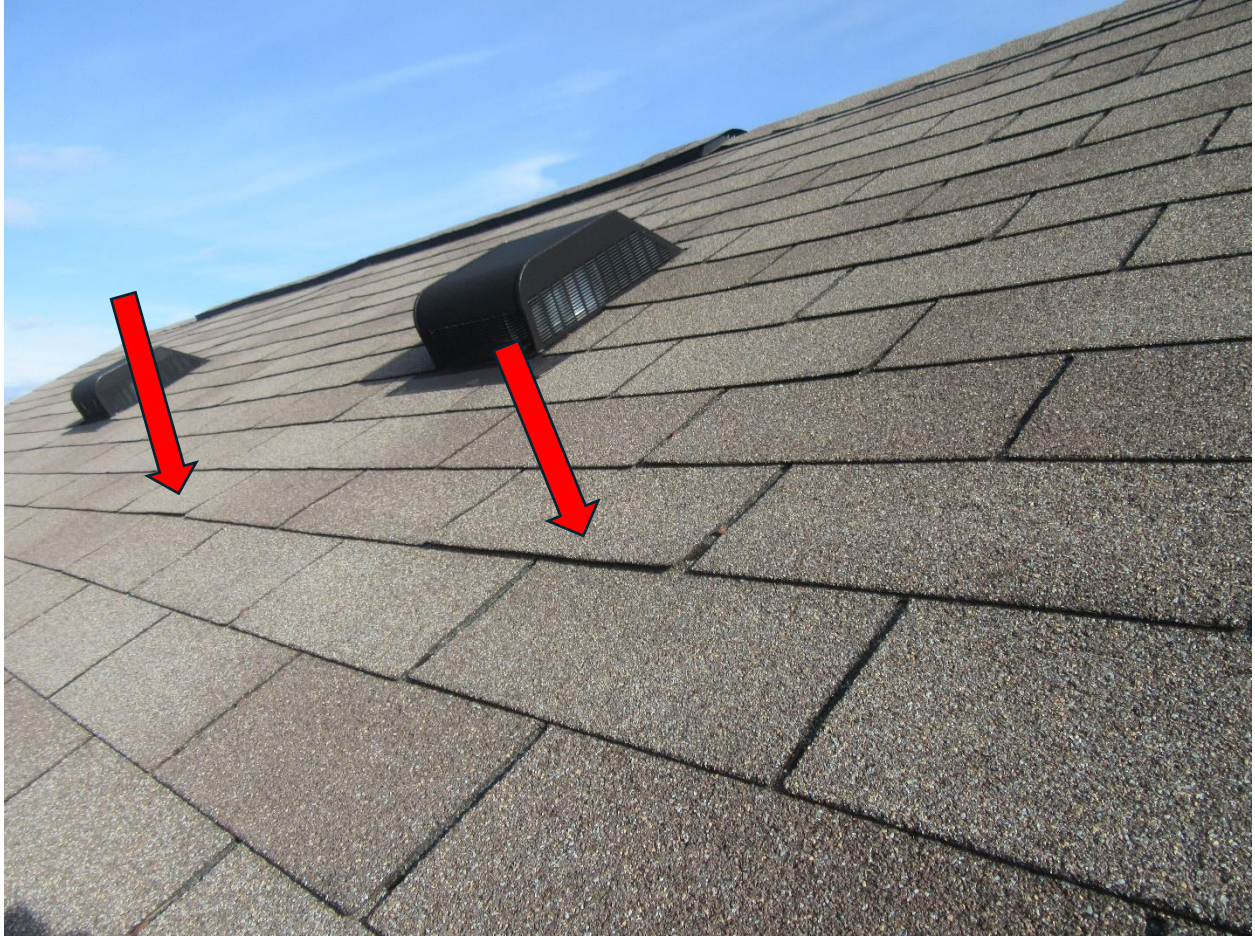
*A few shingle tabs have slightly raised edges and some are loose. Some shingle tabs may not have originally sealed to the sealant strip. There is a risk of wind raising and loosening the shingle tabs. As the shingles age they become slightly brittle and more susceptible to loosening and breaking off.

#16 A few shingle tabs on the back side are slightly raised and loose.

**It is recommended to seal any loose and raised shingle tabs and monitor the roof for any further issues.

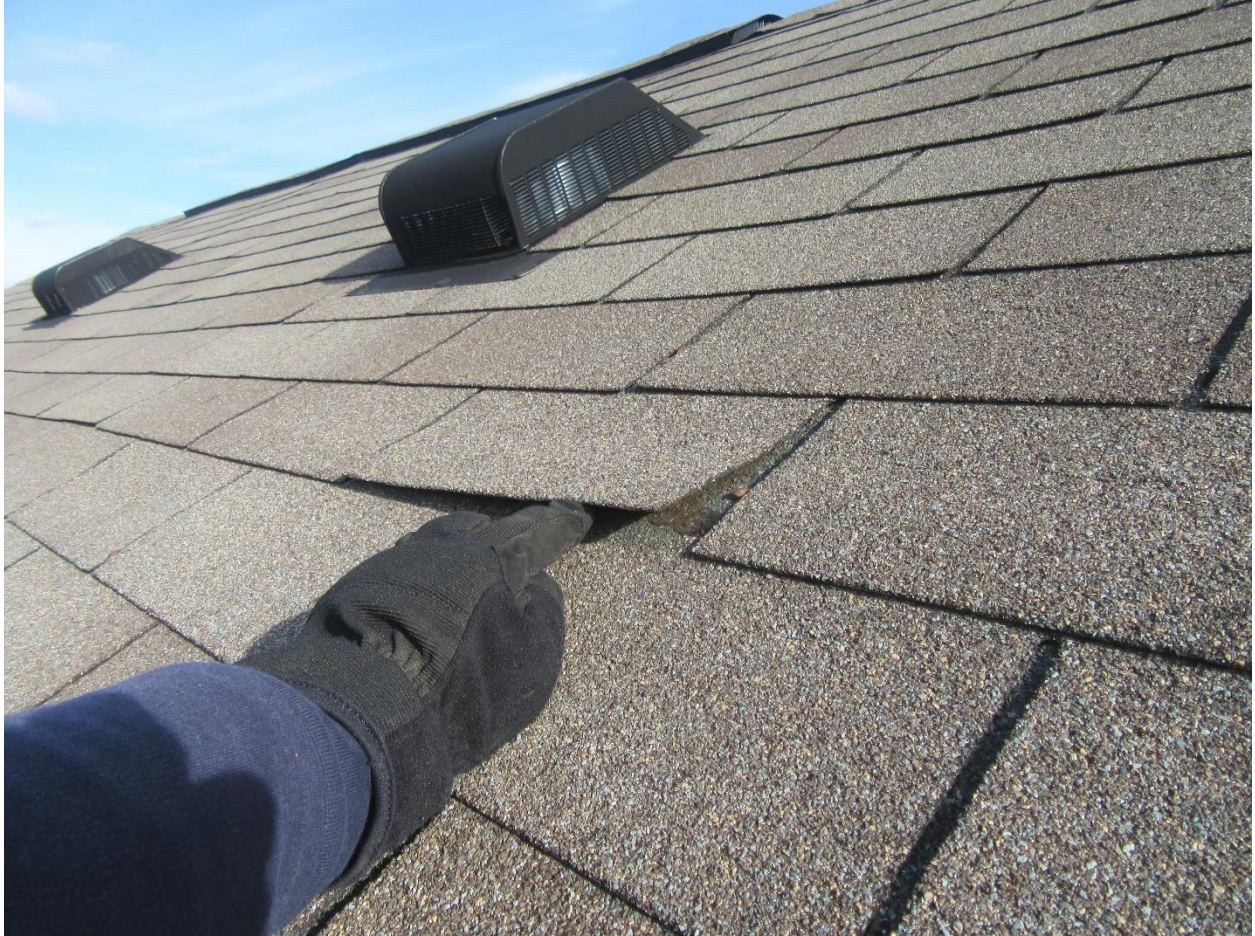
#17 Some shingle tabs are loose and are not properly sealed to the sealant strips.

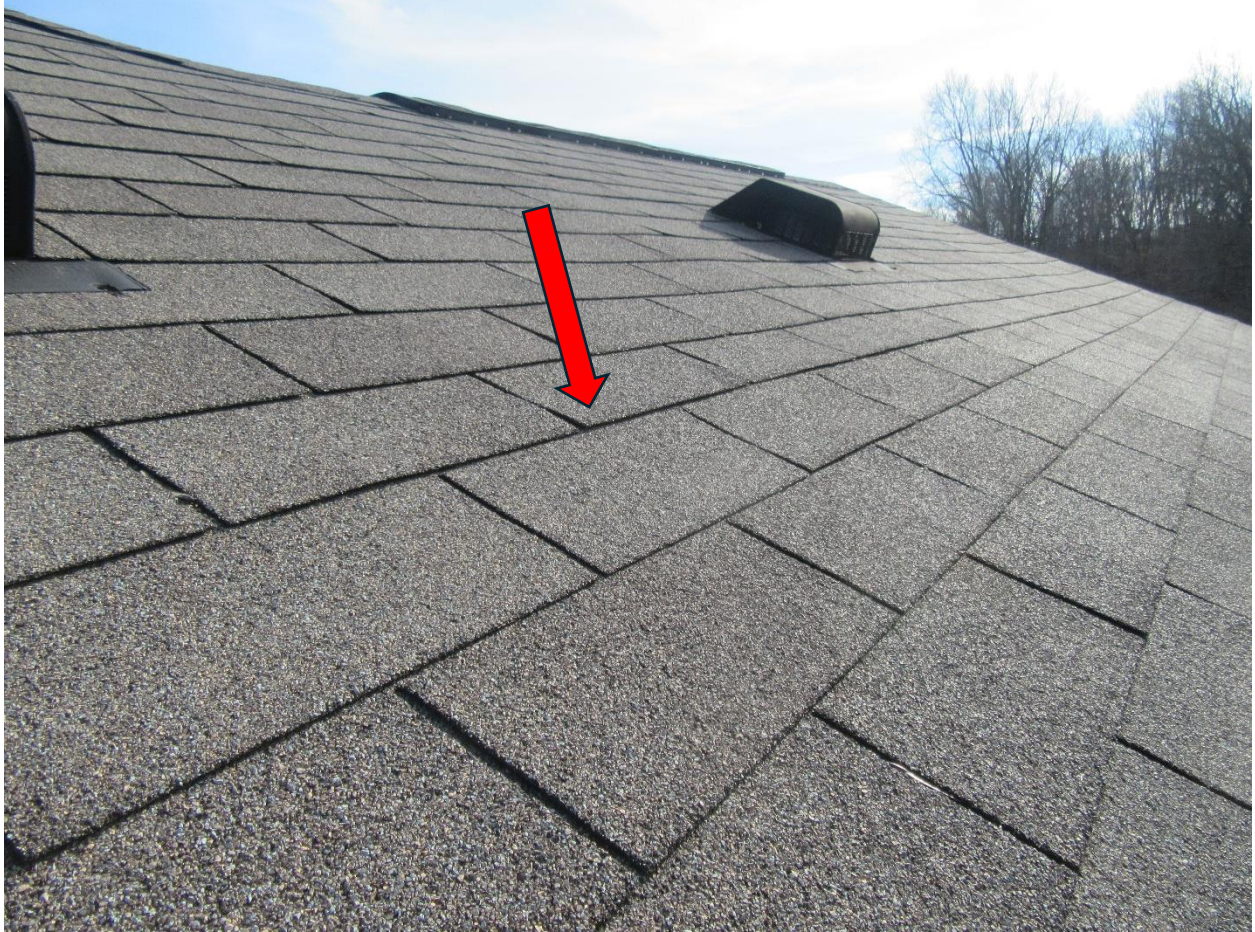
#18 A few shingle tabs on the back side are slightly raised.
(See comments in previous photos)

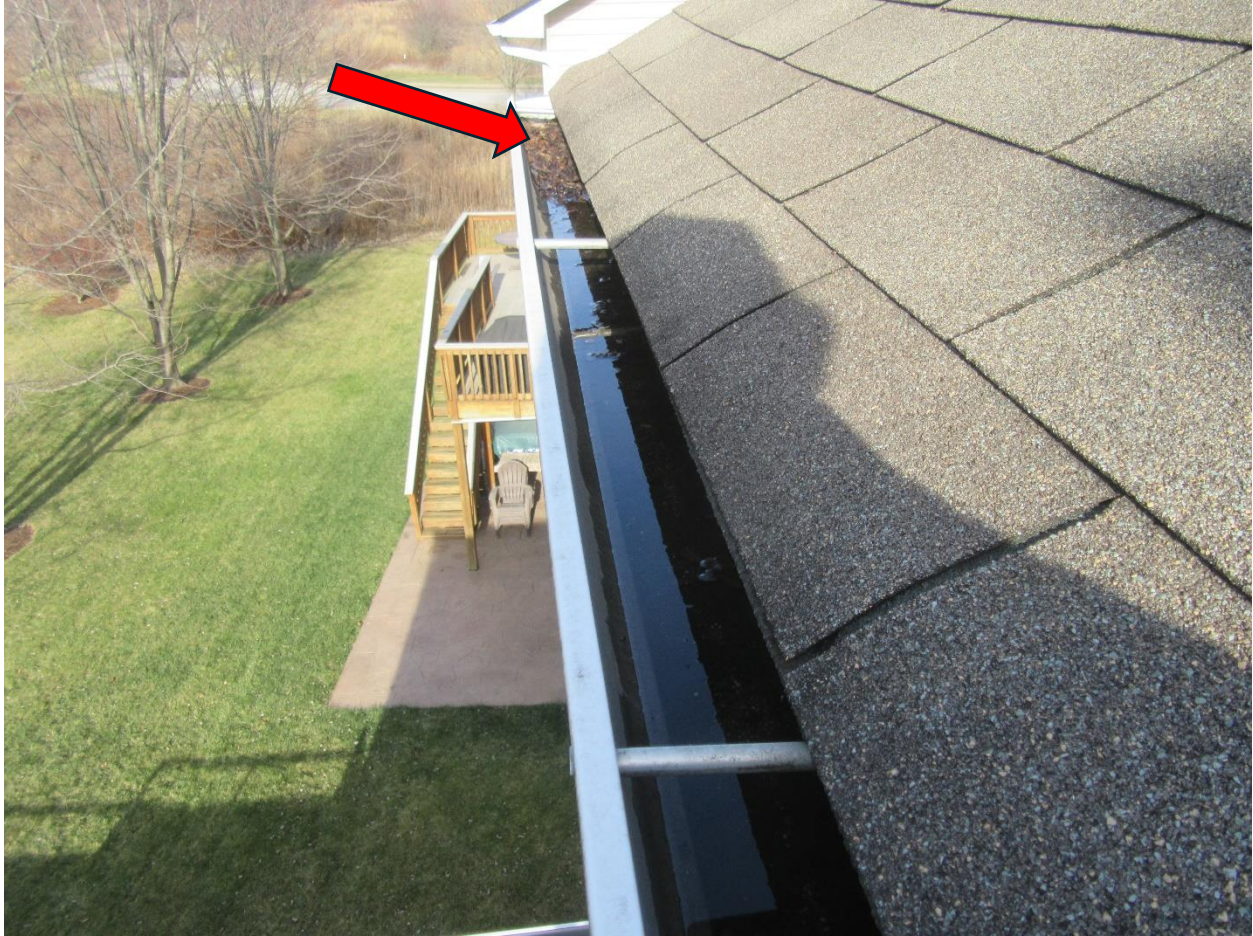
#19 Back side gutters have standing water, and the downspout openings are clogged.

**It is recommended to clean the gutters.

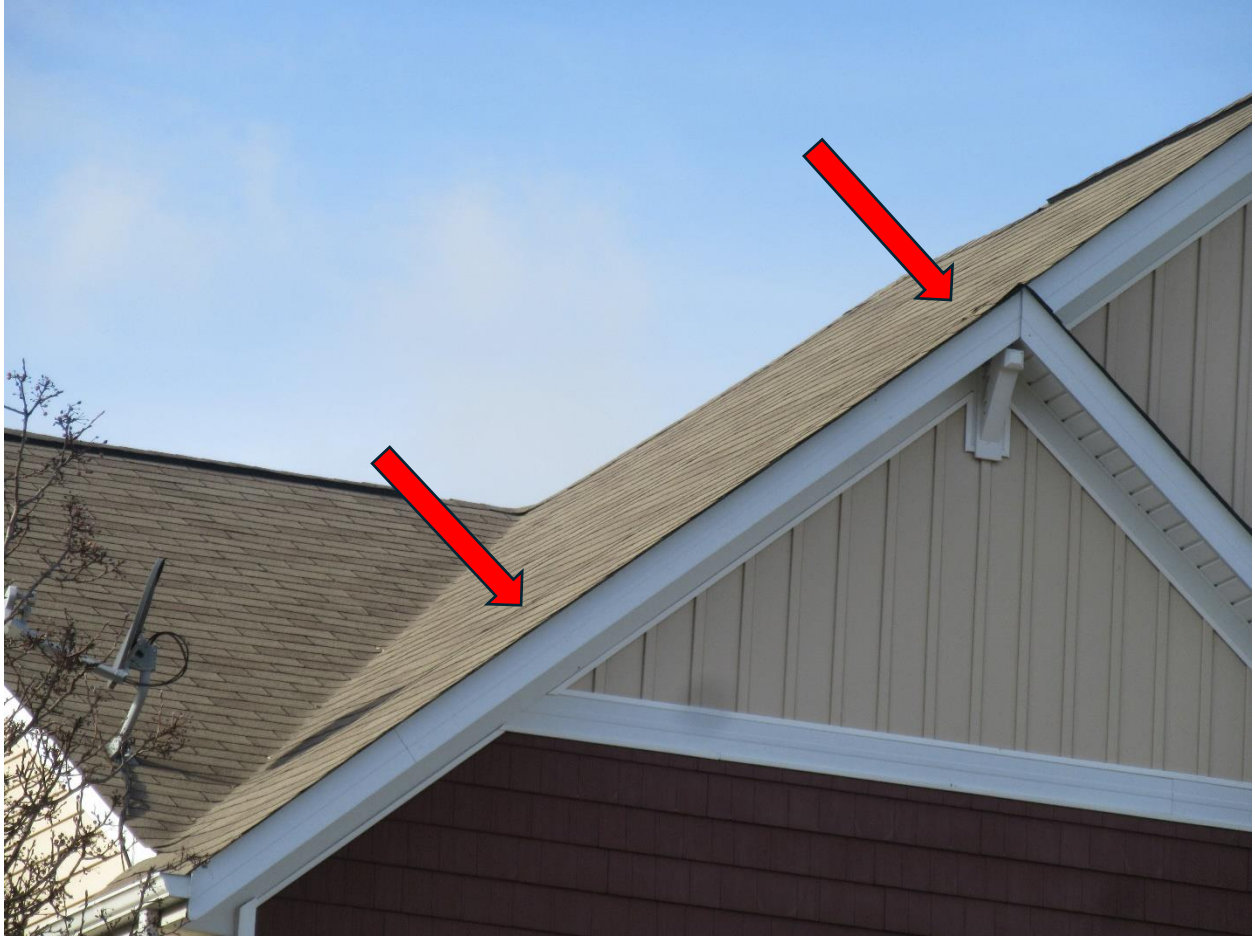
#22 View of the upper front S/E corner roof area. Some of the roof structure decking is slightly sagging and slightly uneven. This is difficult to see in the photo. I did not detect a significant issue.

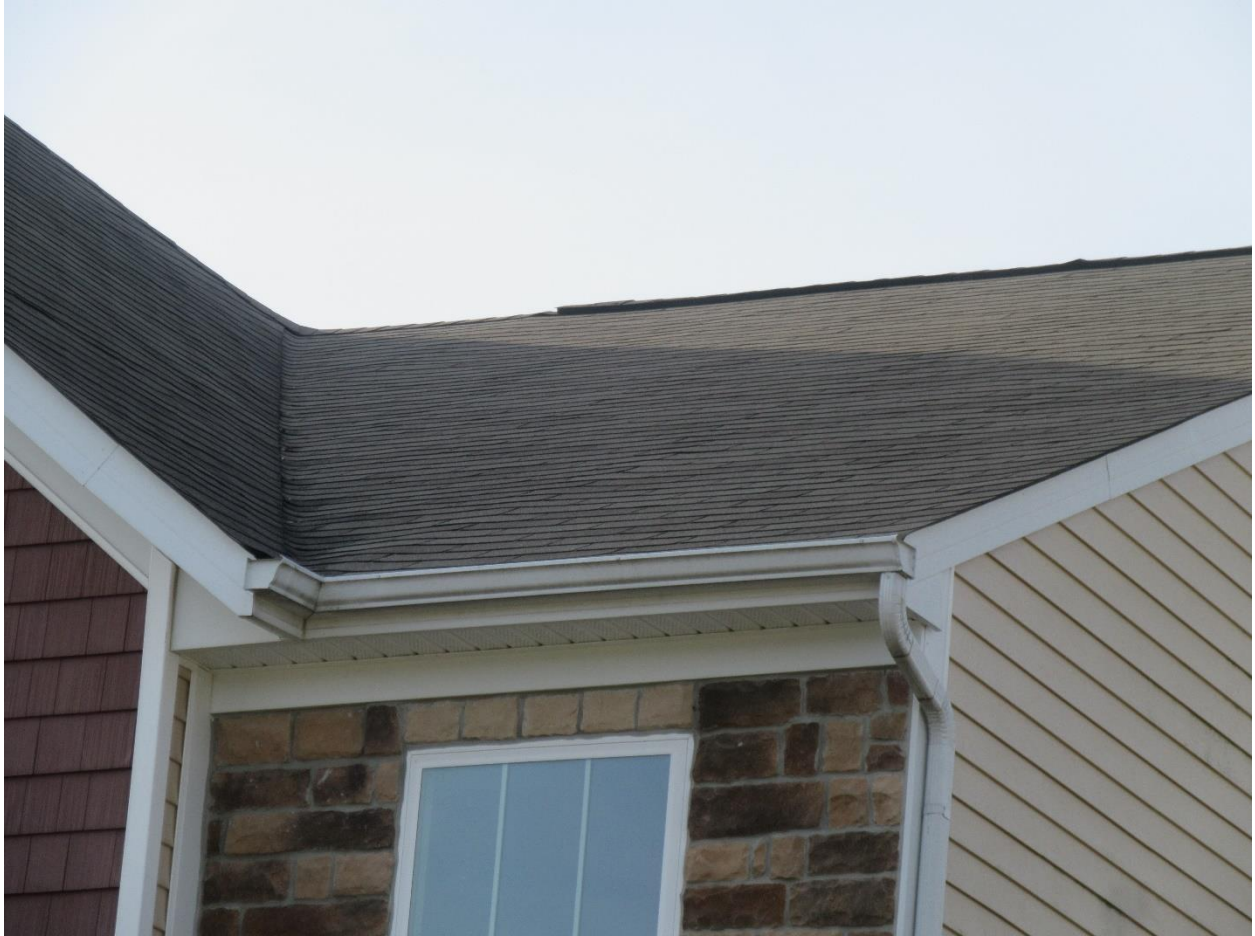
#23 View of the upper front N/E corner roof area. A few shingle tabs have slightly raised edges.

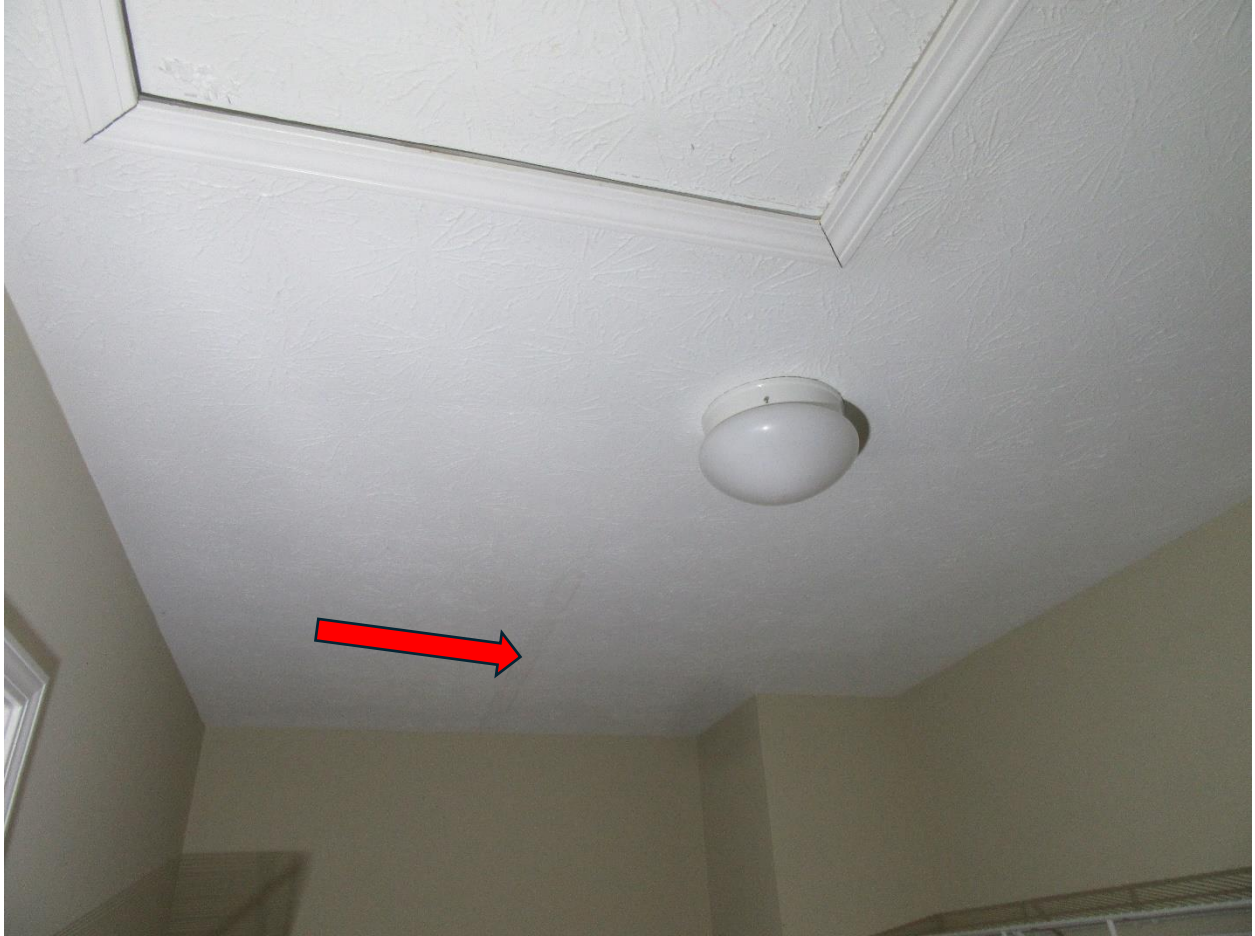
#39 Master bedroom closet ceiling view.

There is a stain on the ceiling. (See the next photo)

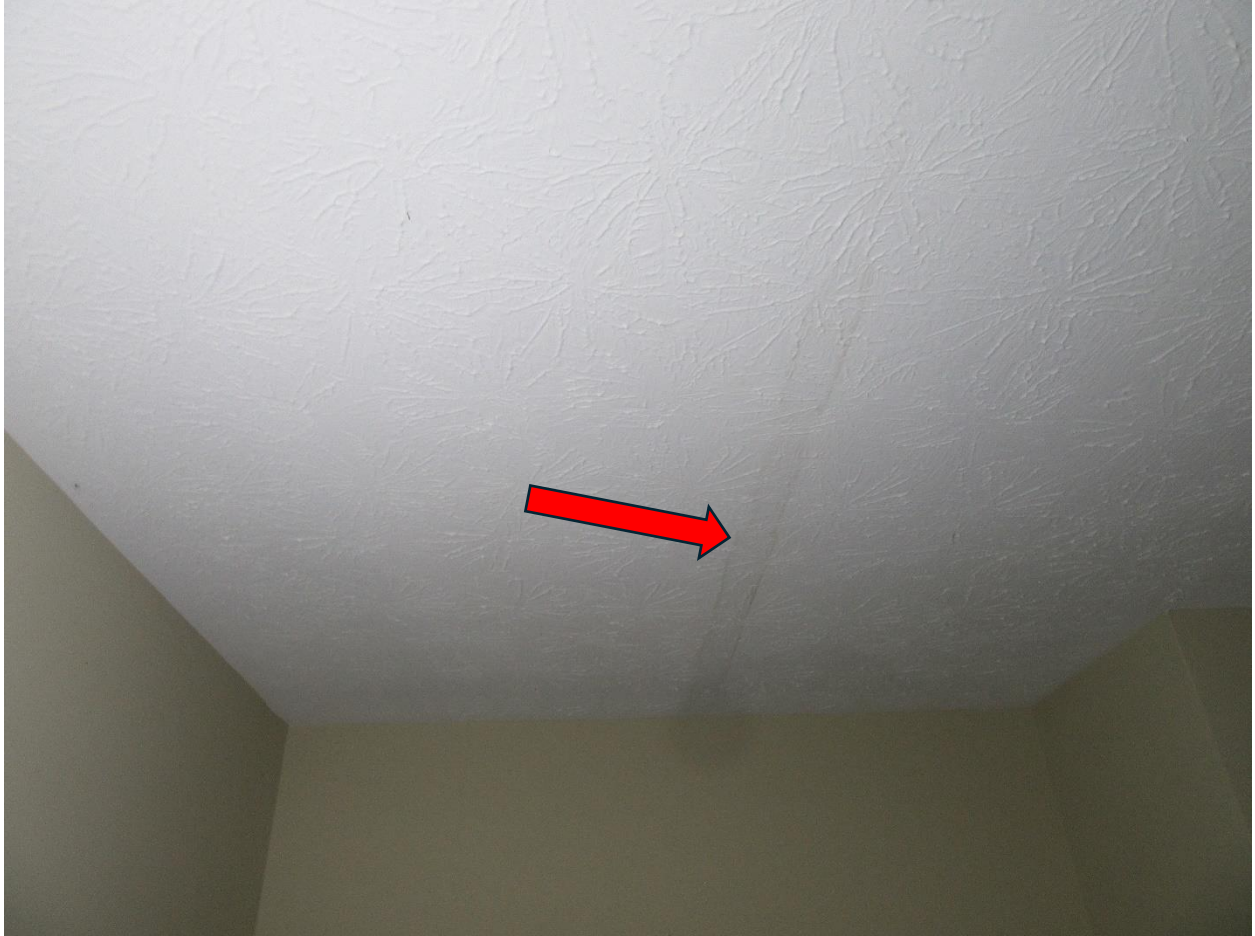
I did not detect evidence of roof leak issues on the ceilings with the exception of a stain in the master bedroom closet. (See upcoming photo #

#40 Water stain on the master bedroom closet ceiling appears to indicate a roof leak at some point in time. I performed a moisture test on the area and did not detect an elevated moisture reading. I looked in the attic directly above the stain and did not see evidence of a roof leak. Since it has rained a lot the last few days I do not believe this is an active roof leak issue.

**I recommend painting the ceiling stain with a stain sealer paint and monitor the ceiling during heavy rains.
