#1 1706 Bolton Road West Terre Haute, IN 47885 4/6/2024

Roof Inspection by: Mark Walcott Roofing Contractor
263 St. Rd. 135 South Nashville, IN 47448 PH: 812-322-6532

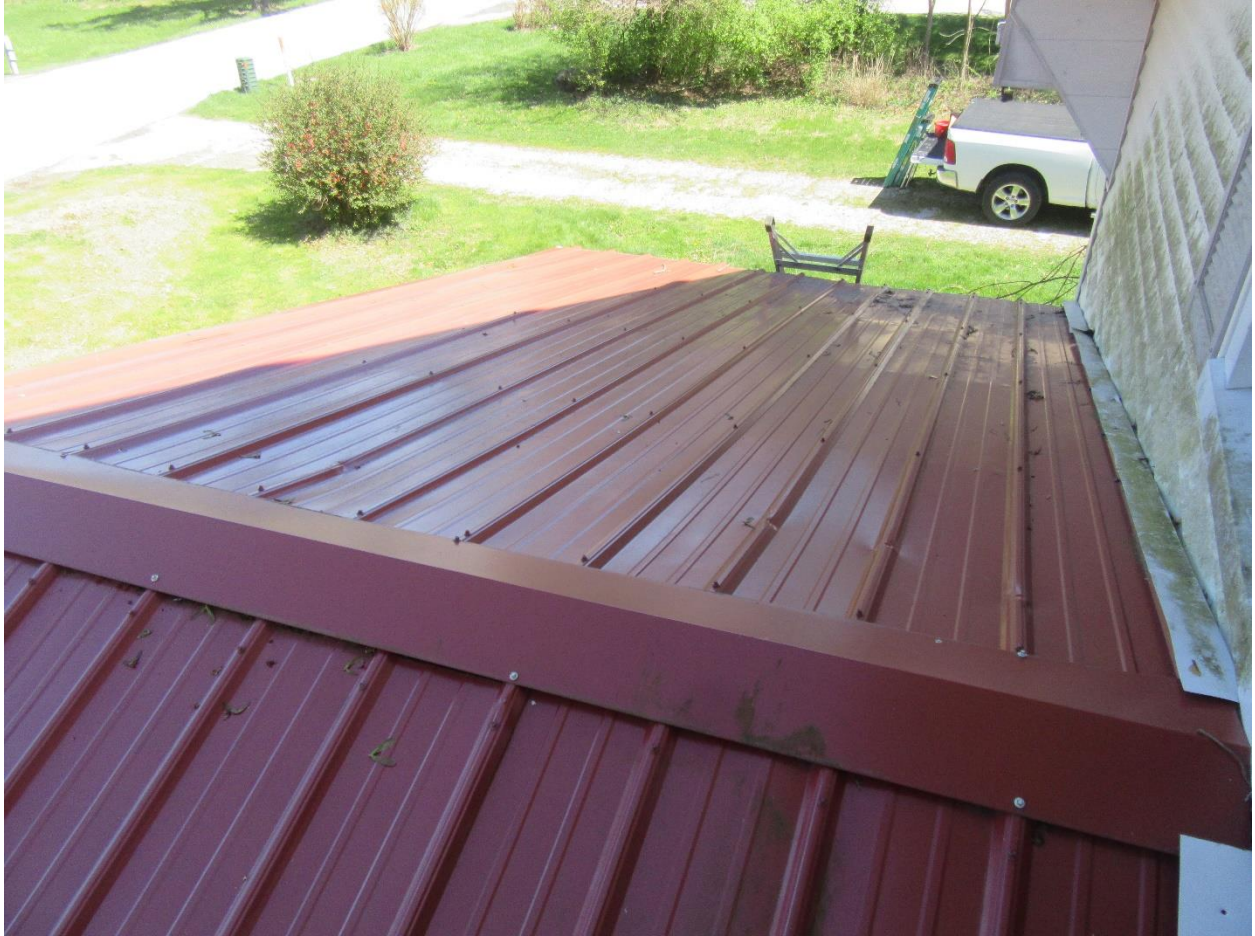
#6 Front porch roof view on the east side.

There are a few dents on the metal roof panels.

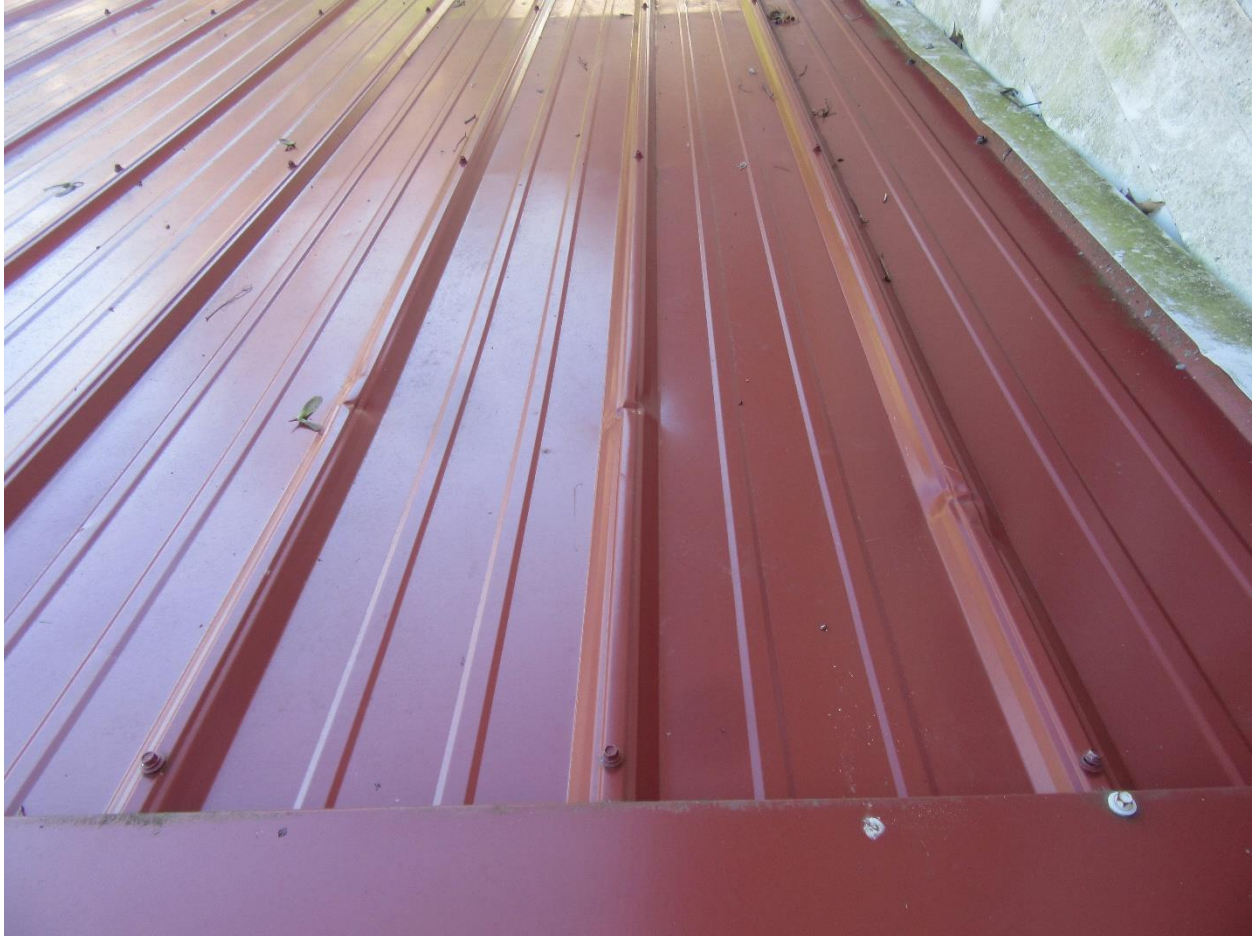
#7 Some of the dents on the front porch roof metal panels.

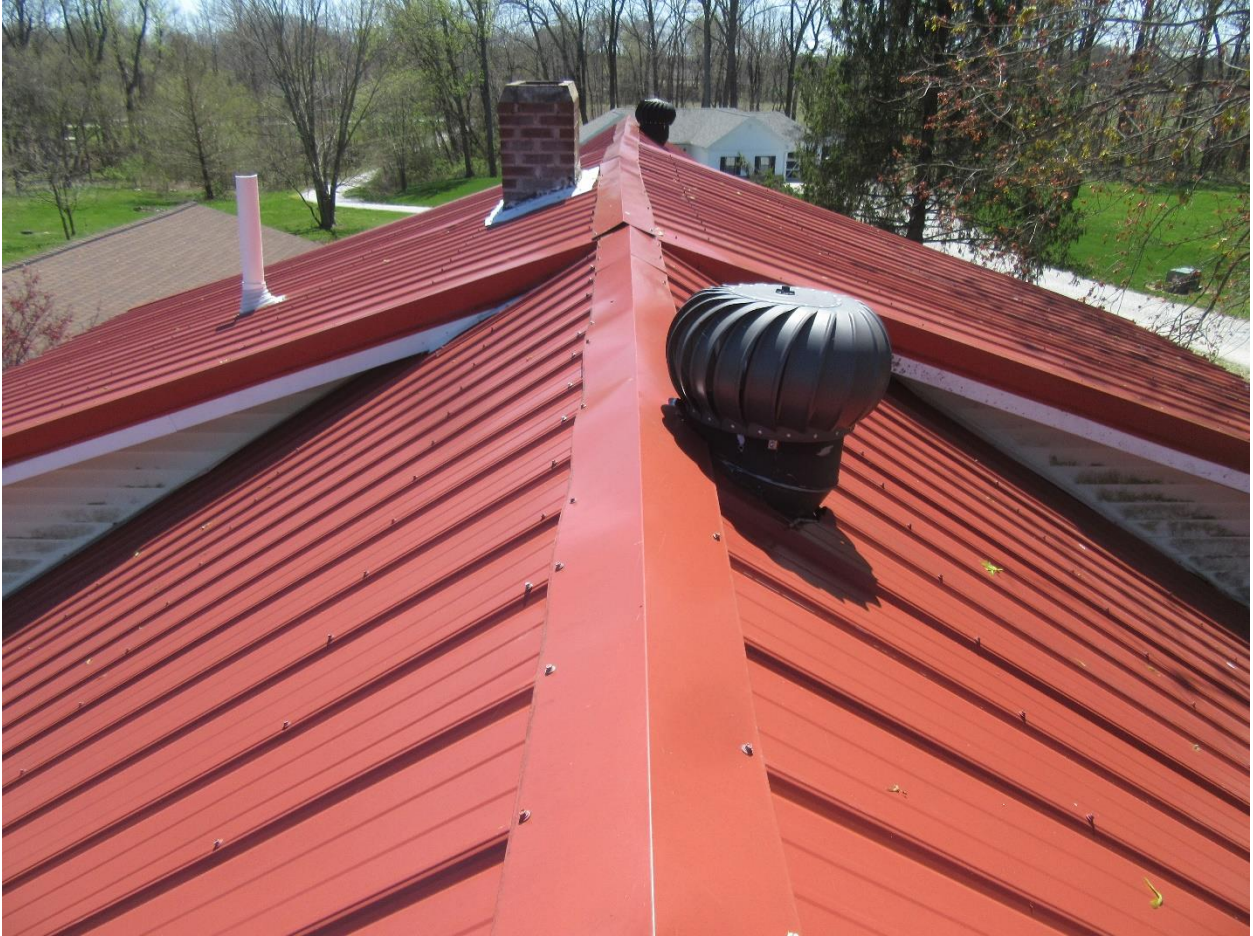
#8 Main upper roof view.

I was unable to safely walk and access these areas due to the steep slope and slick metal.

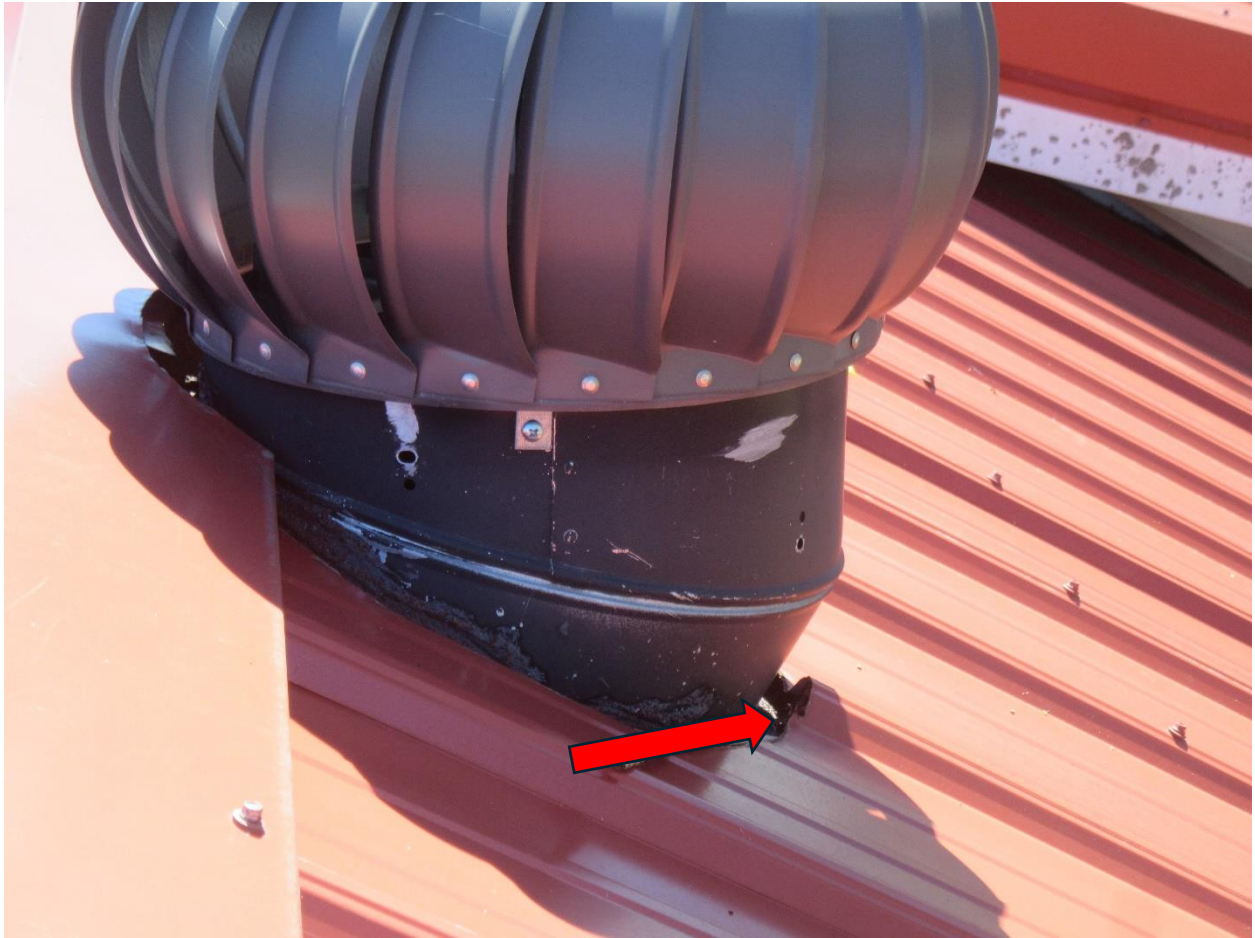
There is a concern that water may leak under the metal roof panels below the wind turbine vents. (See photo #13)

#13 There is a concern that the wind turbine vent is improperly installed. It appears that water may drain in under the metal roof panel. The lower edge wind turbine flashing should be on top of the metal.

There is a concern that the other wind turbine vent may have the same issue.

If the old shingles are still under the metal panels a leak issue may not develop for a while.

*Lower edge extension material may need to be installed in the upper center areas. The chimney needs to be evaluated to determine where the water is leaking, and repairs should be made. Wind turbine vents may need proper flashing.

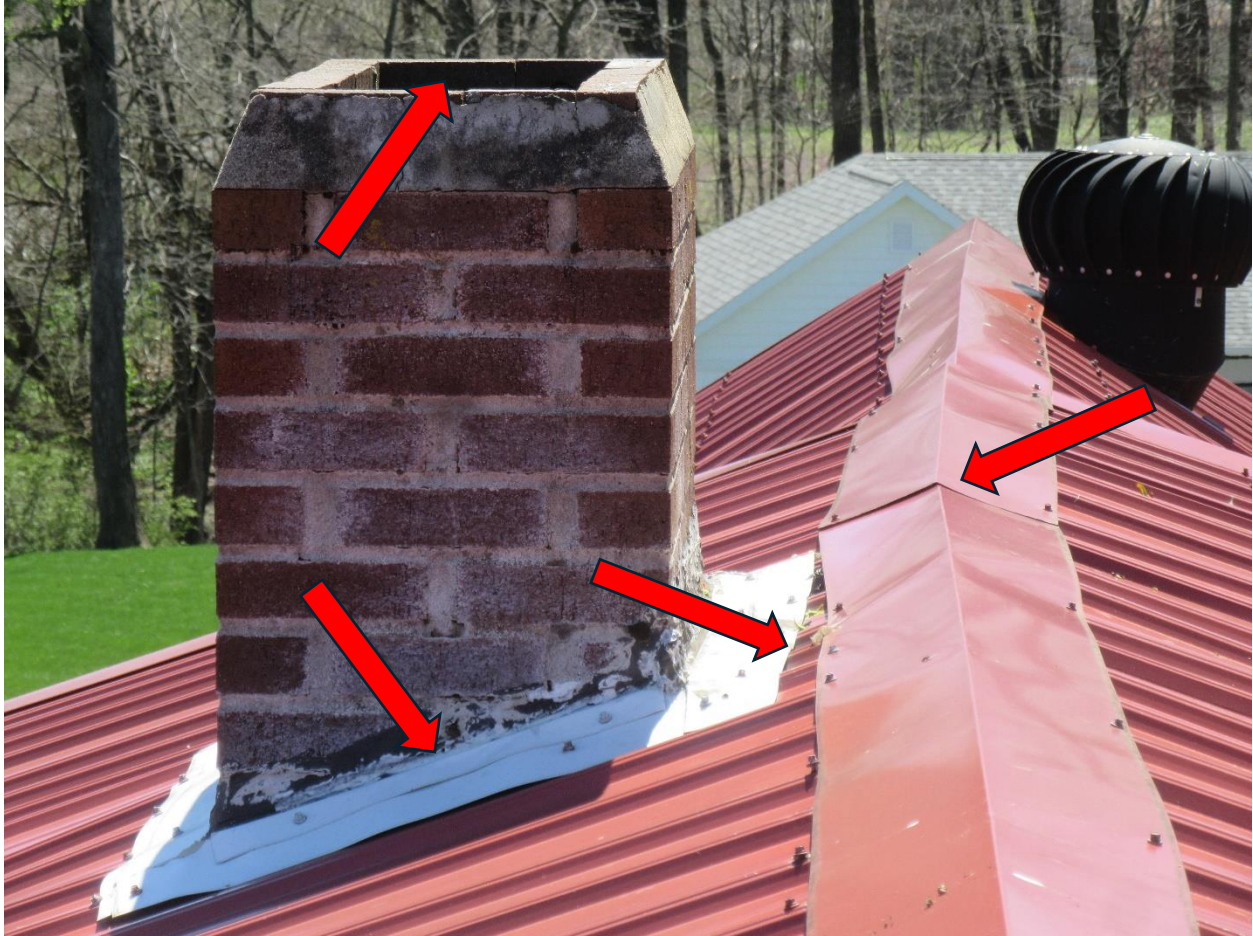
Upper side flashing does not appear to be properly installed.

Water may be able get under the flashing. (See photo #14)

#14 View of the chimney and upper center roof area.

The metal ridge is crooked and poorly installed.

The chimney appears to have a leak issue. Water-stained walls and ceilings below have elevated moisture readings. Water may be able to leak in under the upper chimney flashing edge. I am unsure if the caulking is in satisfactory condition.

Chimney is missing the flue cap/cover.

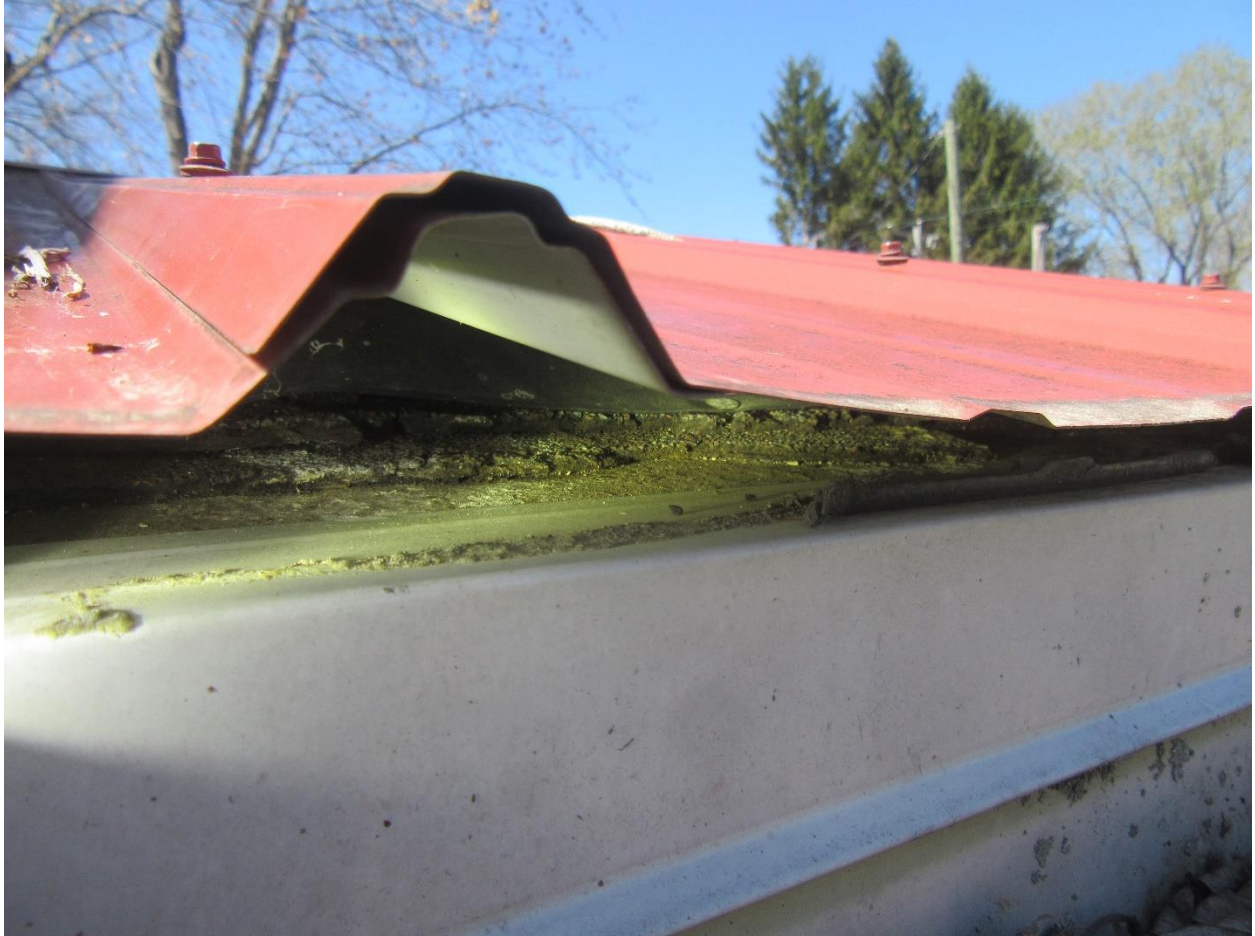
#15 View along part of the lower edge of the metal roof.
(See next photo)

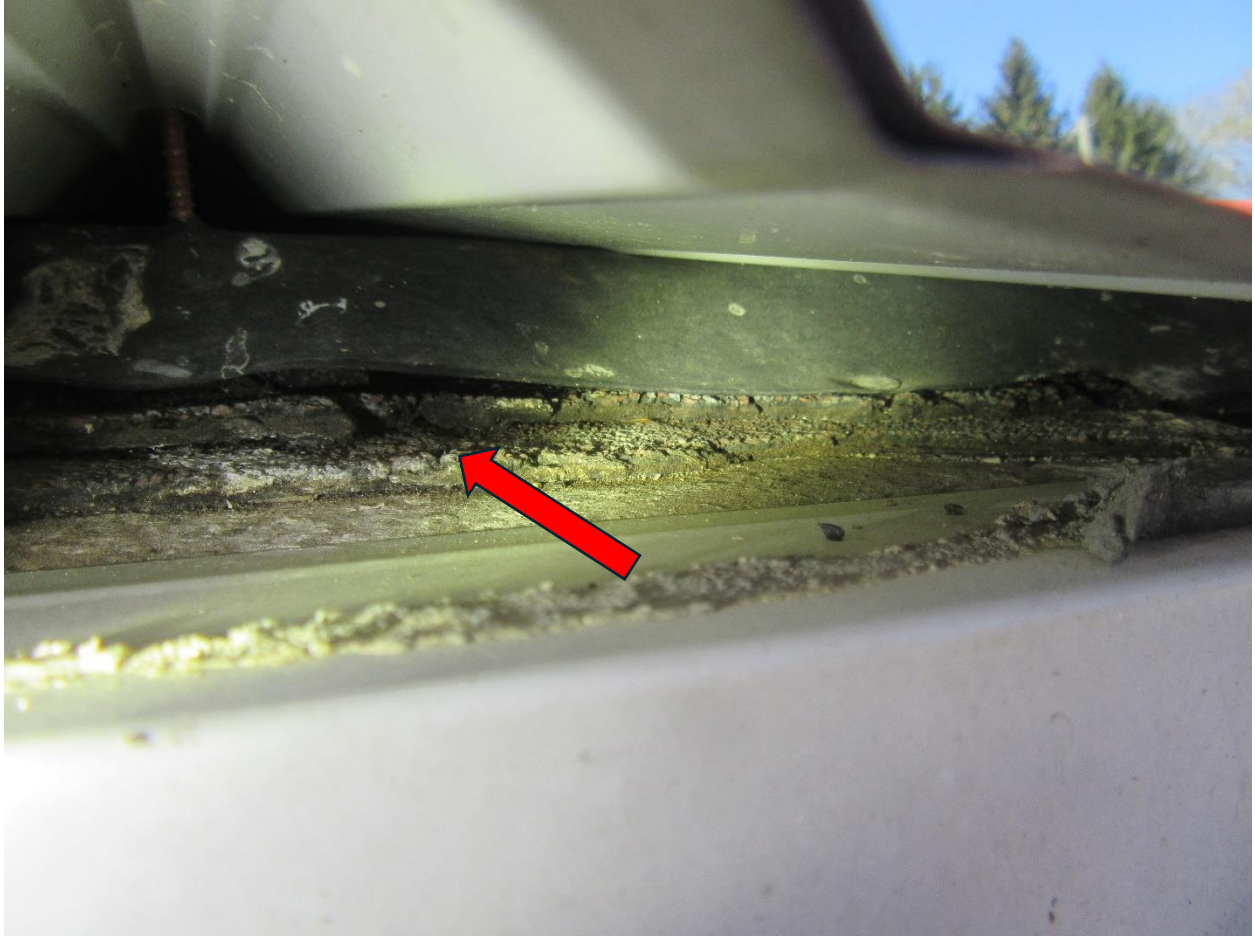
*The metal roof material appears to be in satisfactory condition overall. There are minor dents on the front porch. Metal panels appear to be installed over an existing older shingle roof. (See photos #15, 16) There may be a rubber layer on top of the old shingles. I was only able to view very small lower edges of the old roof material under the lower edges of the metal roof.

#16 View along a small section of the lower metal roof panels. It appears that the metal roof has been installed over an old existing shingle roof. There appears to be a layer of rubber material that may have been installed as a underlayment for the metal roof.

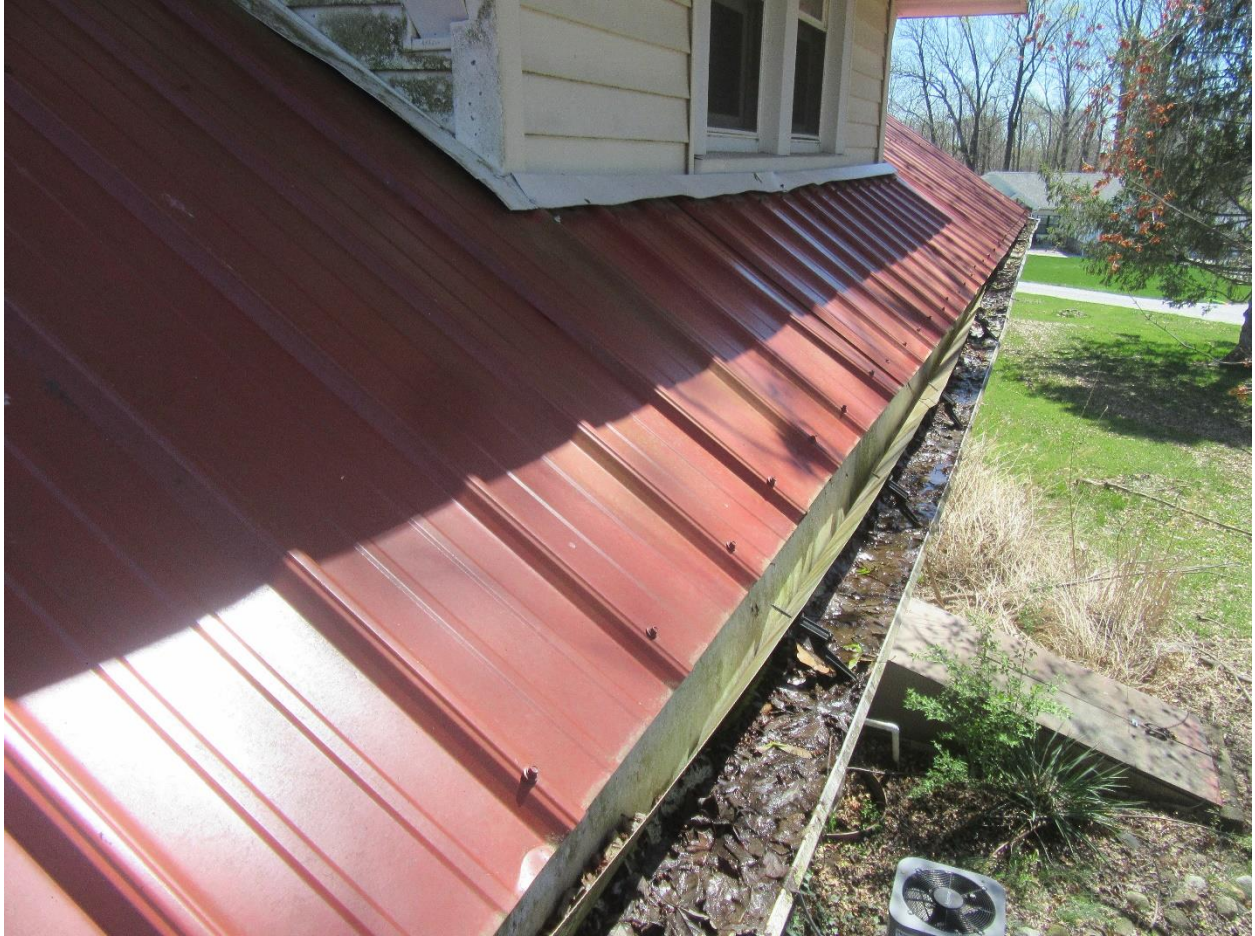
#19 View along the lower west side. The gutter is loose and pulling away from the house.

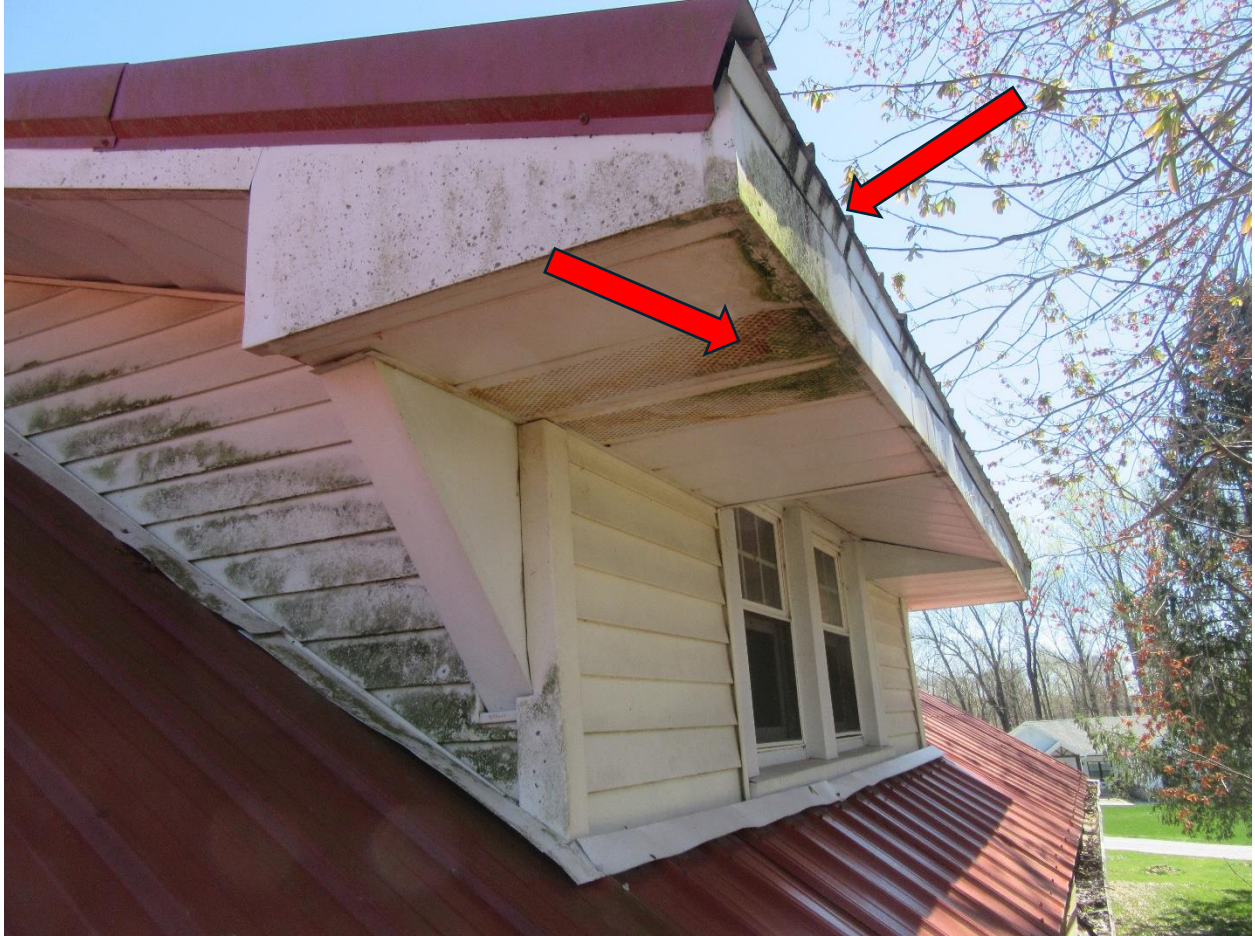
*There are slight concerns with the quality of the metal roof installation. The lower edges of the metal panels do not appear to be extended far enough out past the fascia.

*Water is leaking in behind the fascia and soffit on the upper west side dormer. (See photo #20)

#20 The metal roof panels on the upper center areas are not extended far enough out past the fascia materials. Water is leaking down into the soffit panels.

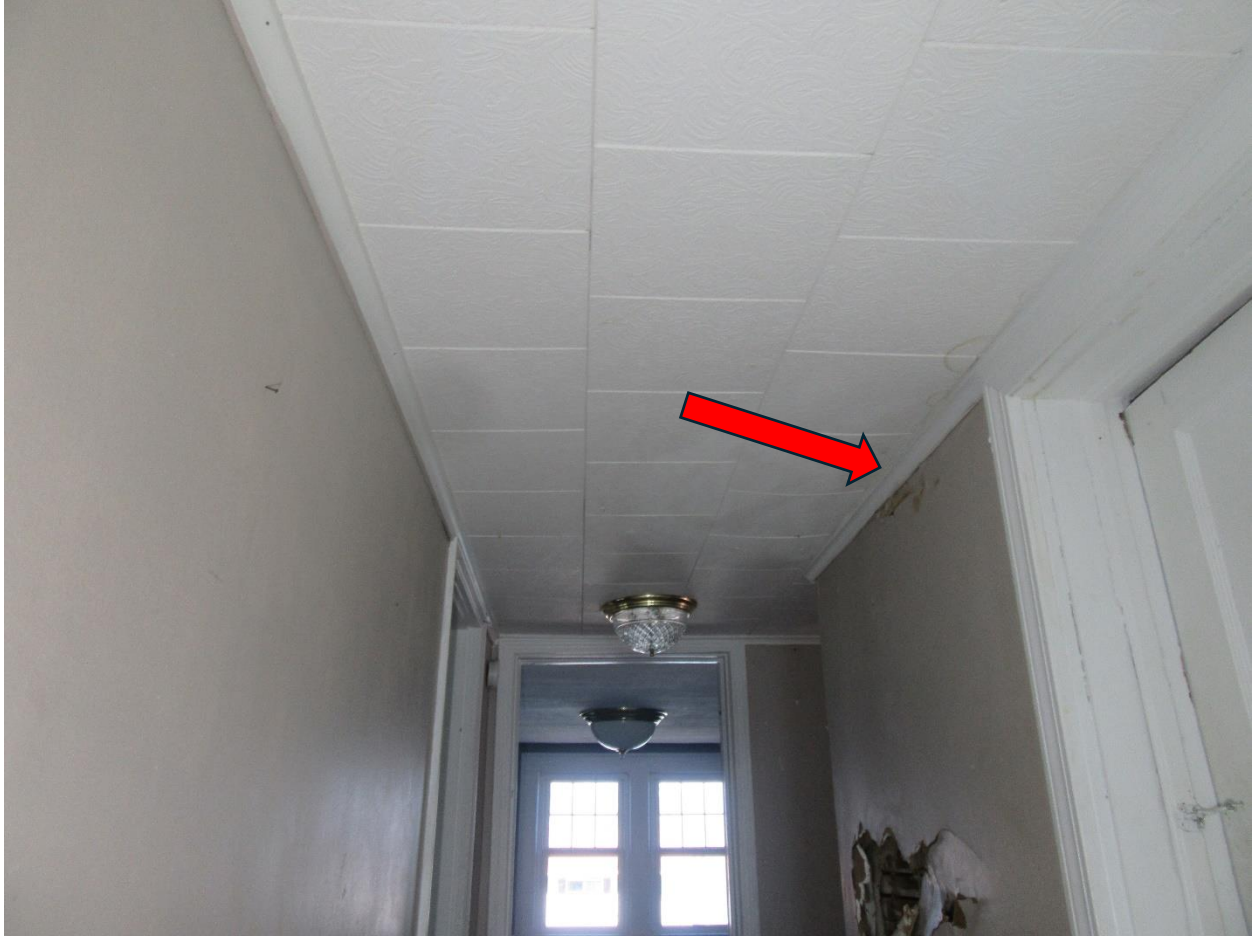
Ceiling/wall stains and damaged areas in the interior around the chimney had elevated moisture readings. (See photos #28, 30, 32, 33) This usually indicates a current leak issue.

#28 Upper level hall view.

There are water stains and damage where there appears to be a leak issue around the chimney. (See upcoming photos)

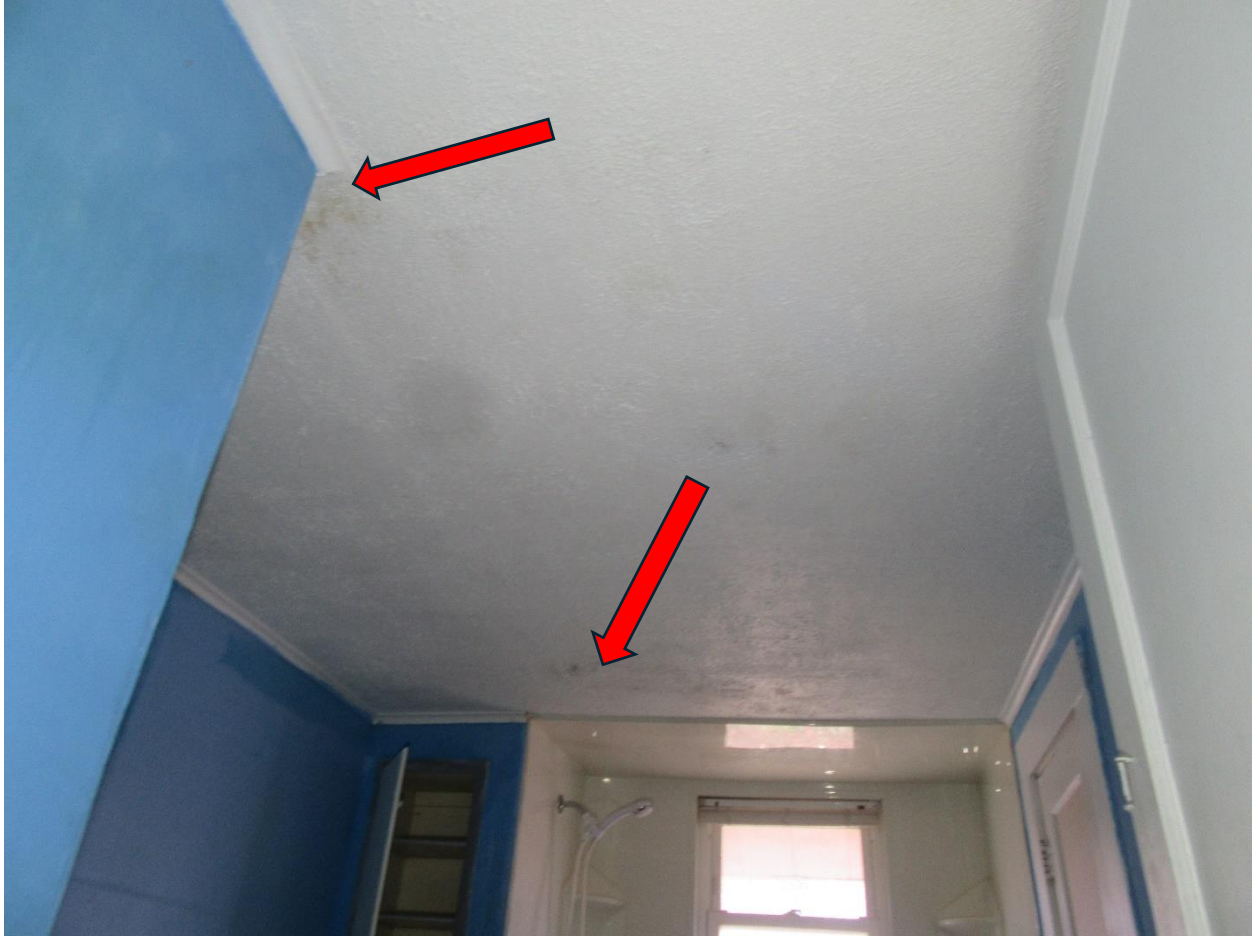
#30 Upper level bathroom view.

Stains and damage on the ceiling indicates current or old roof leak issues.

I did not detect an elevated moisture reading on the area above the tub/shower. Damage may be from an old roof leak.

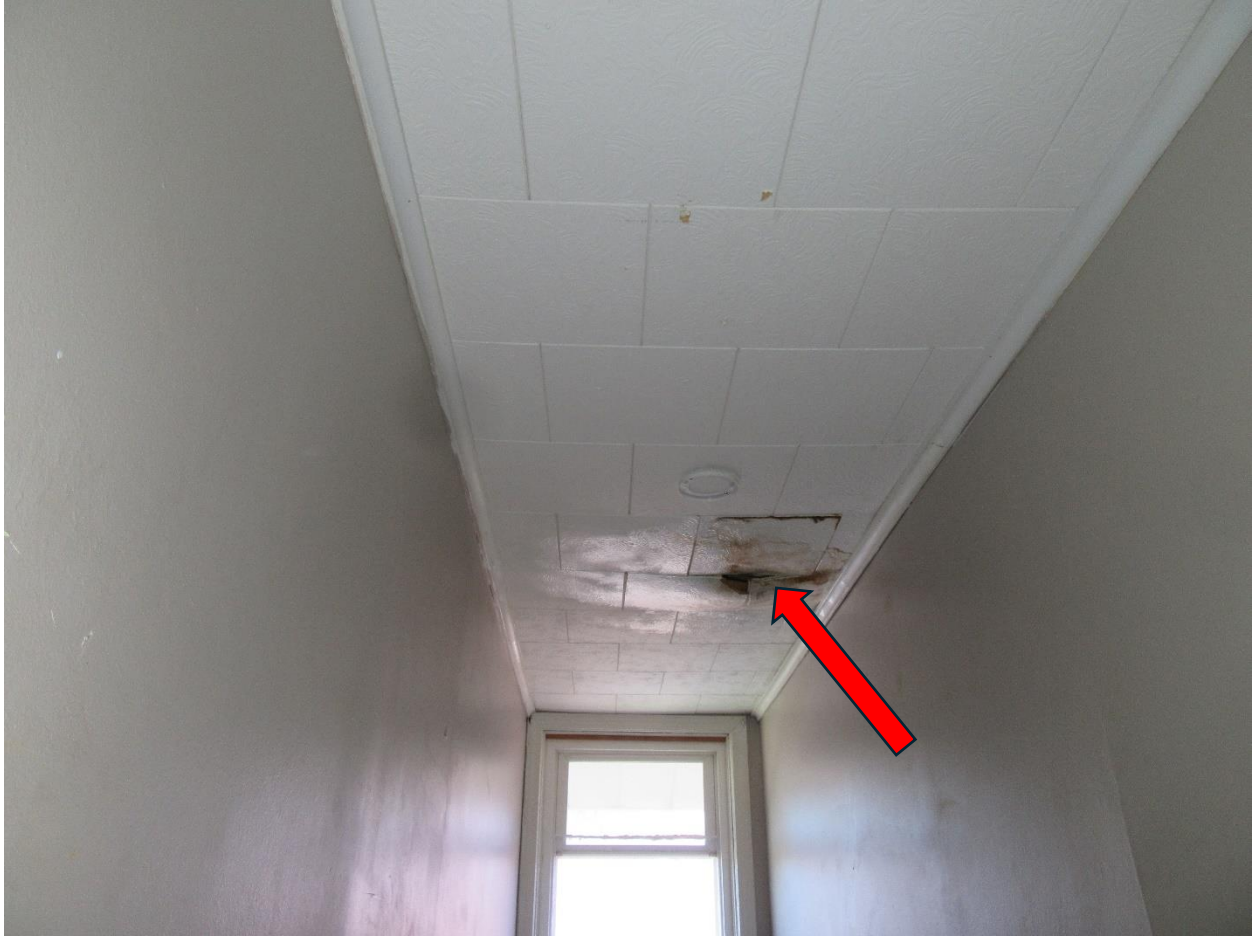
#31 Upper level ceiling view above the stairs.

There has been a significant roof leak issue here. I did not detect an elevated moisture reading and this may be damage from an old leak issue.

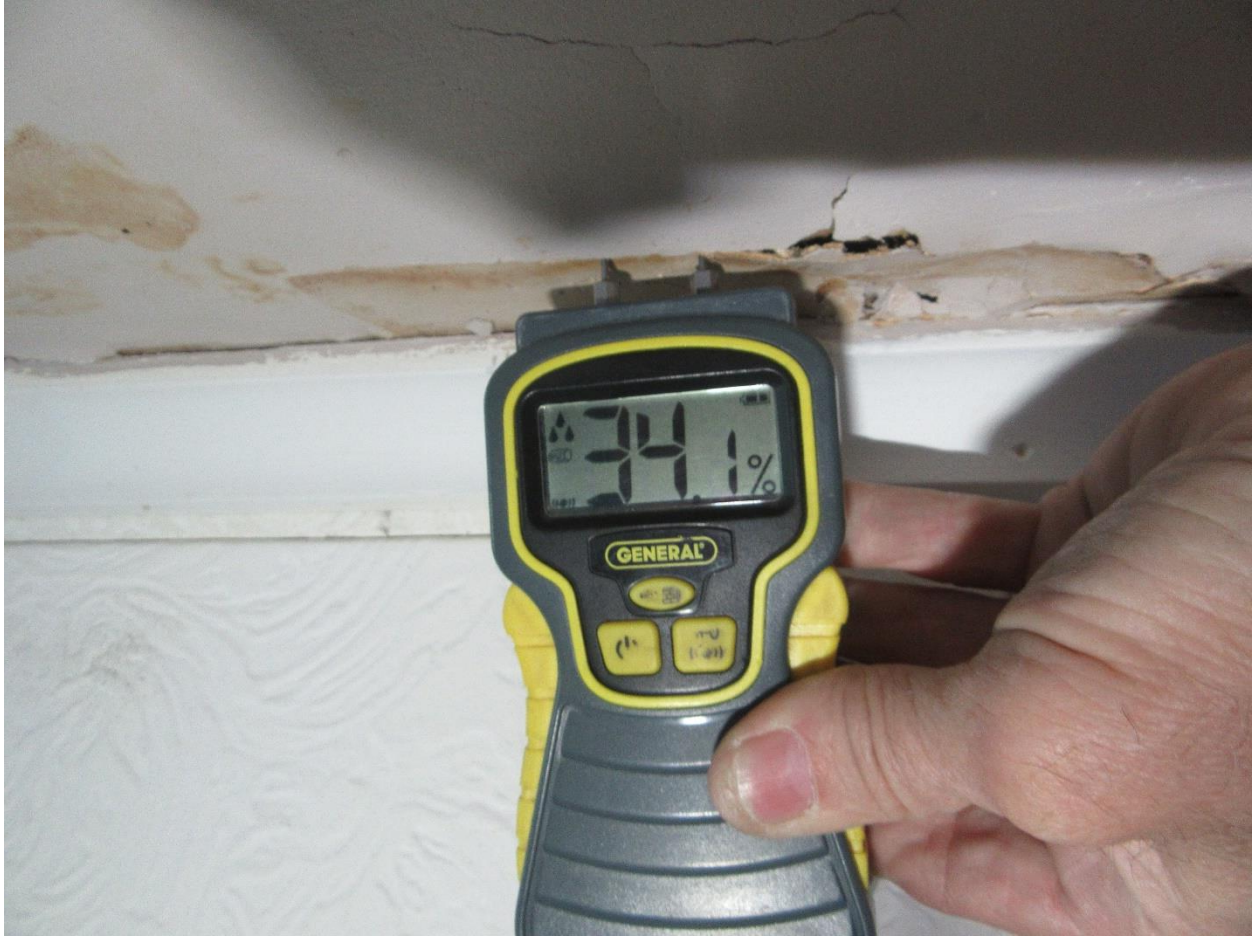
#32 Elevated moisture level in the upper level hall wall/ceiling damage. This appears to indicate a current leak issue. Chimney is located behind the wall here.

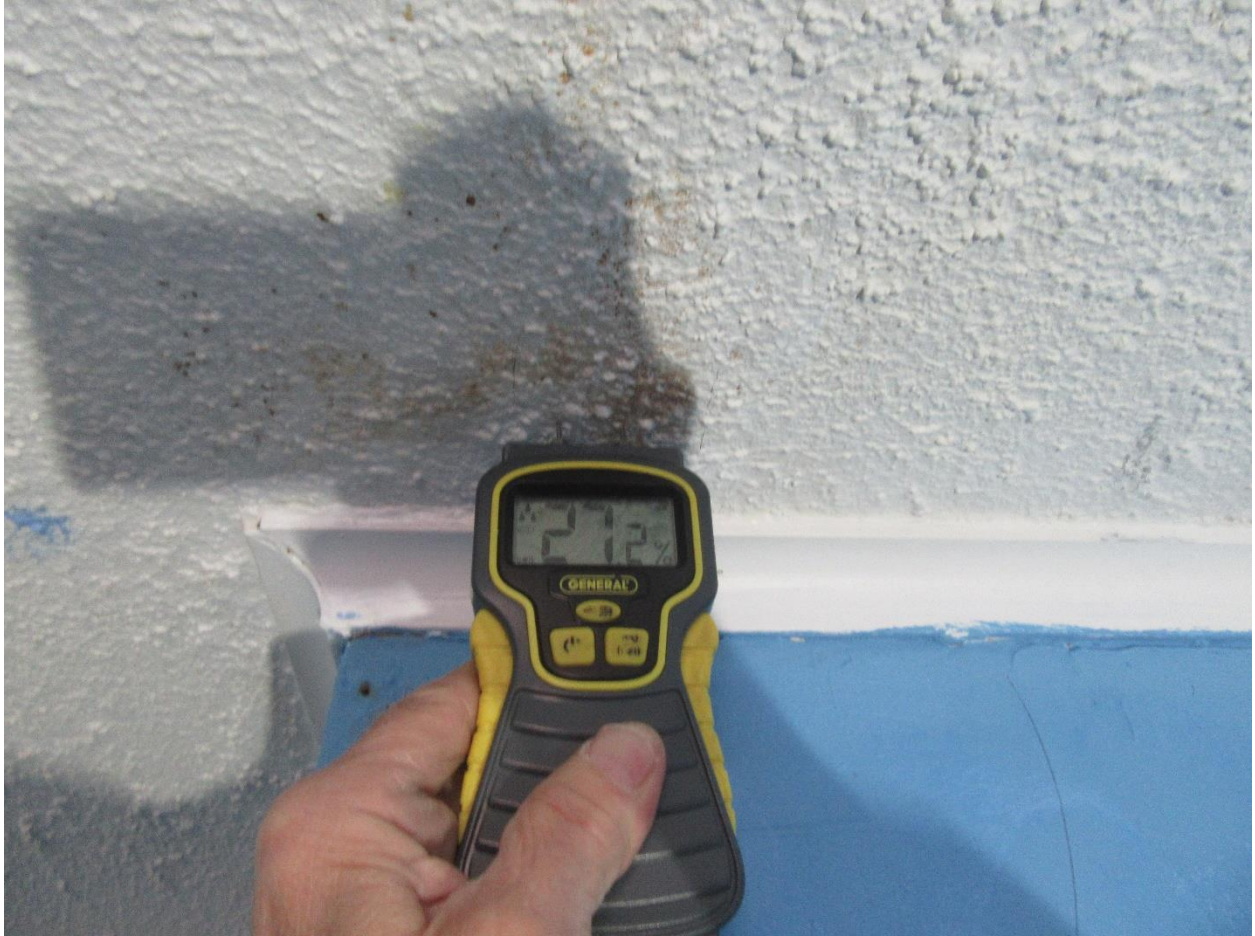
#33 Elevated moisture level reading on the upper level bathroom ceiling. The chimney is located behind the wall.

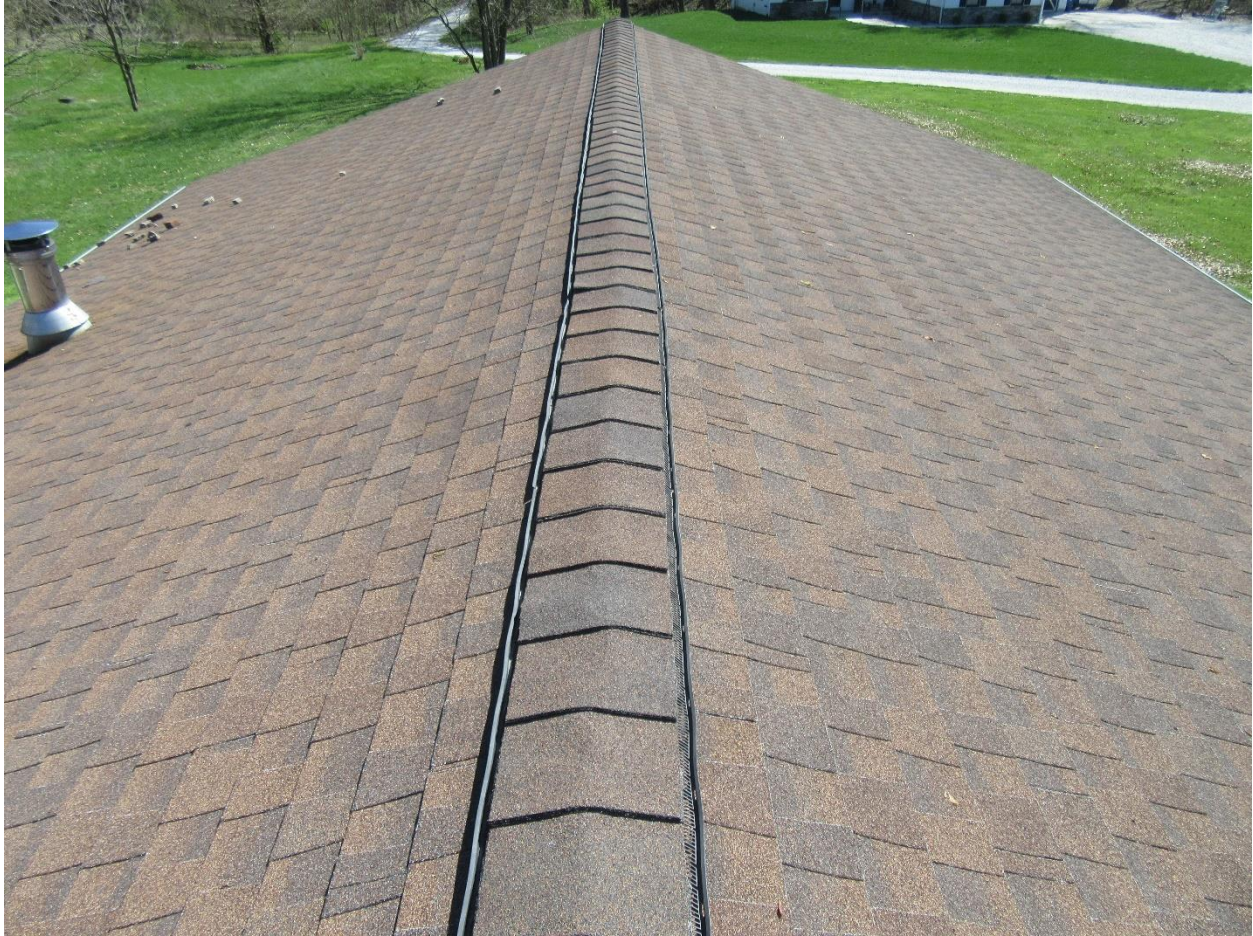
#36 Detached garage building roof view looking to the south end.

Shingles appear to be in satisfactory condition for the age.

There are minor defects.

Appears to be 1 layer of shingles.

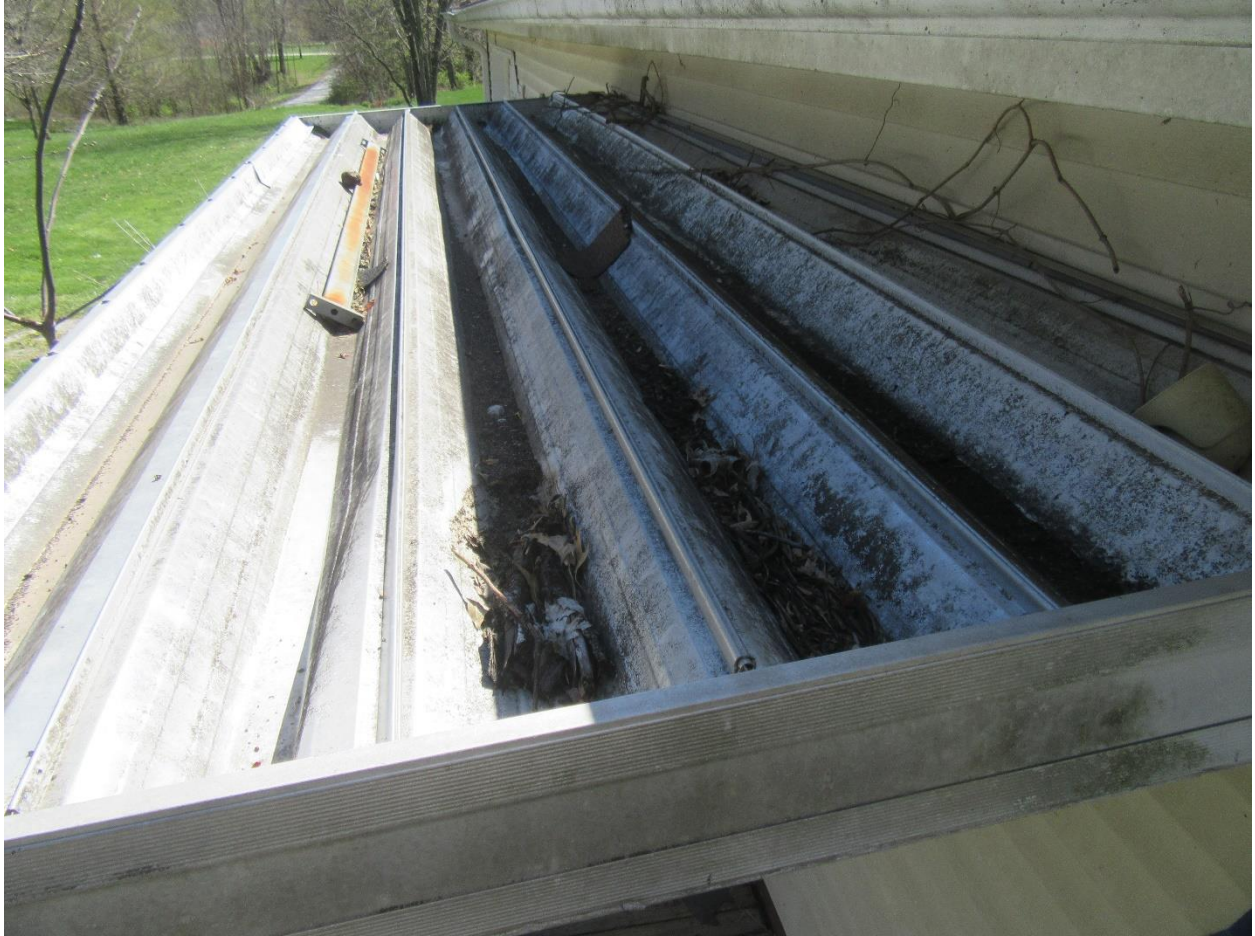
#38 Small metal roof above the detached garage building entry door.

Metal appears to be in satisfactory condition, but needs to have the debris removed and the metal properly cleaned.
