422 N. 7th St. Mitchell, IN 47446 Roof Inspection 9-30-24

Performed by: Mark Walcott Roofing Contractor

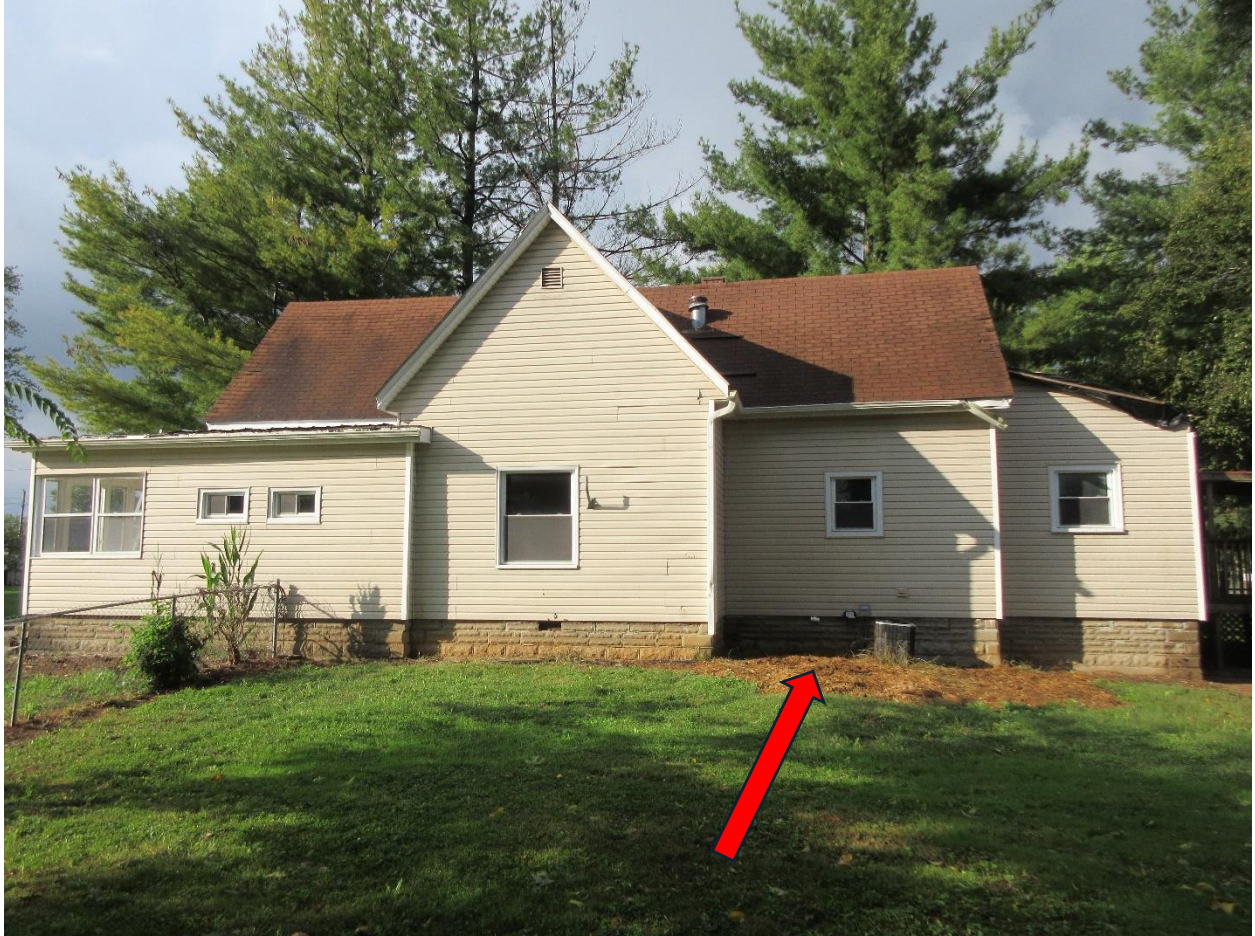
#8 South side view

A tree appears to have been recently removed in this area.
The tree may have fallen and caused roof damages.

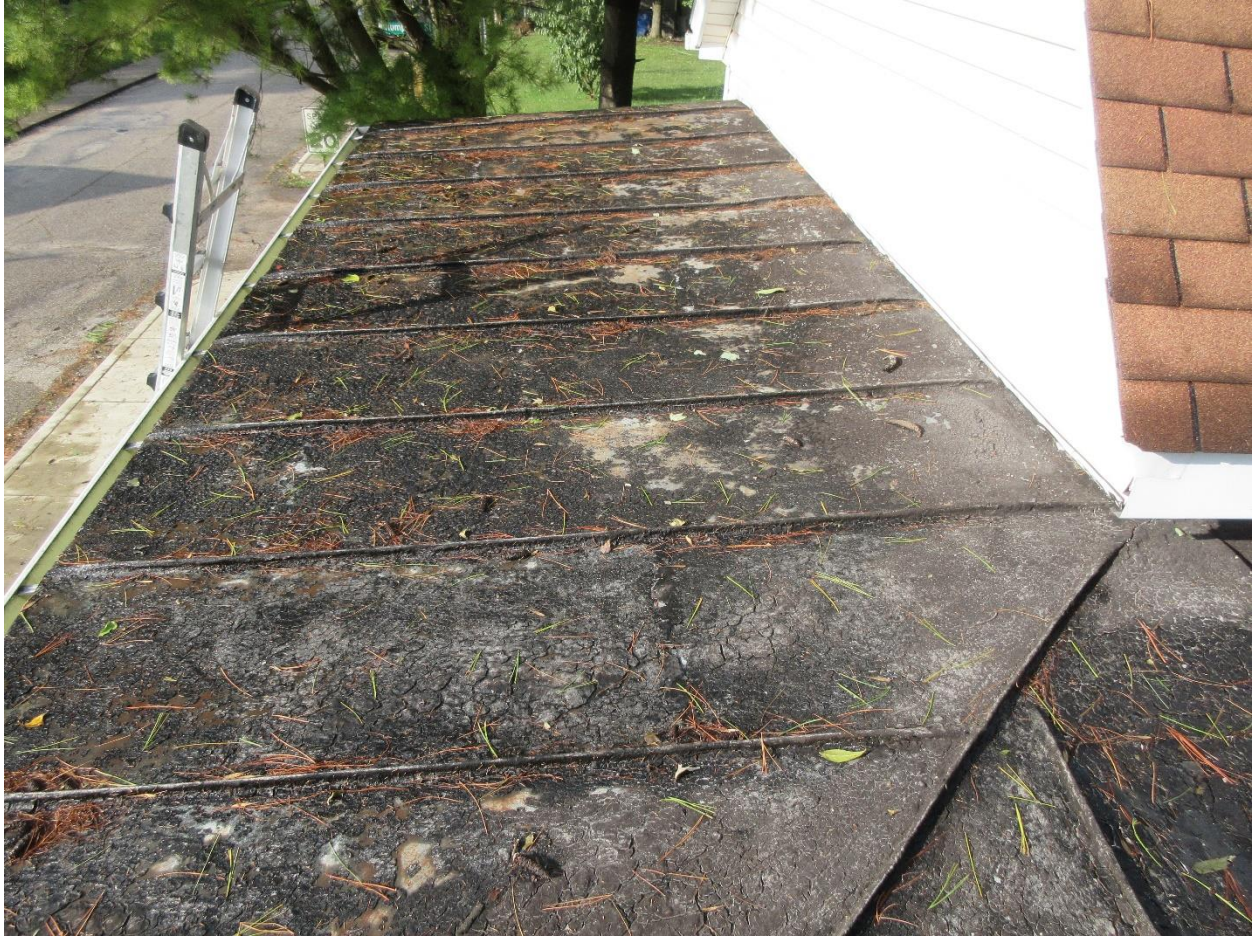
#9 Front porch roof view.

The low-slope metal standing seam roof material has been improperly coated with tar. Tar is cracked and peeling loose.

Roof has leak issues. I recommend removing the old metal roof, replace any damaged decking materials, and install a low-slope roof material such as a Granulated SBS Modified Bitumen Membrane roof material.

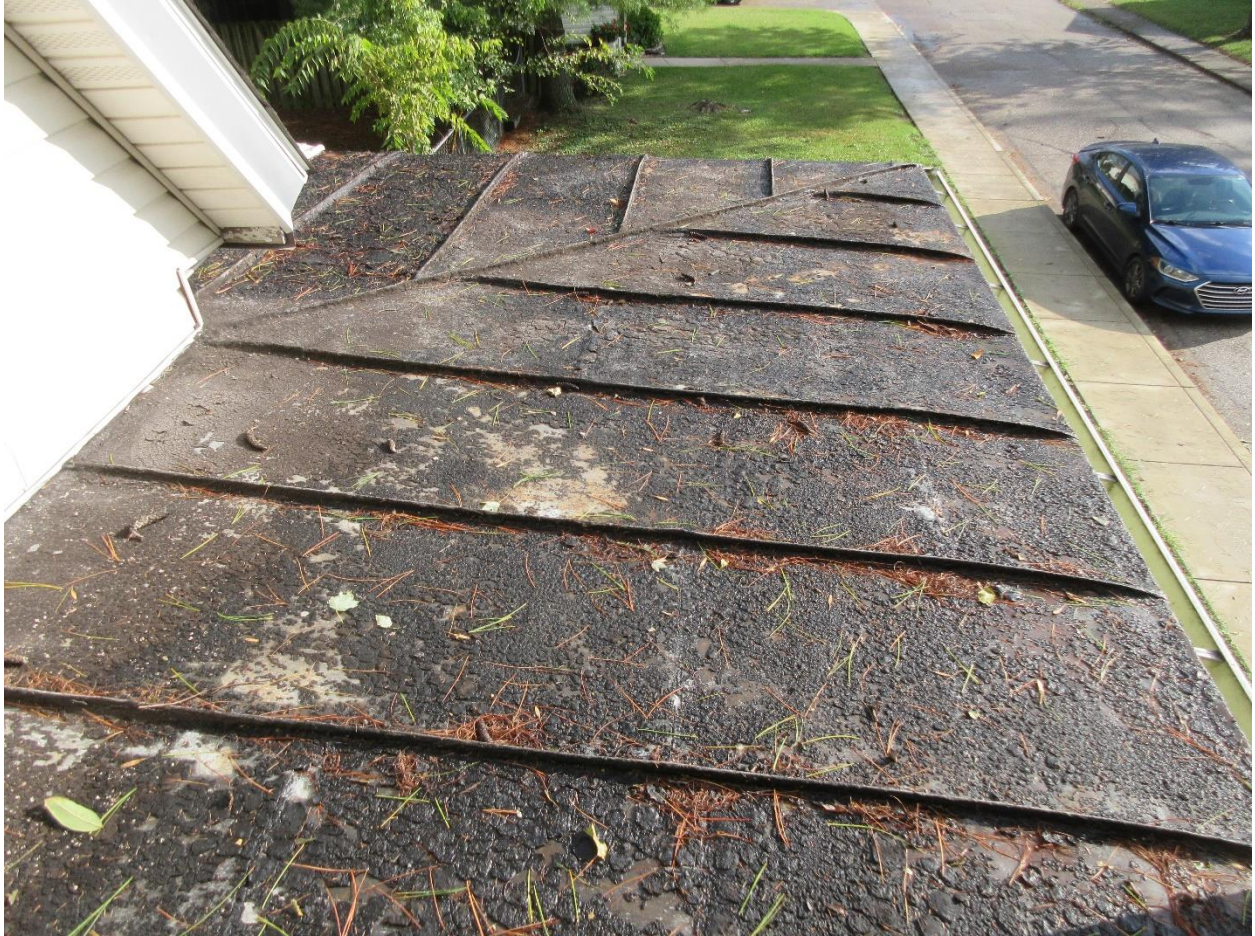
#10 Partial front porch roof view.

The tar coating is damaged and peeling loose.

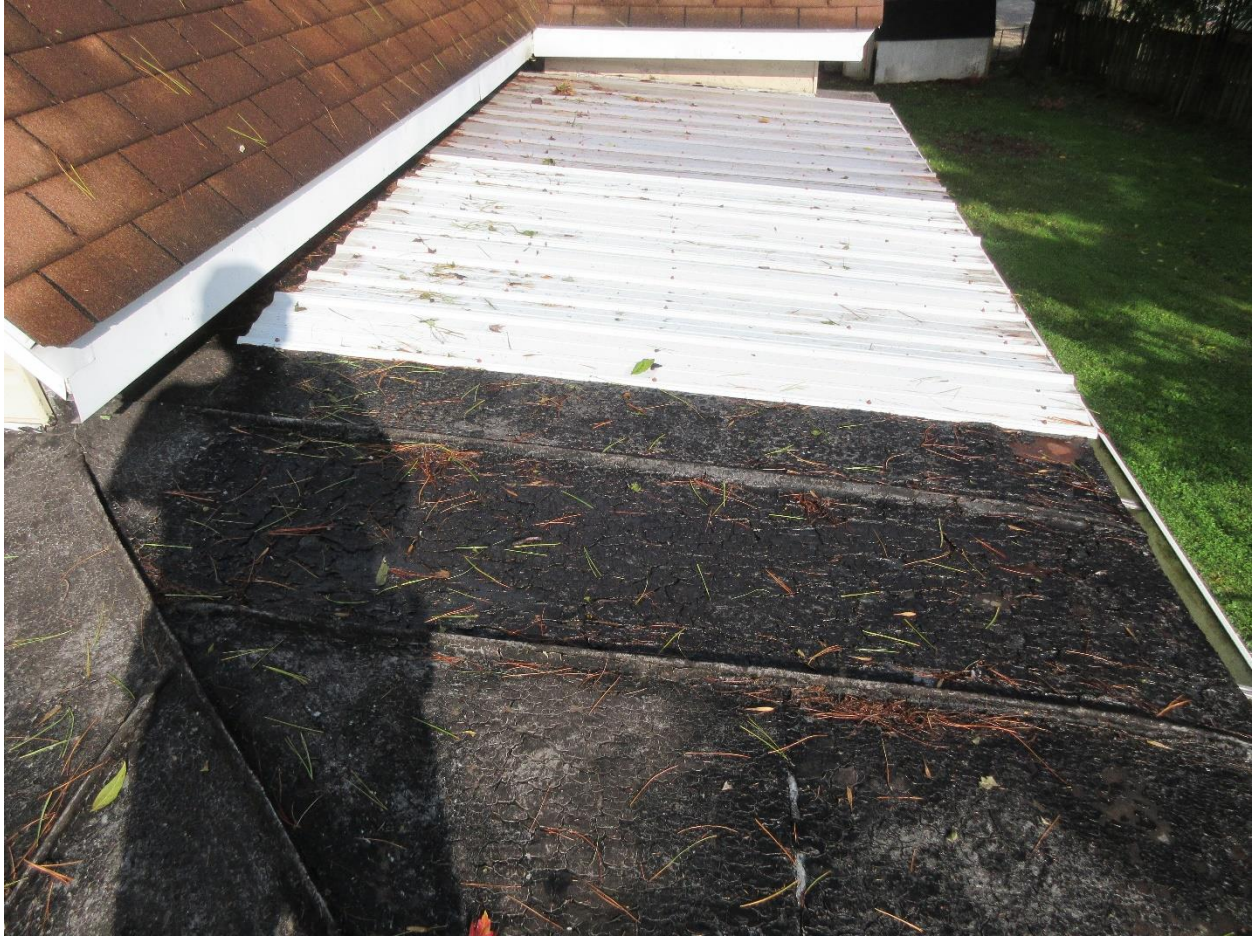
#11 Porch roof view on the south side.

A second layer of metal roof material has been improperly applied over the older metal roof. Some of the material is buckled up. There have been leak issues in this area.

*The entire porch roof should be removed. Any damaged structural and decking materials need to be replaced. A new low-slope roof material can be installed. An SBS Modified Bitumen Membrane roof is recommended.

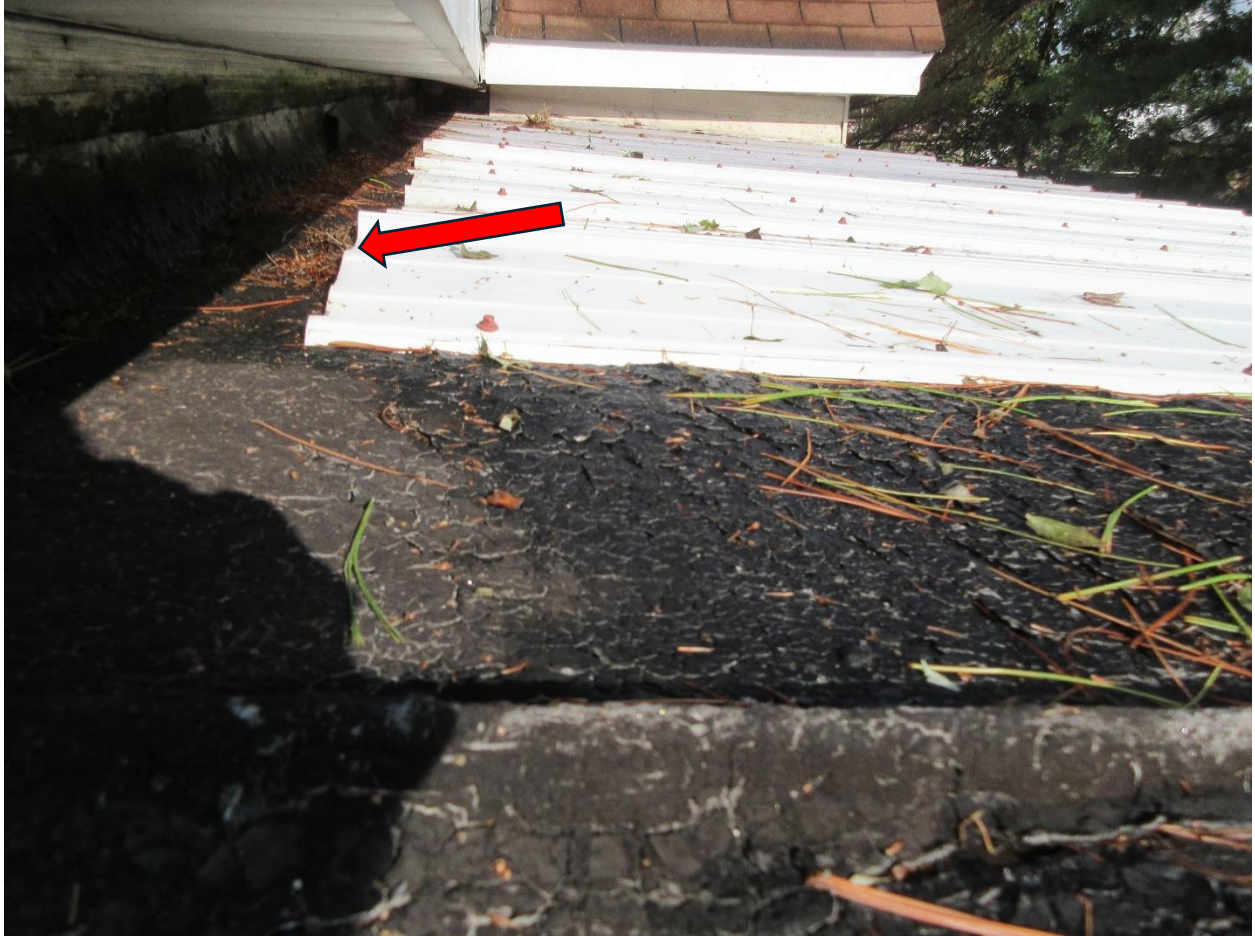
#12 Improperly installed metal roof material does not extend all of the way under the main roof overhang. Water can get underneath the new layer of metal.

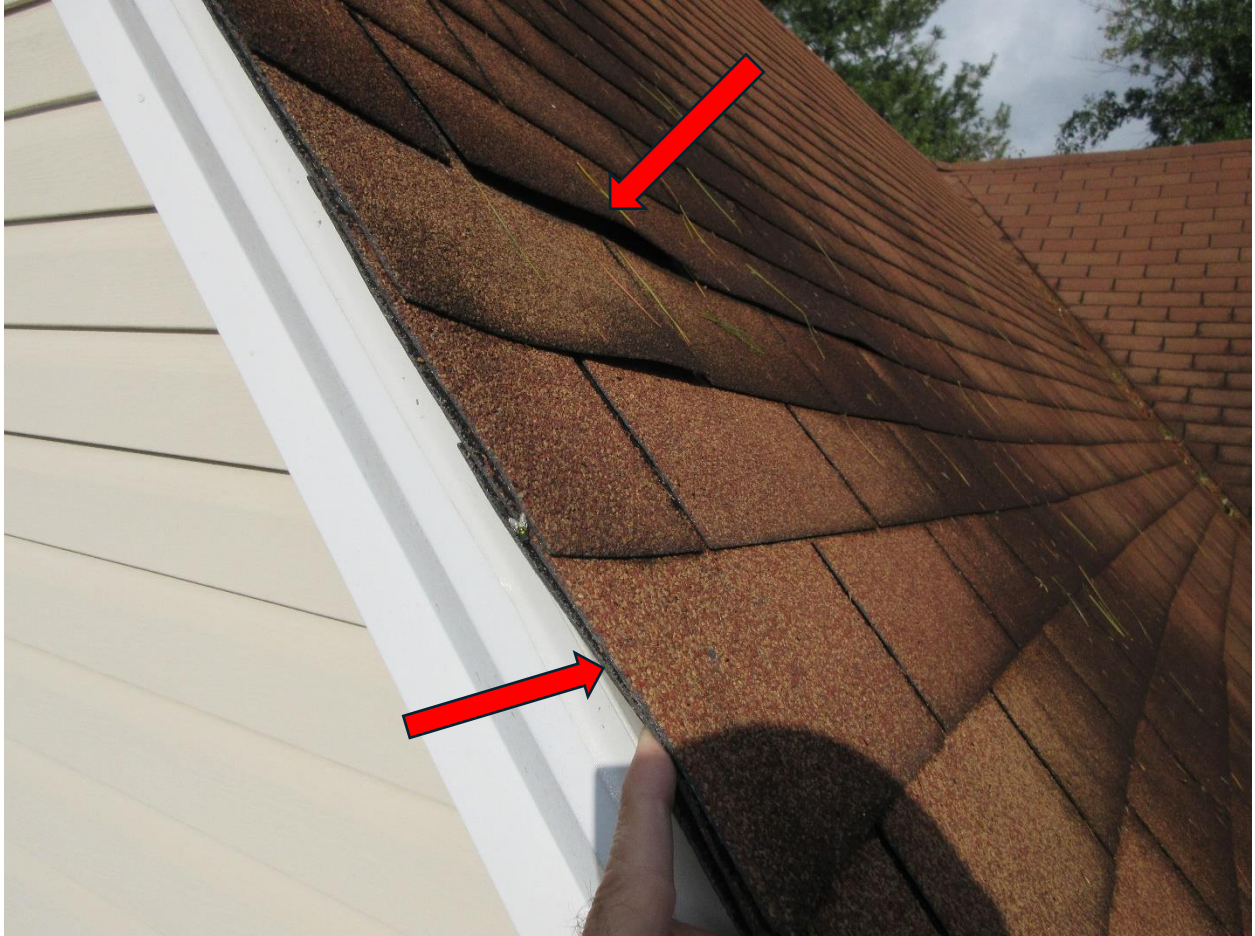
#14 There appears to be one layer of standard three-tab shingles on the main roof areas.

There are a few slightly raised shingle tabs that may need to be properly fastened.

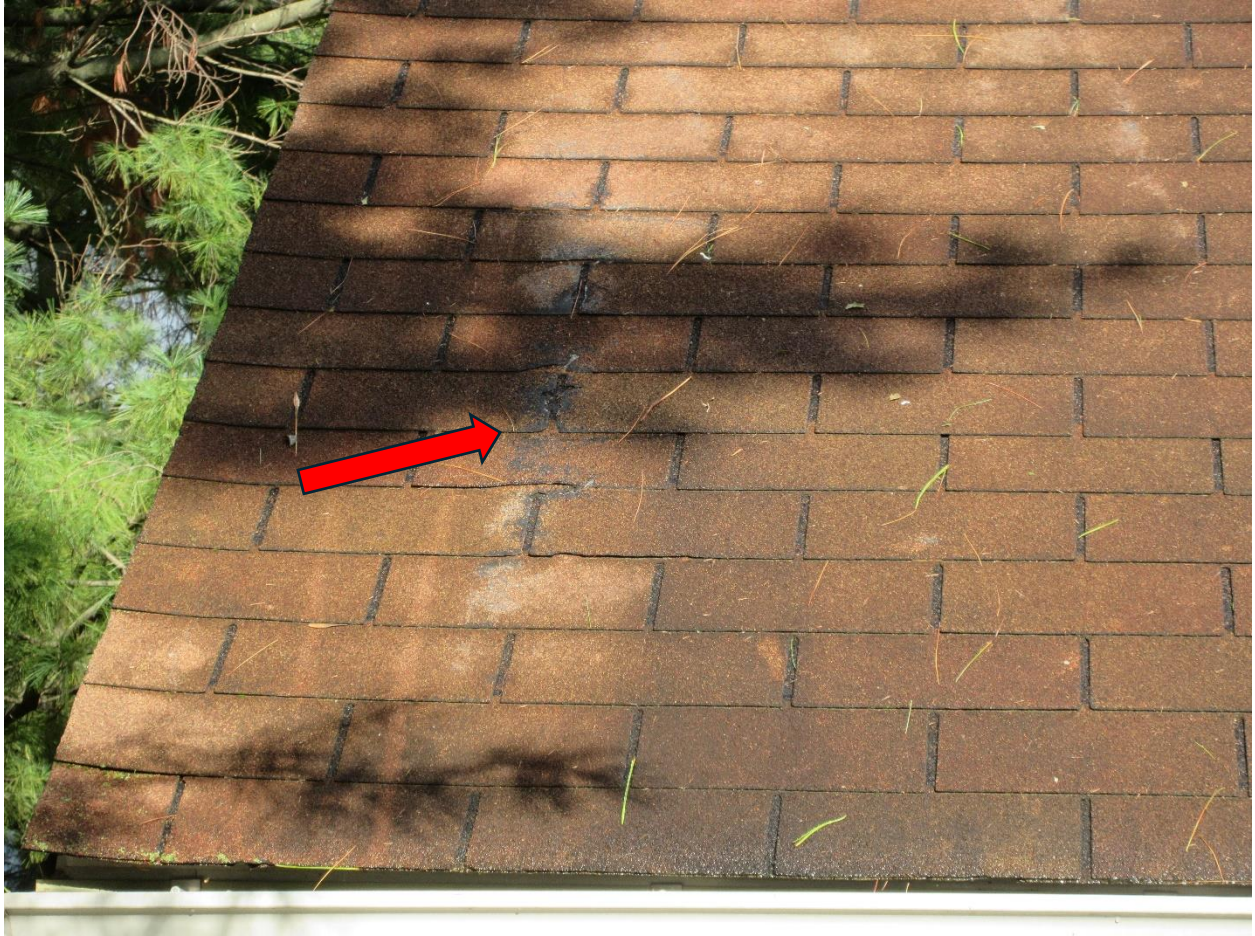
#16 Shingle damage on the N/W corner roof area.
Damaged shingles should be repaired or replaced.

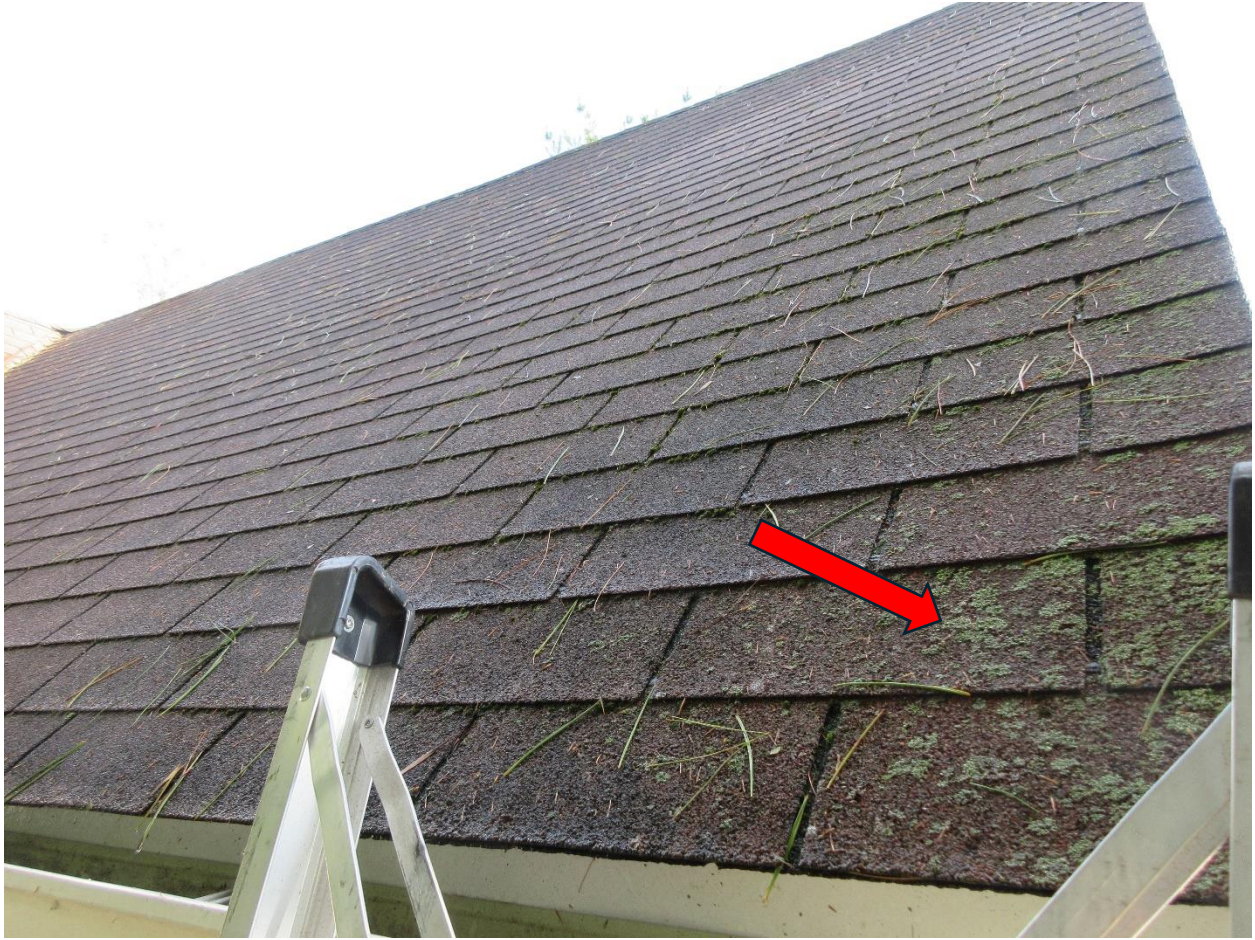
#17 N/W corner roof view.

Algae and moss are forming on some roof areas.

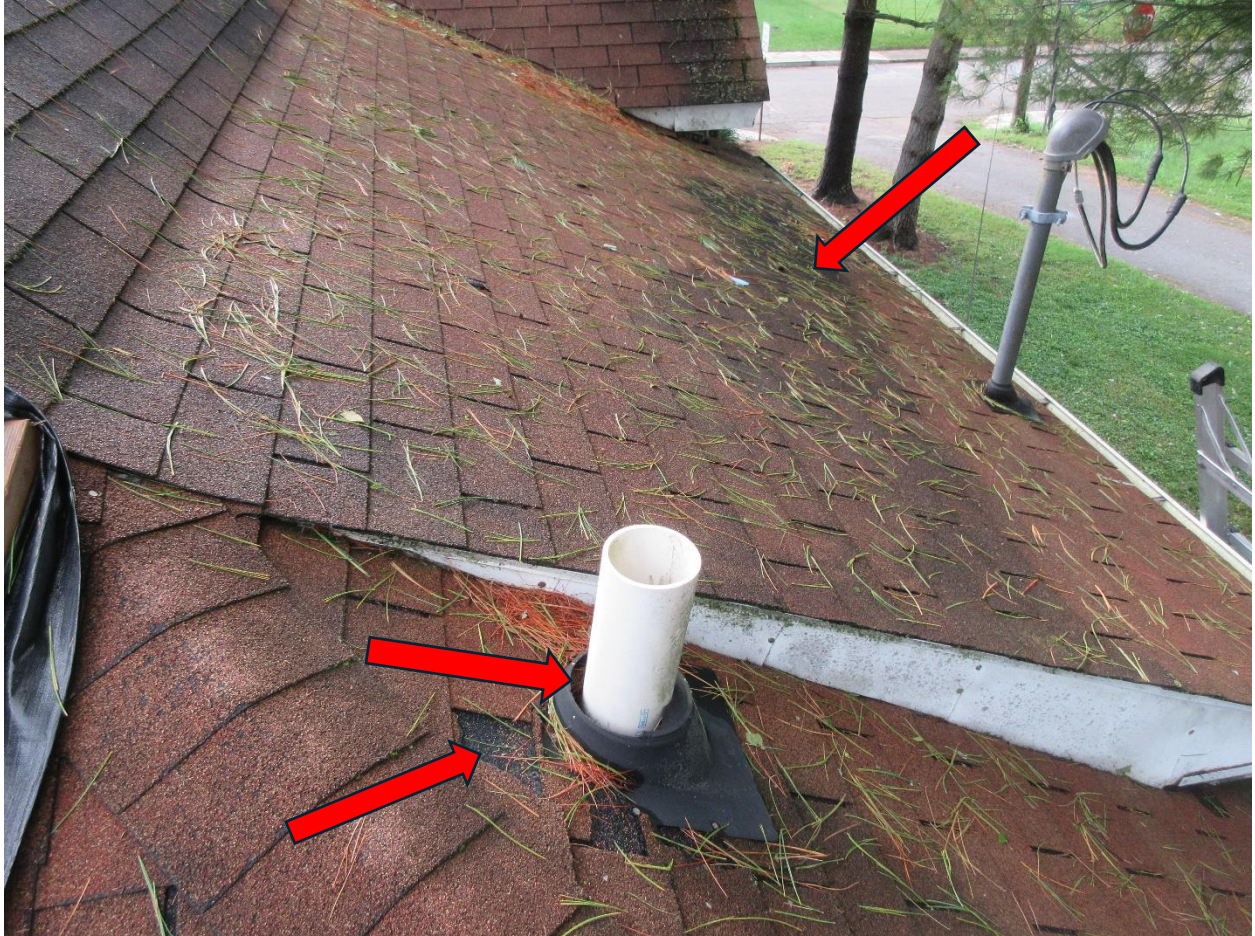
#19 Roof view on the N/E corner area.

Shingles have algae growth in the darkened area.

Shingles are damaged around the plumbing vent pipe.

The rubber pipe flashing boot is damaged.

*Damaged shingles and the pipe flashing boot need to be replaced.

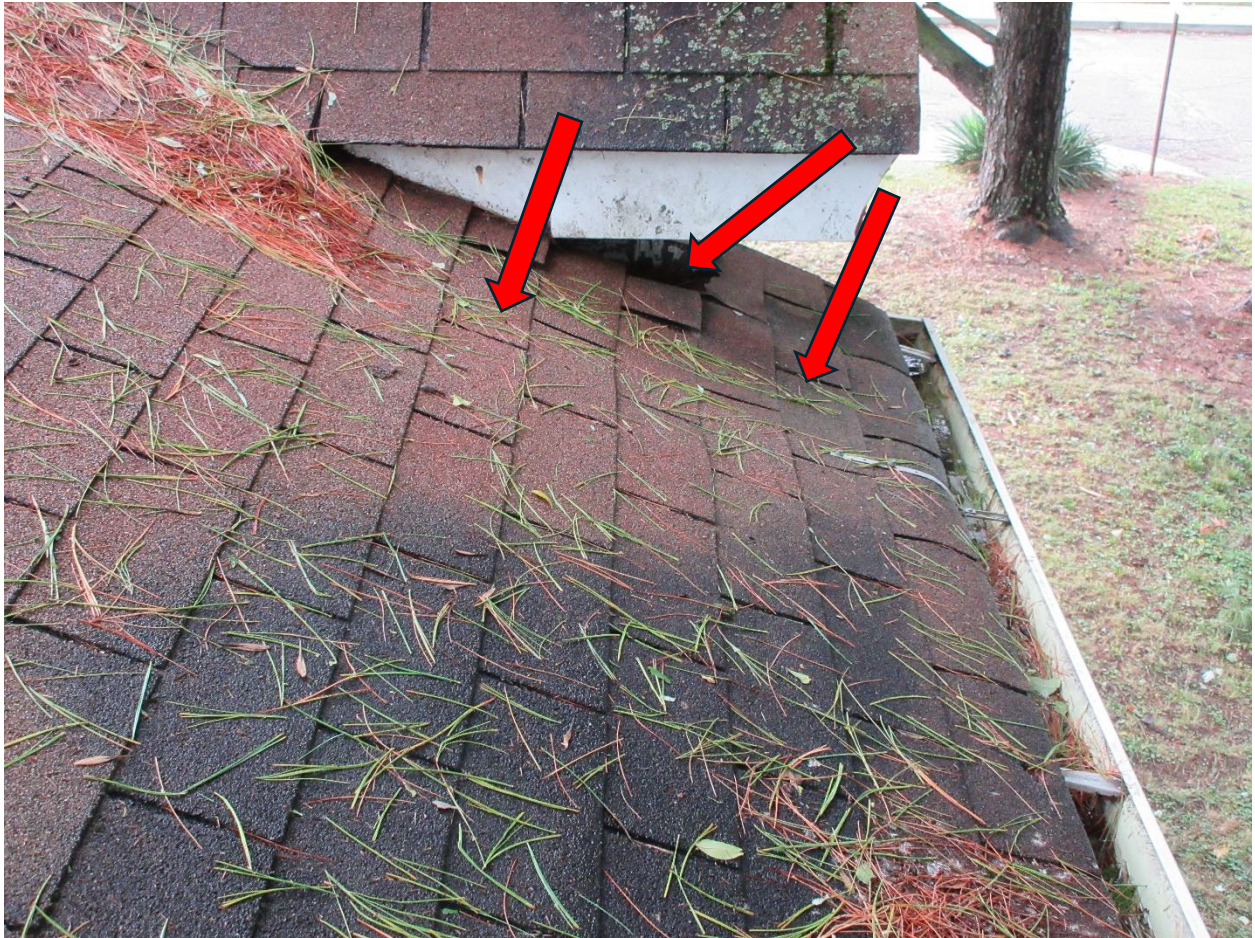
#20 Roof damage on the center area on the north side. There appears to be a leak issue in this area.

The decking is sagging in this area. There is damaged material and an opening under the overhang area.

*The shingles need to be removed in this area.

Damaged decking/sheathing in this area will need to be replaced. Proper underlayment and new shingles will need to be installed.

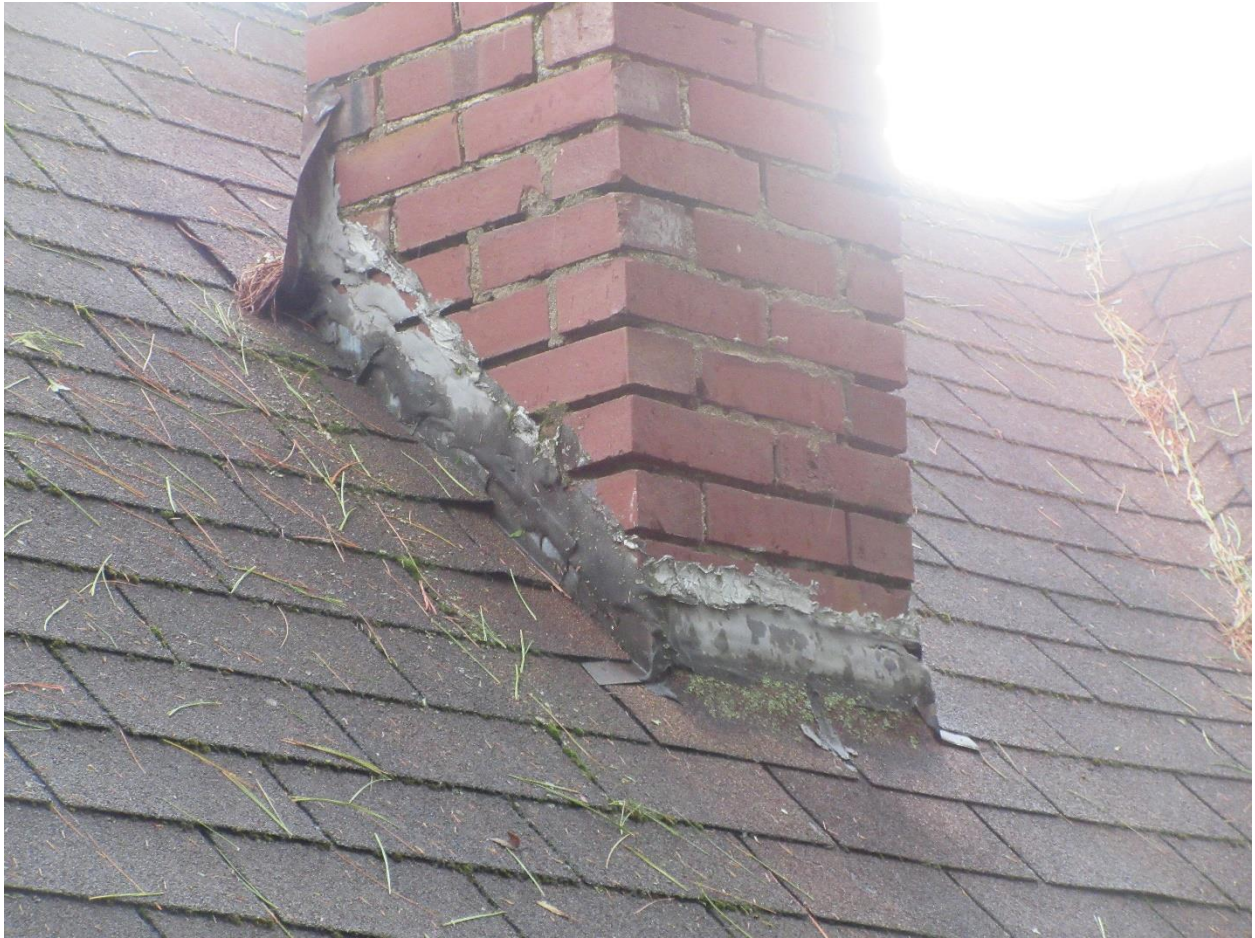
#22 Chimney has some damaged and missing mortar in the joints. Proper flashing is missing.

*The damaged chimney brick and mortar will need to be repaired or replaced. Proper flashing should be installed.

*If the chimney is only being used for furnace venting, it may be able to be removed and replaced with a metal exhaust pipe. This will help prevent leak issues.

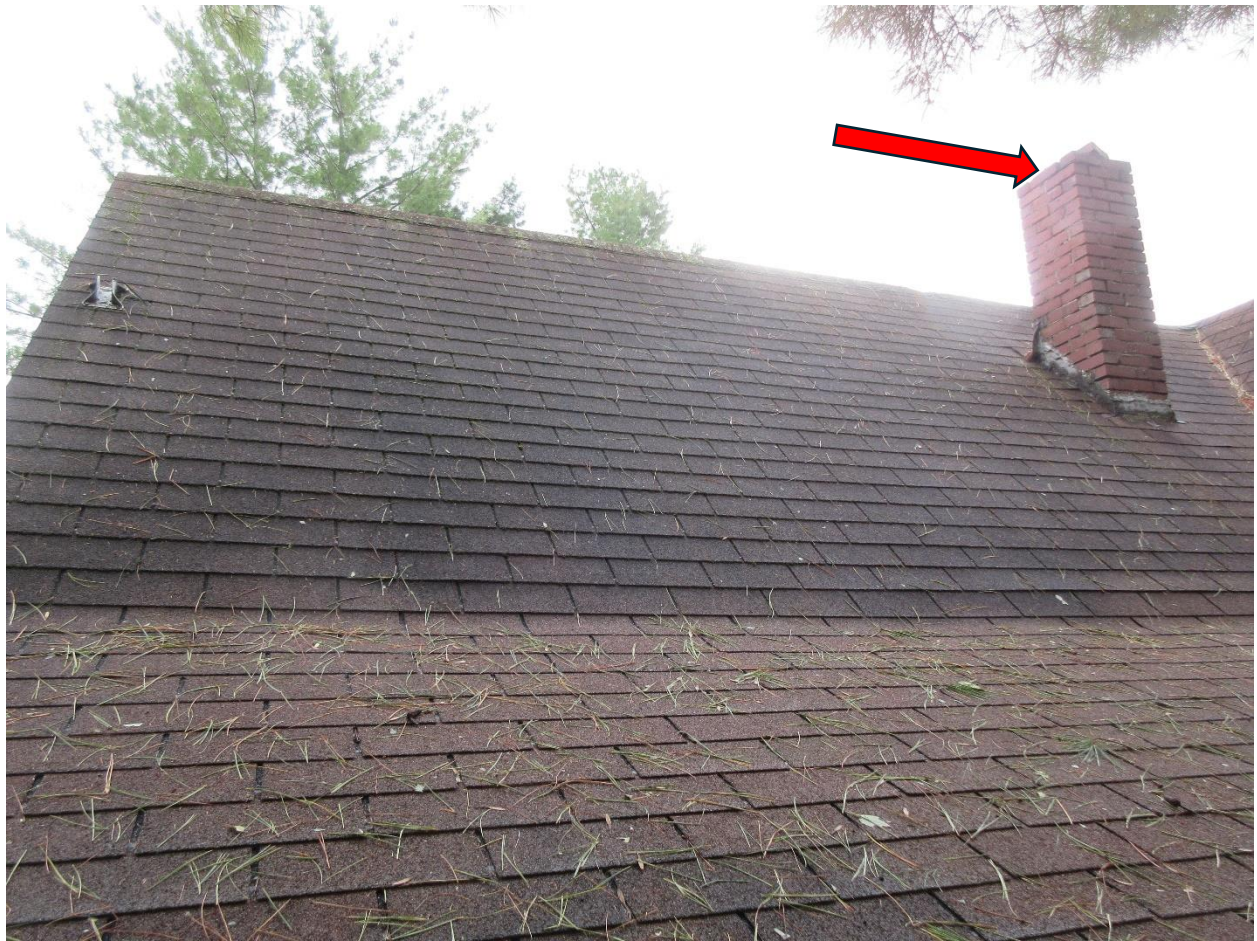
#23 Roof view on the north side area.

The chimney is missing a proper cap. A proper cap should be installed if the chimney is left in place.

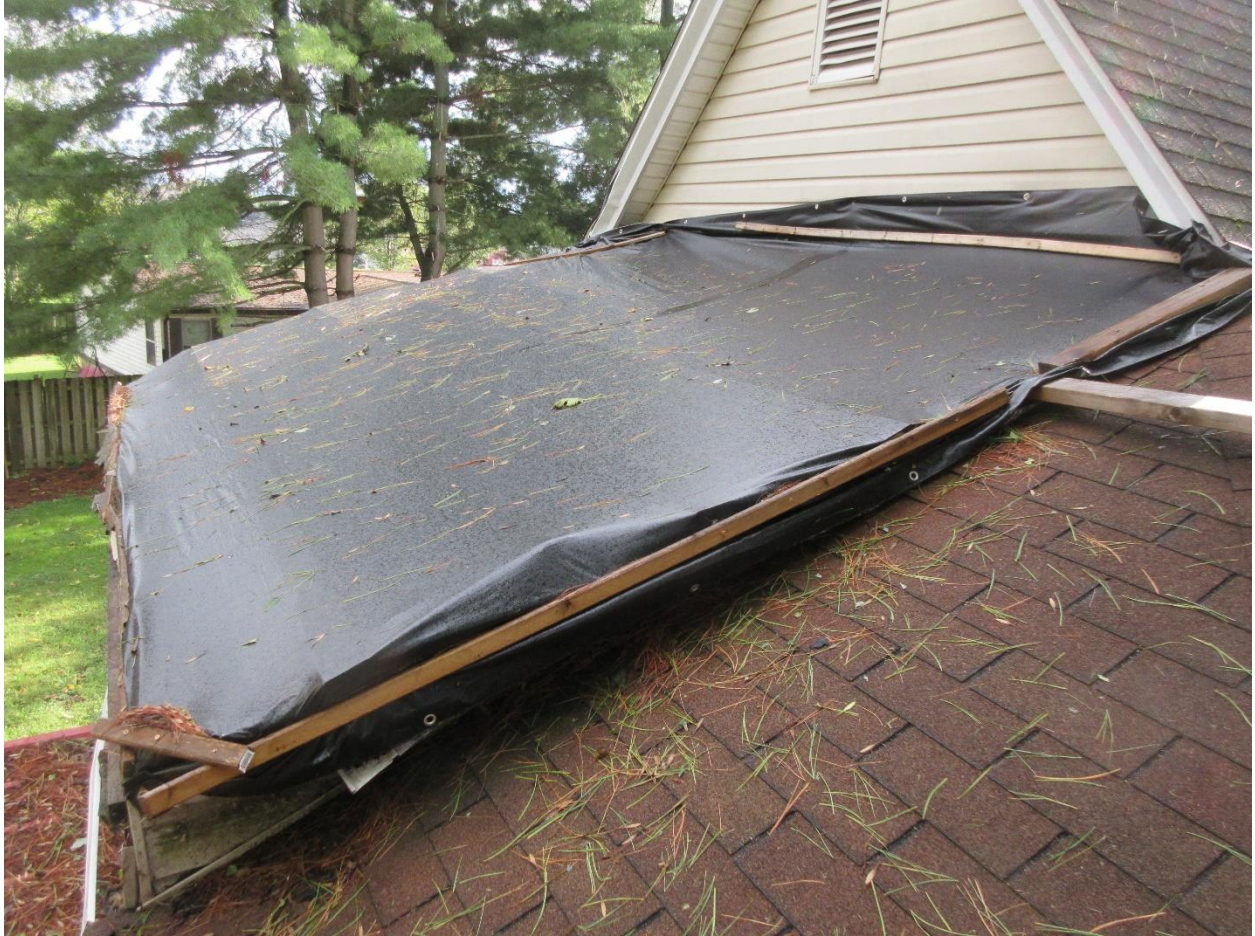
*The significant issue is on the east side where it appears that a tree has fallen on the house. (See photos #25, 26)

The upper gable edge is damaged, and the lower roof structure and shingles are damaged and missing.

#25 The east side roof area is missing shingles and decking below. The temporary tarp has been installed.

A temporary tarp has been installed. Tree damaged sections will require removing and replacing damaged decking and other structural materials.

#3 New shingles with proper underlayment and drip edging will need to be installed in these areas. Damaged exterior siding, trim, soffit, fascia, and gutter materials should be replaced. The main house shingled areas may last a few more years after repairs and replacements are made.

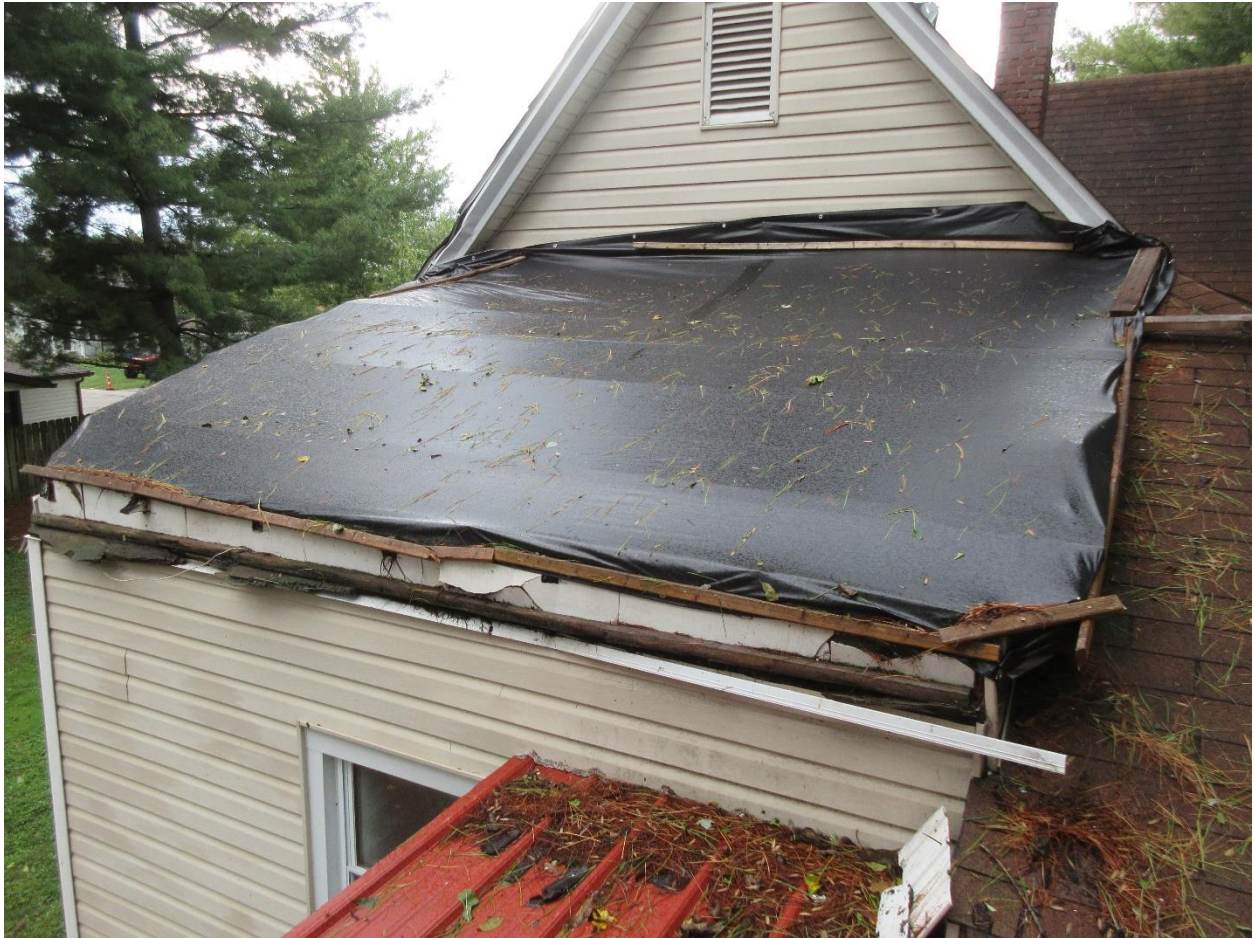
#26 View of the east side damaged roof and a temporary tarp covering. There is significant damage. Damage may have been a result of a fallen tree. A tree appears to have been recently removed near this corner of the house.

*The tarp needs to be removed so a proper assessment of damages can be made. Damaged structural and decking materials will need to be replaced. New underlayment, drip edge, and shingles will need to be installed. Any damaged siding, trim, and fascia materials will need to be replaced. A gutter needs to be installed.

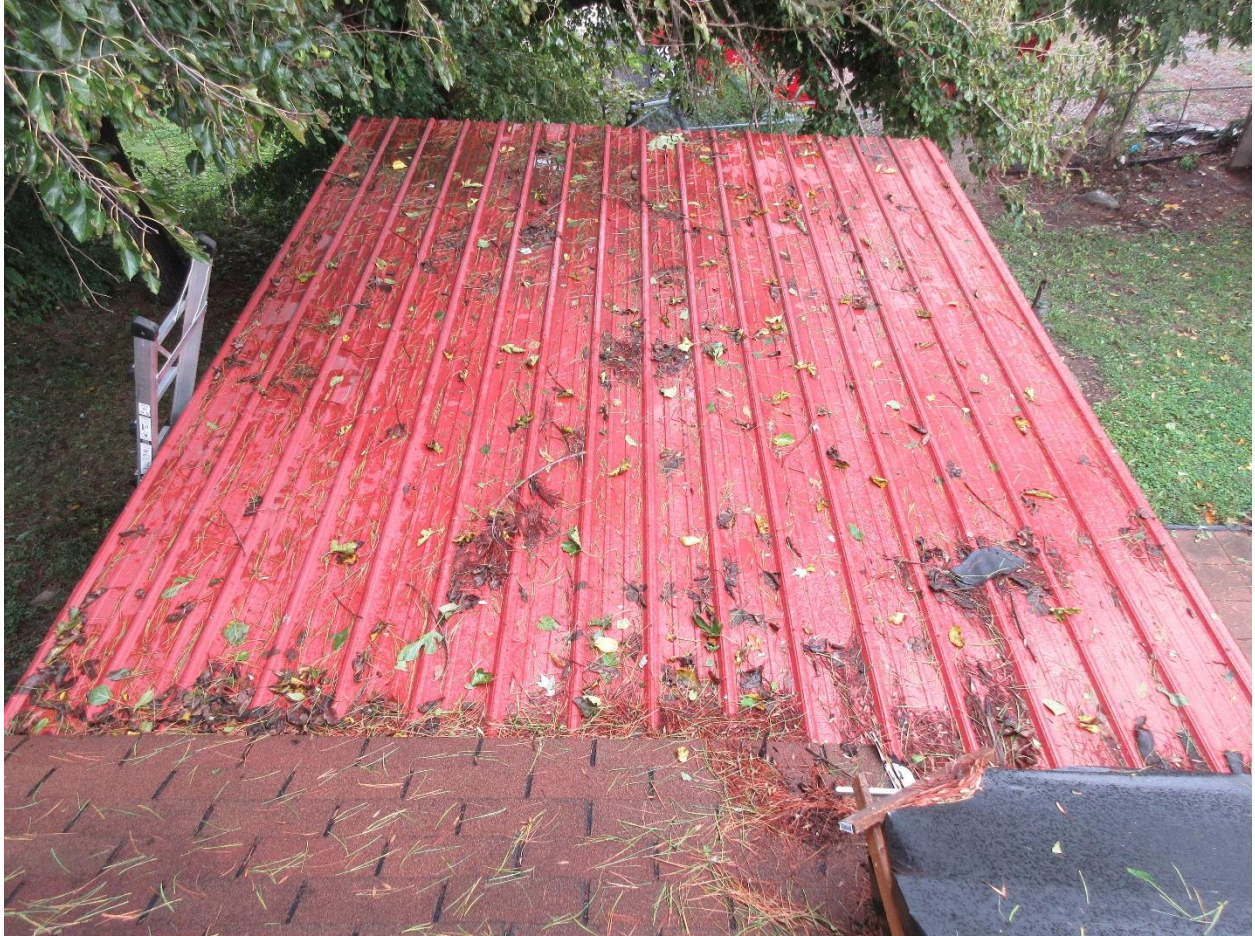
*Metal roof above the back deck appears to be in satisfactory condition, except for a small section that is slightly sunken where it appears a person may have stepped in the wrong area. Since this roof structure has minimal slope there is a concern that the metal roof may be prone to leak issues. (See photo #27)

#27 View of the back deck metal roof.

This roof structure has minimal slope for proper water drainage. Metal roofs are prone to leak without adequate water drainage slope.

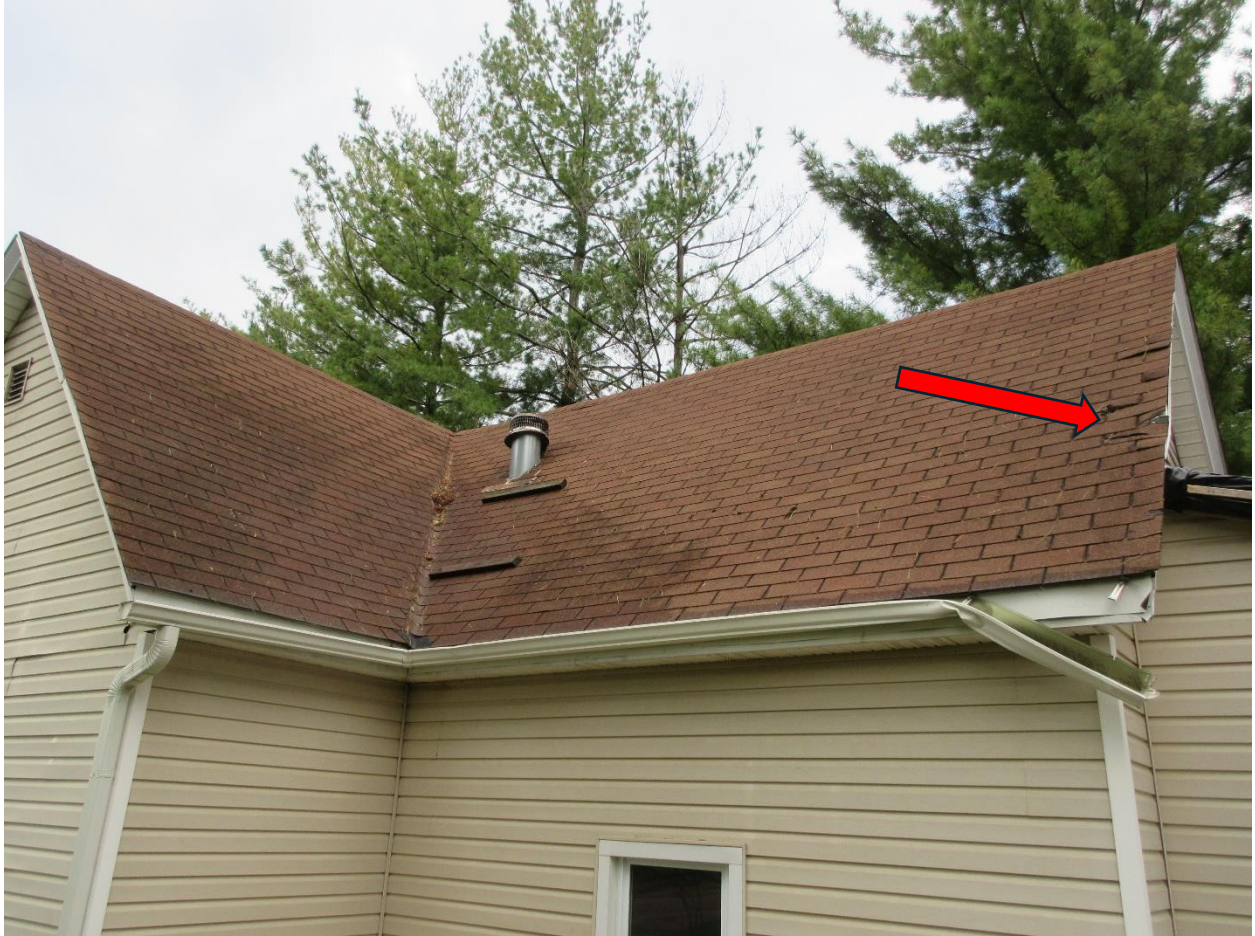
#28 Roof view on the S/E corner area.

The east end has shingle and gutter damage that may have been where a tree fell on the house.

*Damaged shingles, fascia, trim, and gutter will need to be replaced.

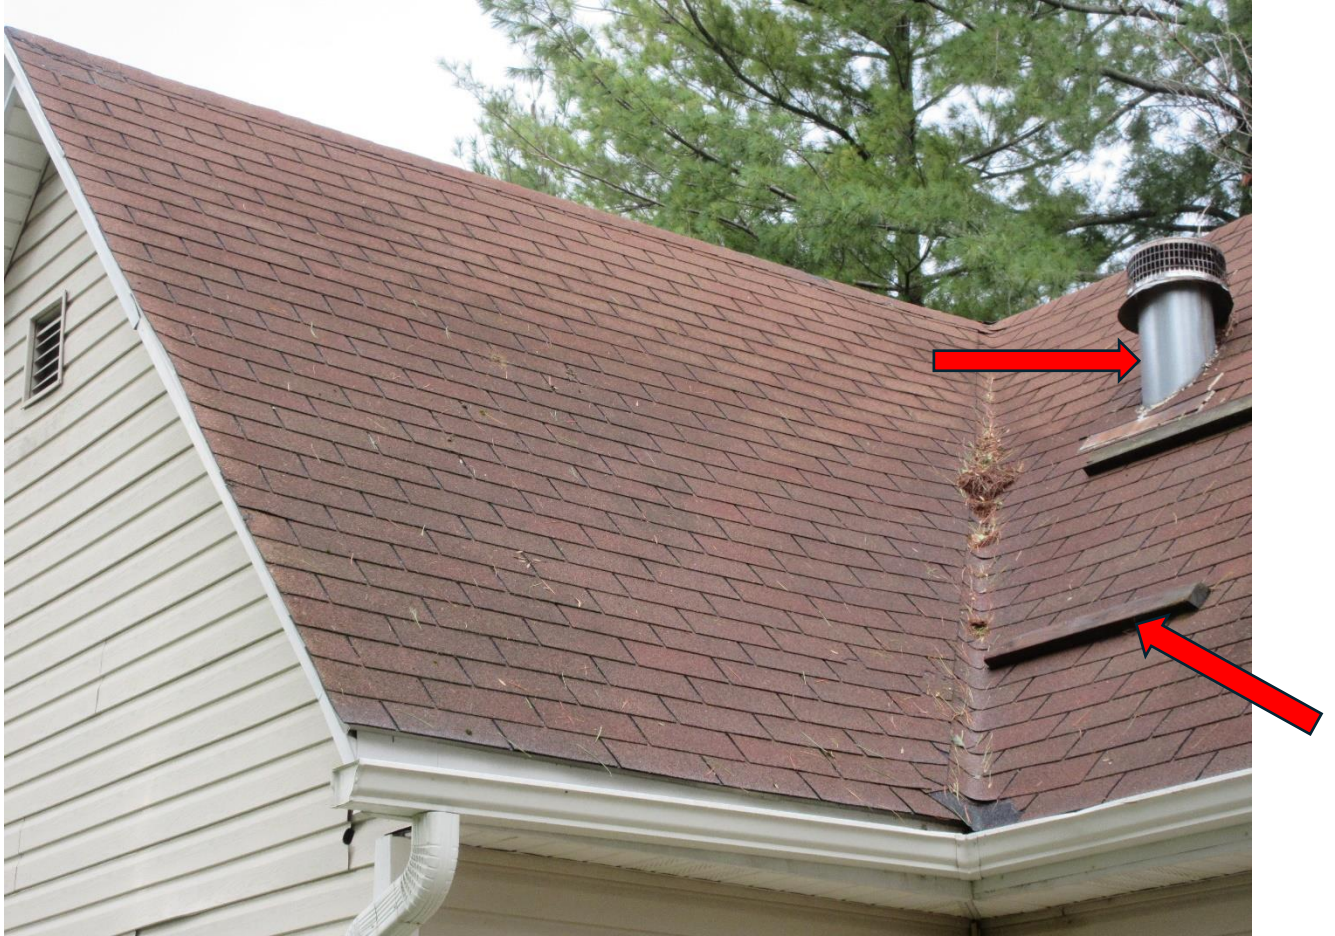
#29 Roof view on the south side center area.

Boards may have been installed for workers to access the metal pipe. Metal pipe is not in use.

*The metal pipe should be removed. Decking and shingles can be installed on the opening. The toe boards should be removed, and any damage shingles repaired or replaced.

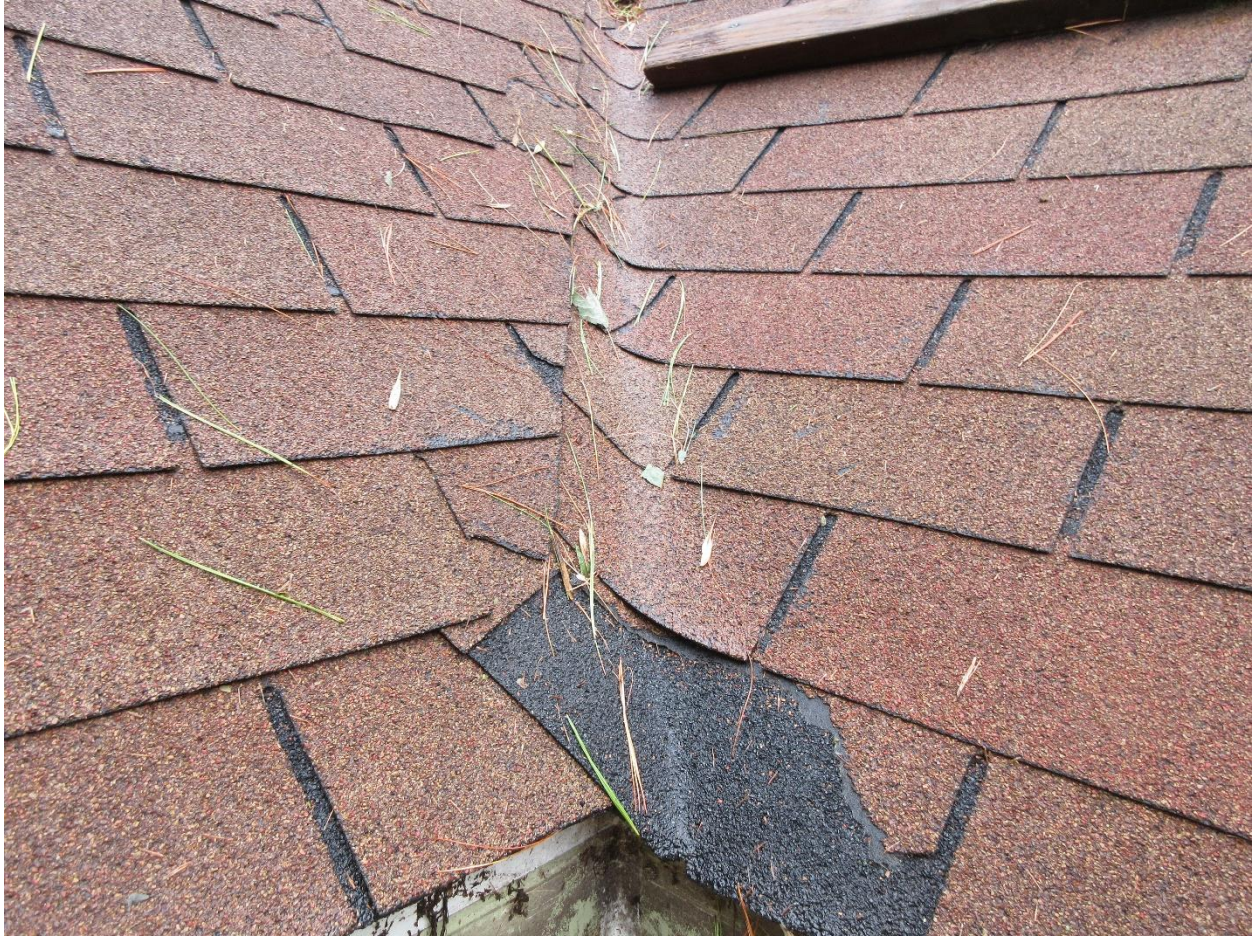
#30 Damaged shingles in the lower S/E corner roof area.
Damaged shingles should be repaired or replaced.
