422 N. 7th St. Mitchell, IN 47446 Roof Inspection 9-30-24

Performed by: Mark Walcott Roofing Contractor

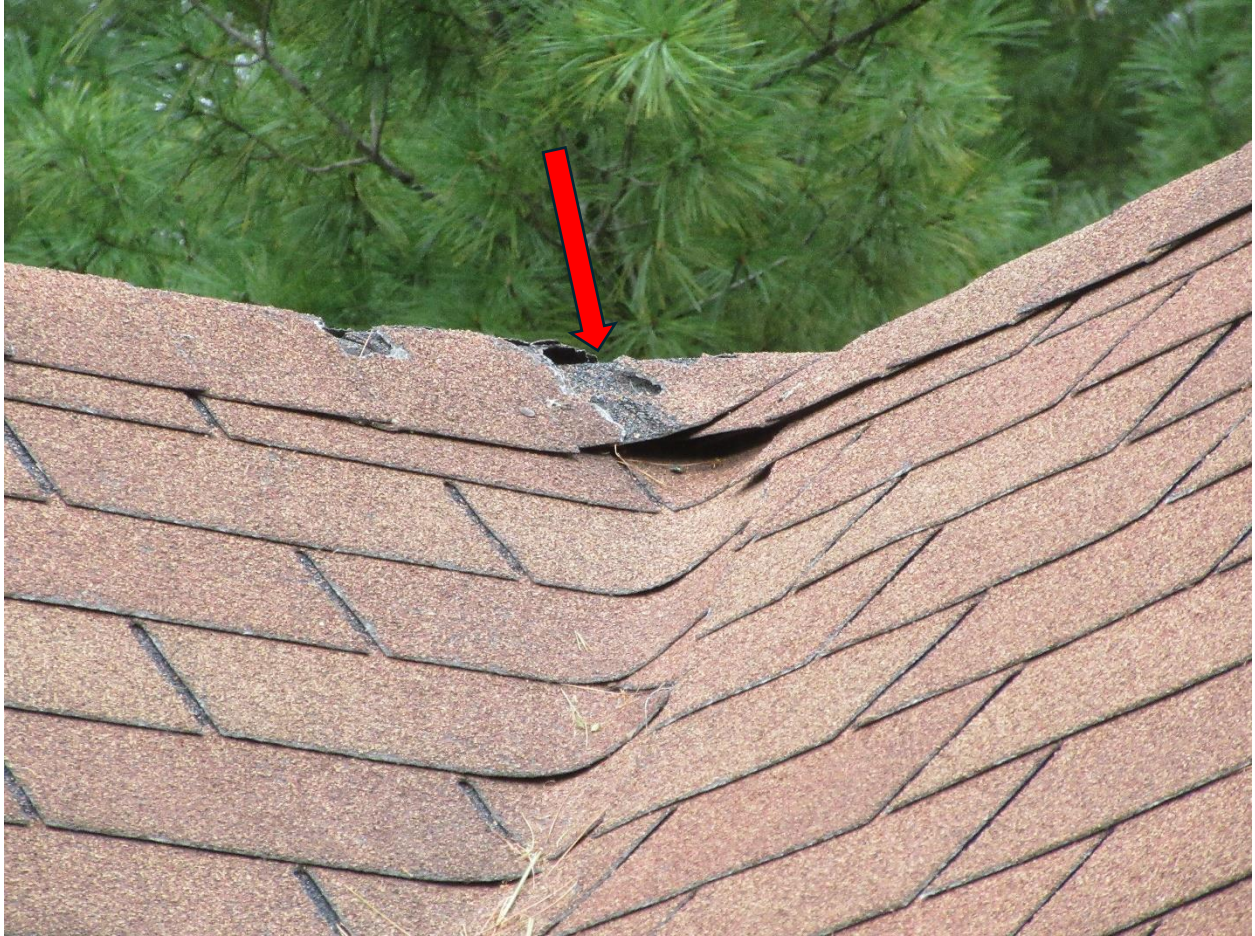
#31 Damaged ridge cap shingles in the center of the house.

*Damaged shingles should be replaced.

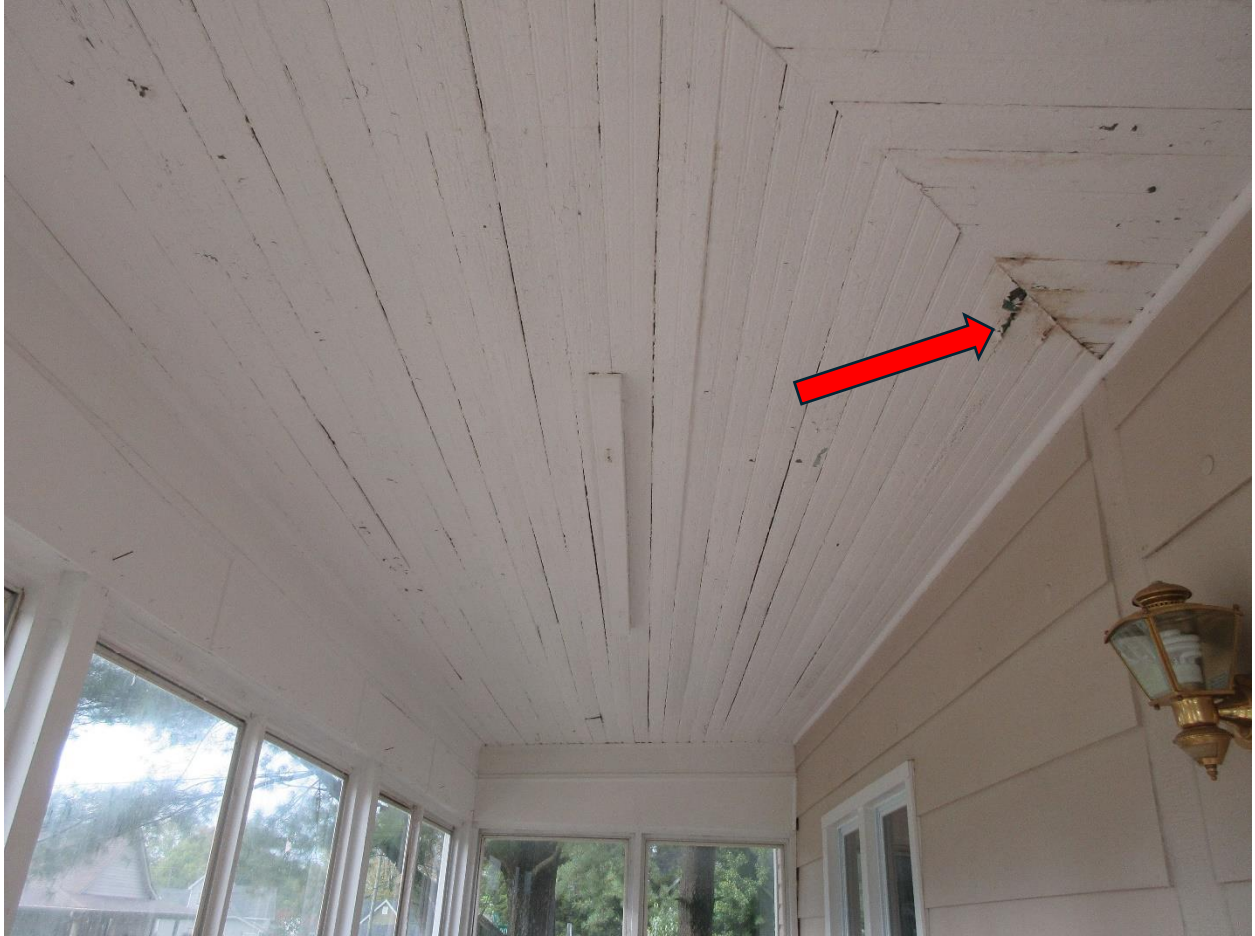
#32 View of the front porch ceiling. Water stains and damage appear to be a result of a metal roof leak issue above.

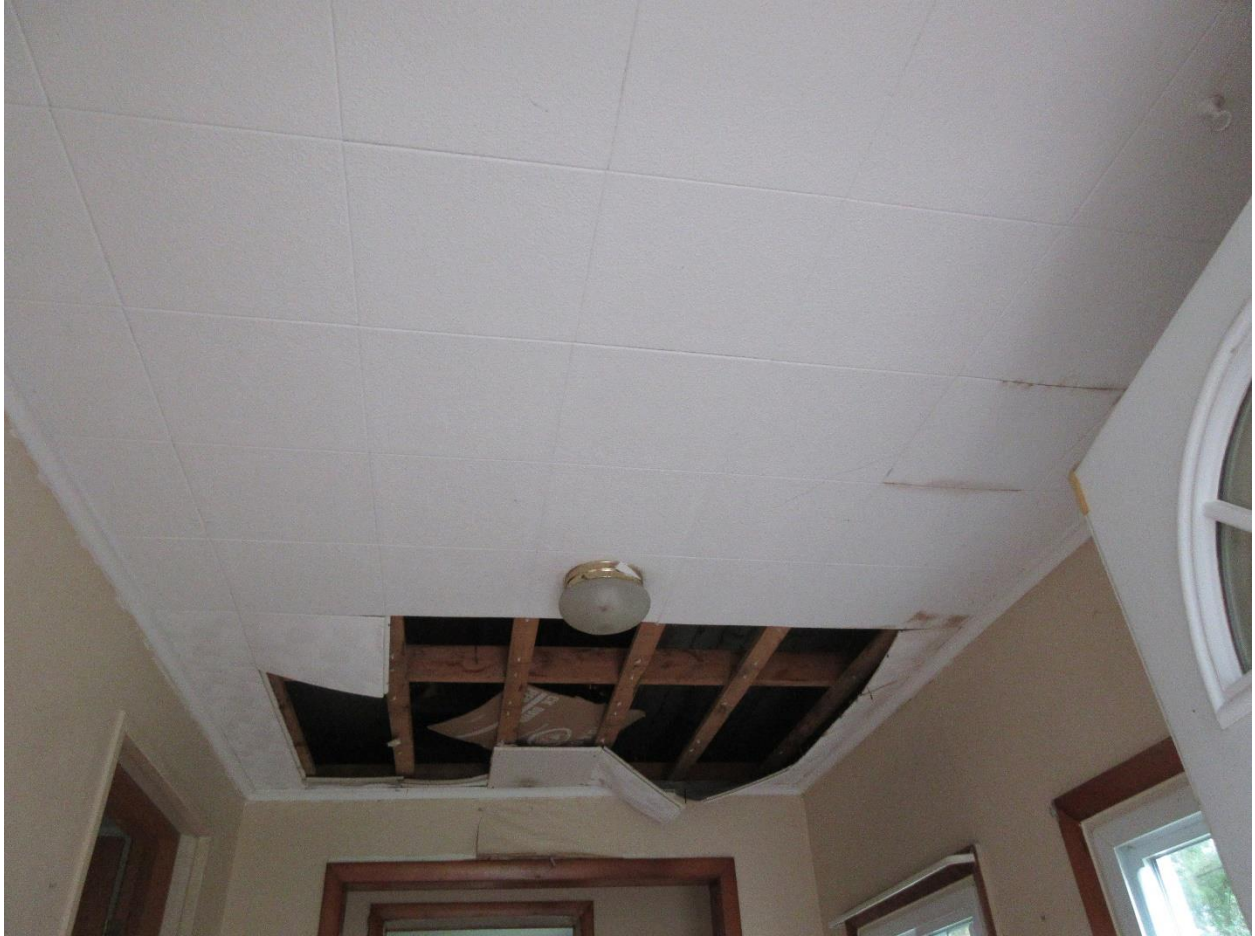
#33 View of the ceiling in the front entry area.

There appears to be a roof leak issue on the low-slope metal roof area above where the ceiling is stained and damaged. Several ceiling tiles are missing.

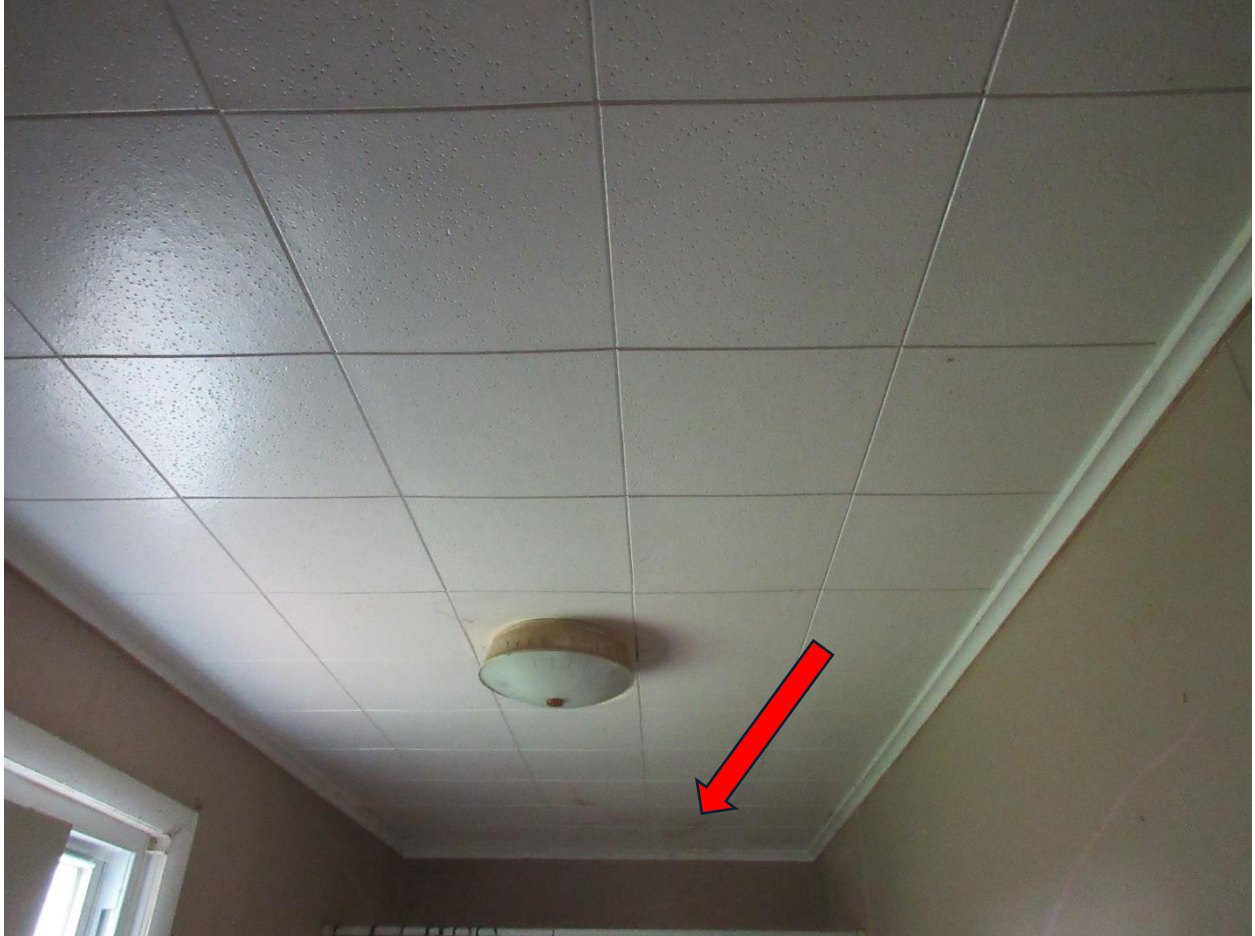
#37 Partial ceiling view in the south side bathroom. Stains on the ceiling appear to be from the shower causing excessive steam and moisture issues. I do not believe the roof is leaking in this room.

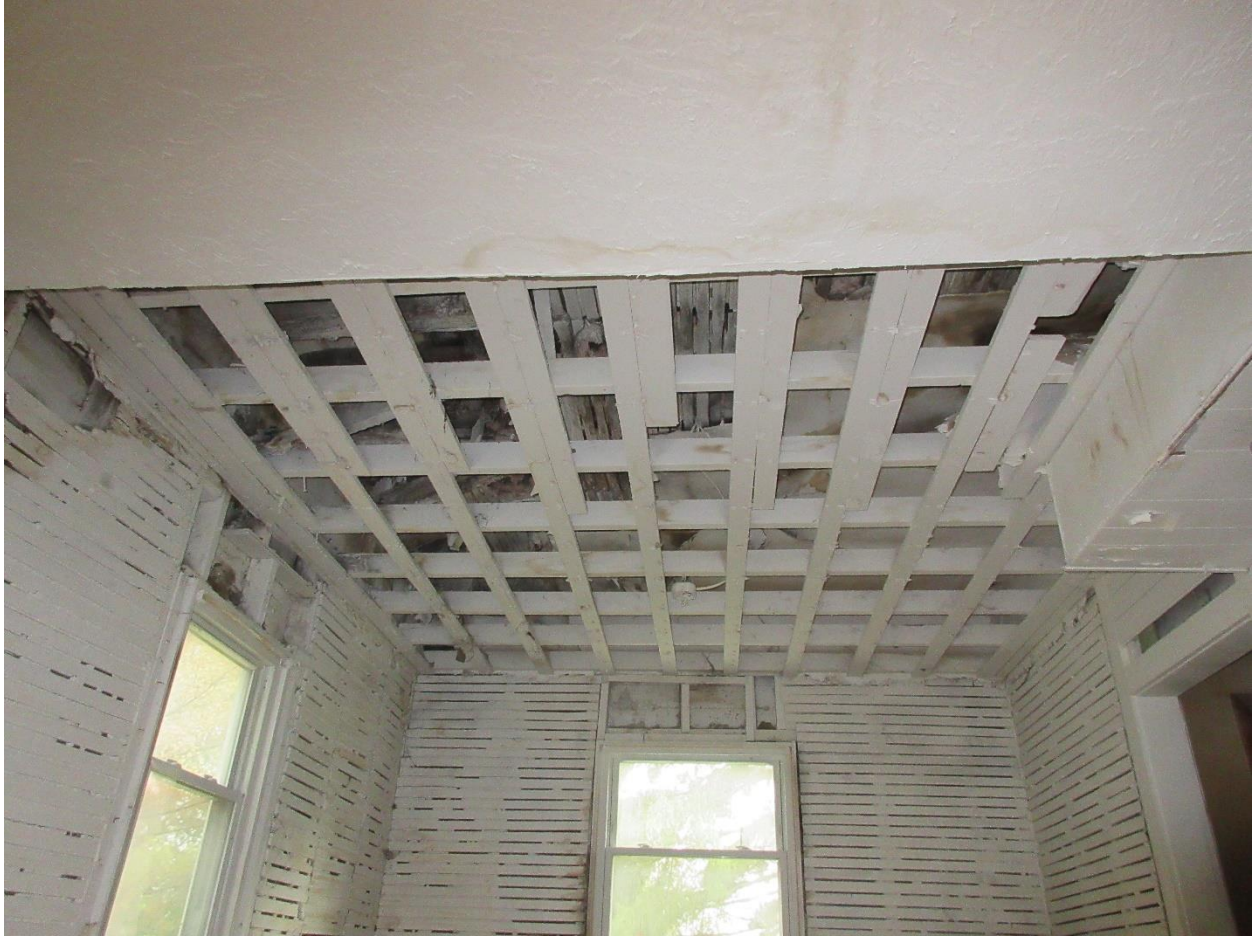
#39 Ceiling view in the east room that may have been the kitchen or dining area. There is significant roof structure and roof damage above. This is where it appears a tree fell on the house.

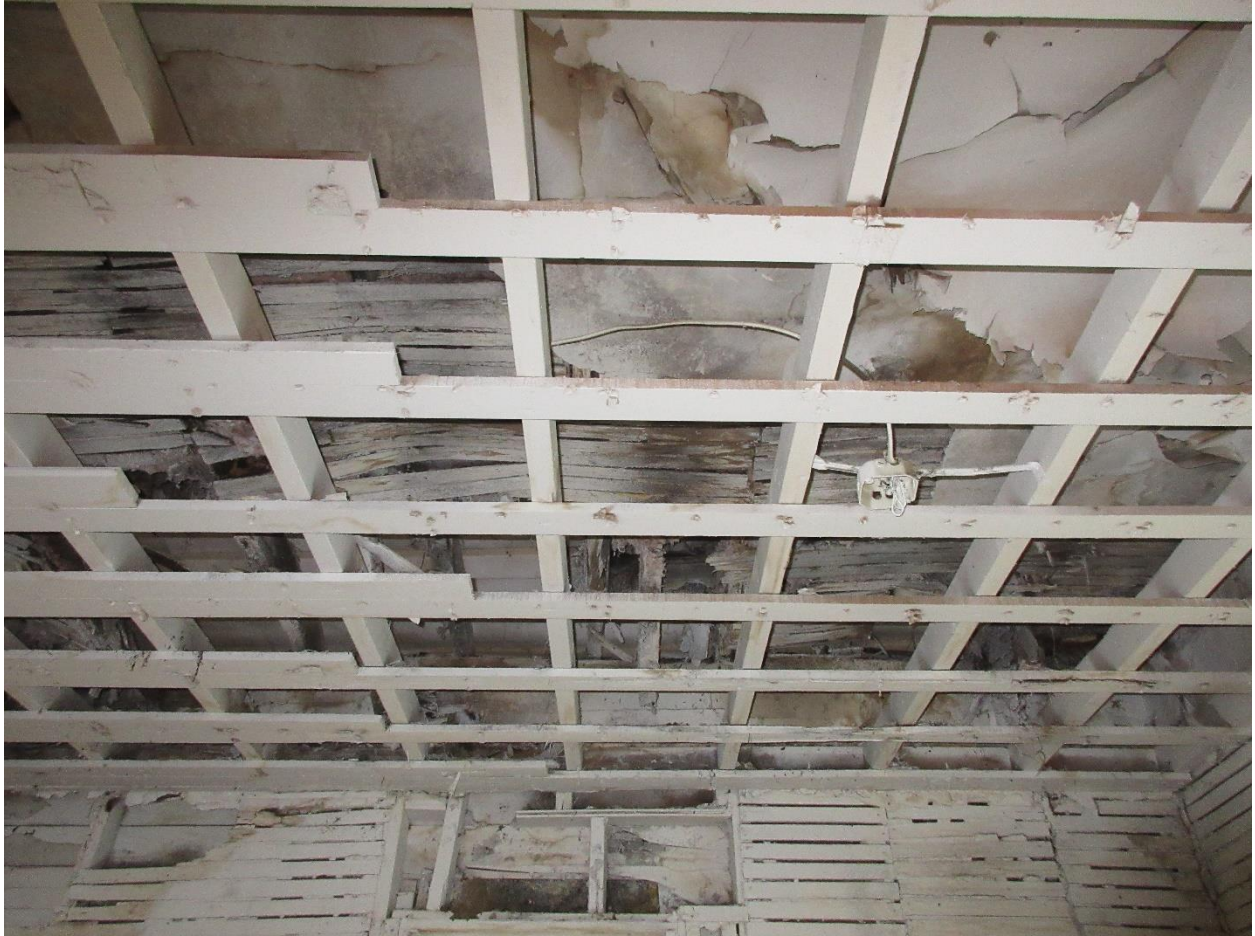
#40 Roof structure and roof damage above the east room.

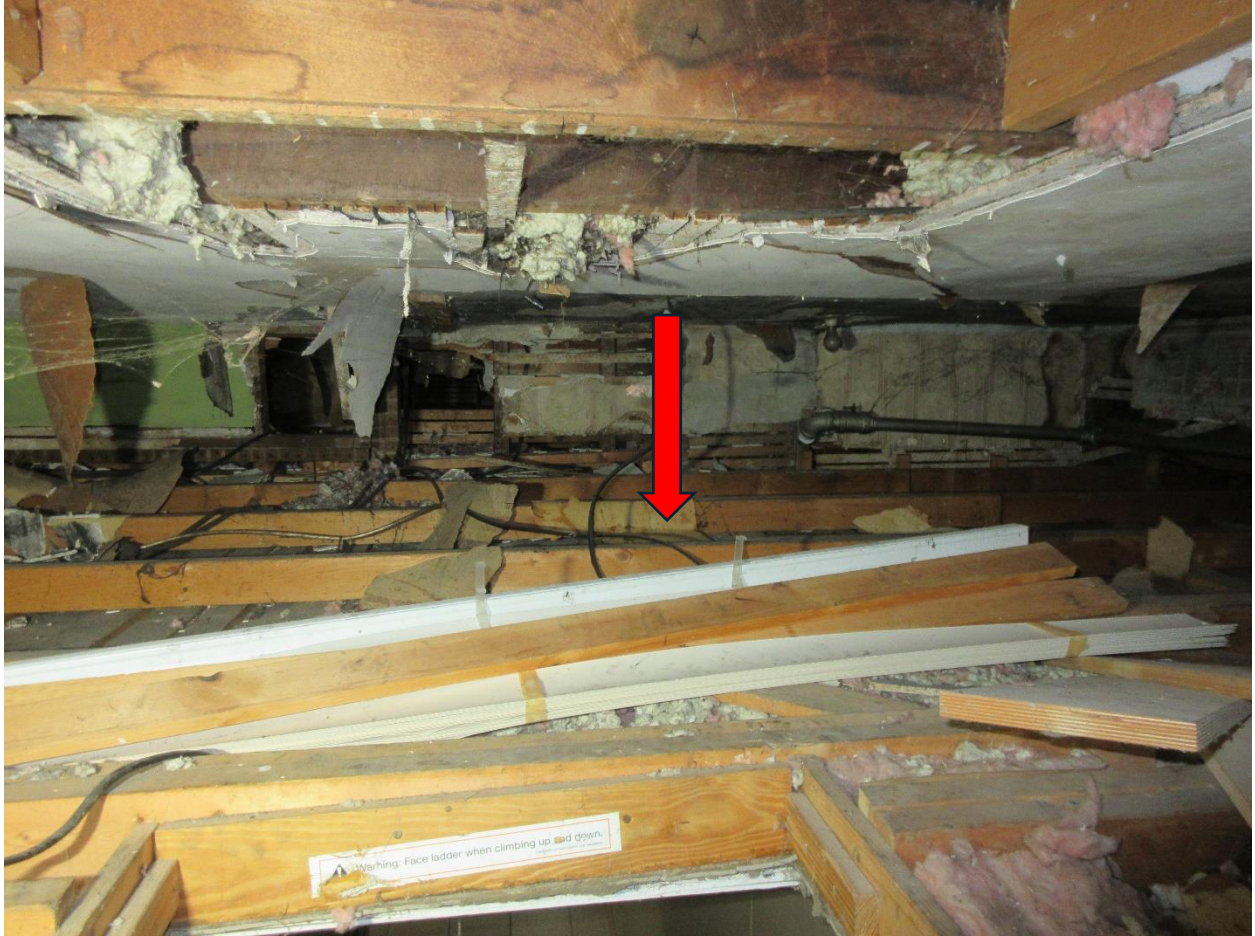
#42 The interior ceiling has been lowered about two feet from the original ceiling.

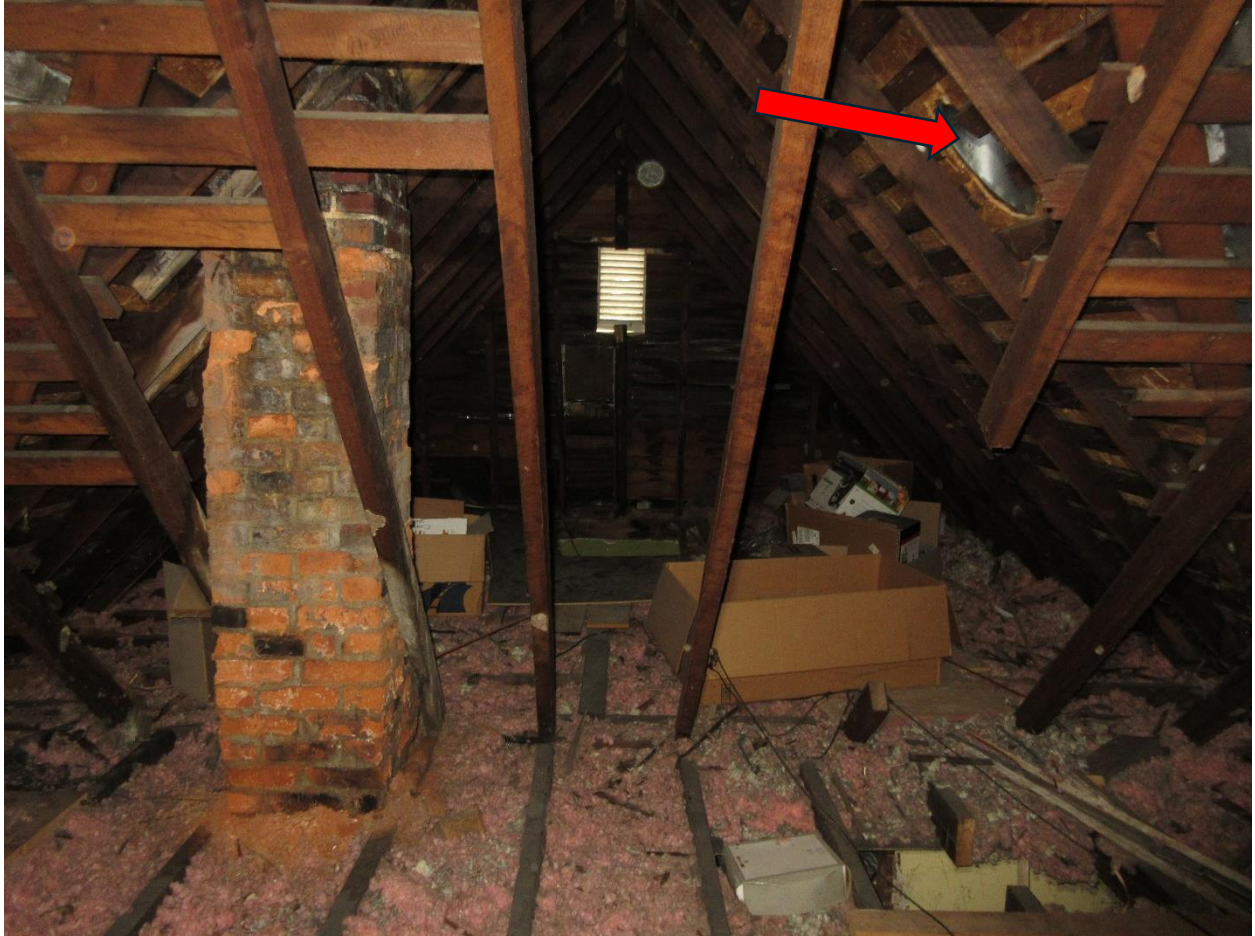
#46 Attic view in the east center area.

The chimney brick are damaged and flaking apart.
(See chimney comments in photo #49)

The metal pipe is not in use.

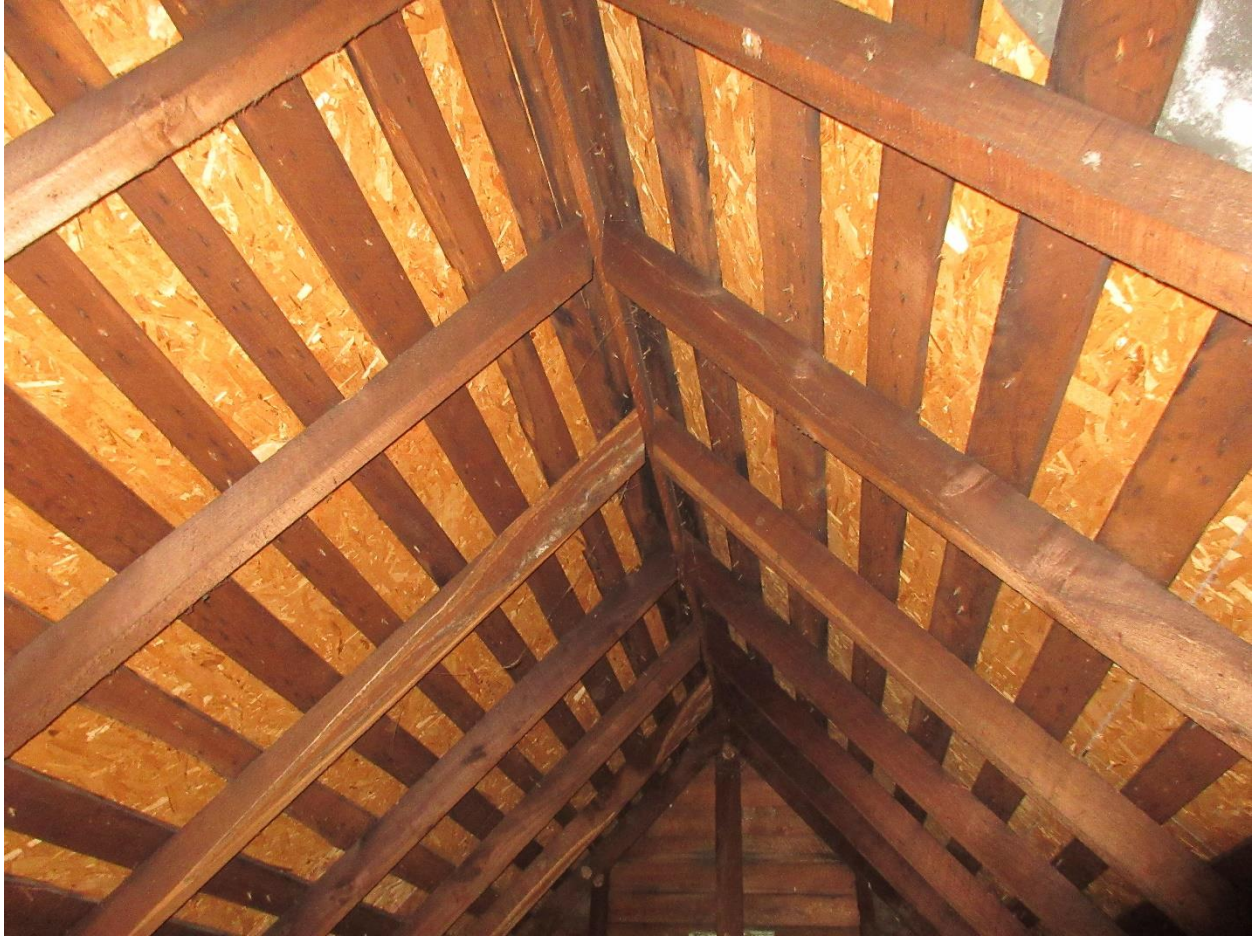
#47 Partial upper roof structure view. The original roof may have been wood shingles. When the wood shingles are removed, new sheathing/decking is installed. Newer O.S.B. sheathing/decking has been installed on the roof structure purlin boards.

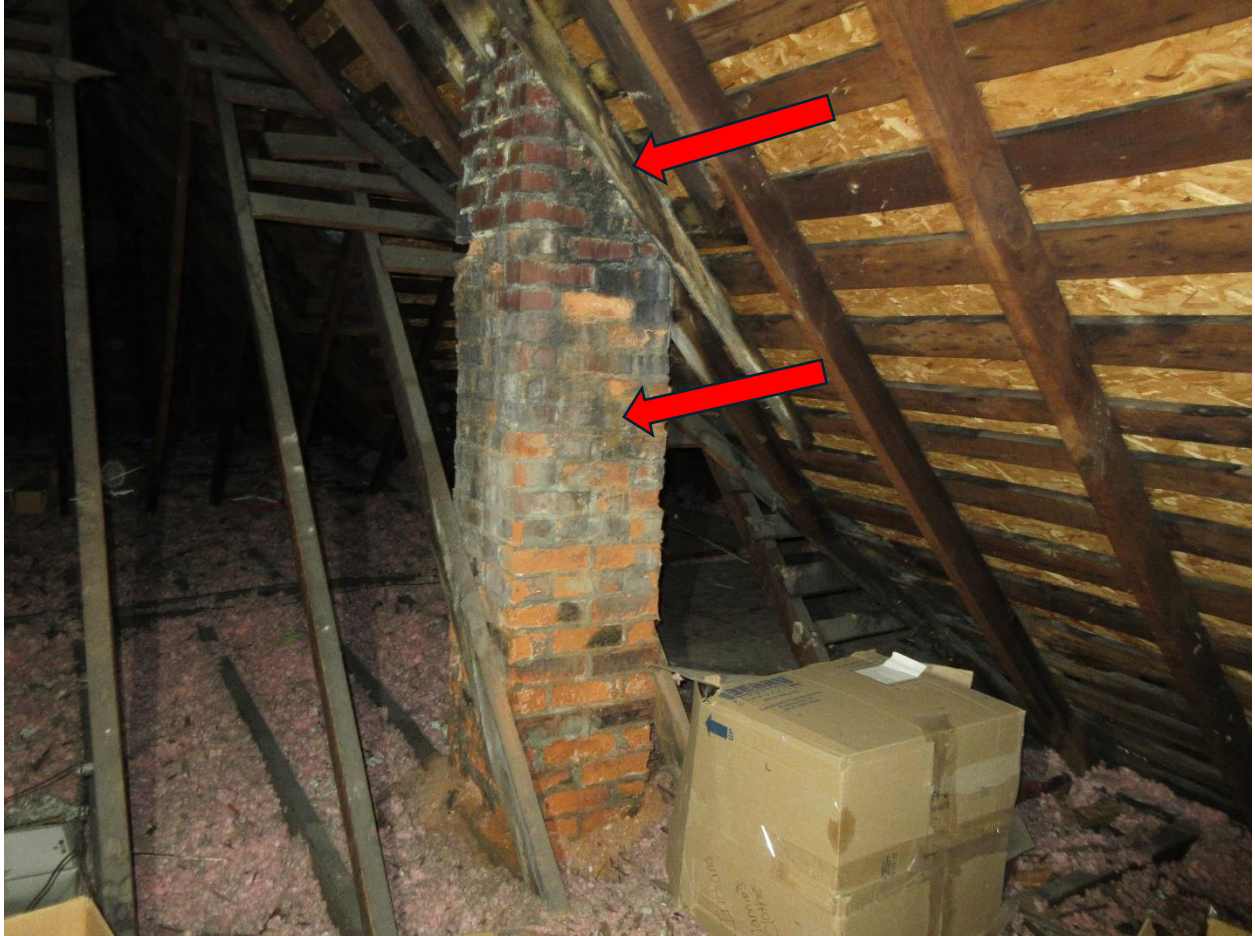
#49 The chimney has damaged bricks. Stains on the roof structure around the chimney indicates leak issues at some point in time.

*The damaged chimney needs to be evaluated by a qualified contractor to determine if it is safe to leave in place. The chimney may be able to be replaced with a metal exhaust pipe.

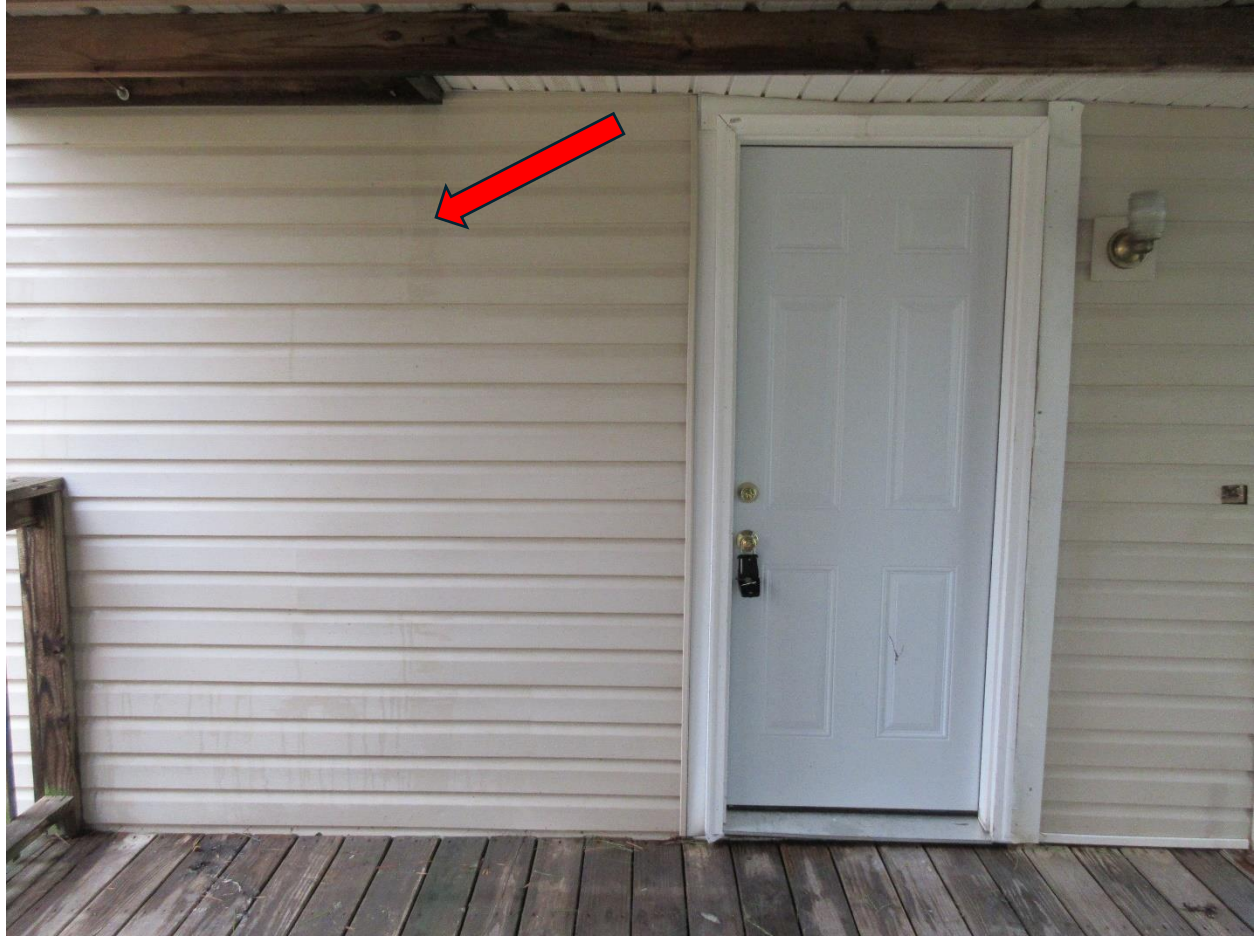
#50 Water is leaking down the exterior siding on the east end deck area. This is below the damaged roof area above.
