#1 7201 South Kingswood Street Terre Haute, IN 47802

Roof Inspection performed by Mark Walcott Roofing Contractor  
263 State Road 135 South Nashville, IN 47448 Ph: 812-322-6532  
1/1/2024 Weather: Overcast, 35 degrees, Damp conditions.

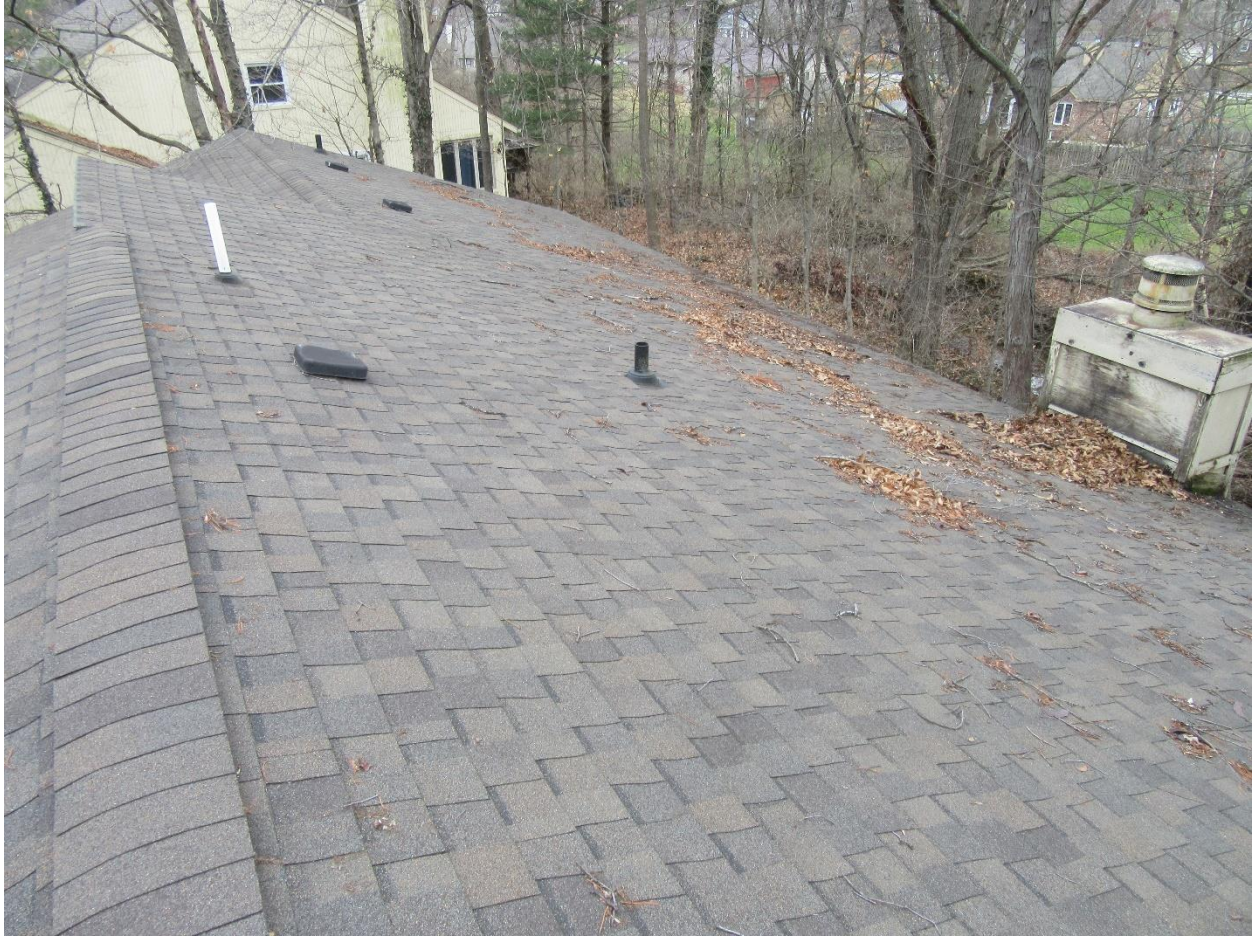
#6 Roof view on the back side.

Leaves prevented viewing all of the roof areas.

Shingles are marginally installed and some rows are not straight, and some shingle rows are stretched too wide.

\*I recommend removing all leaves from the roof.

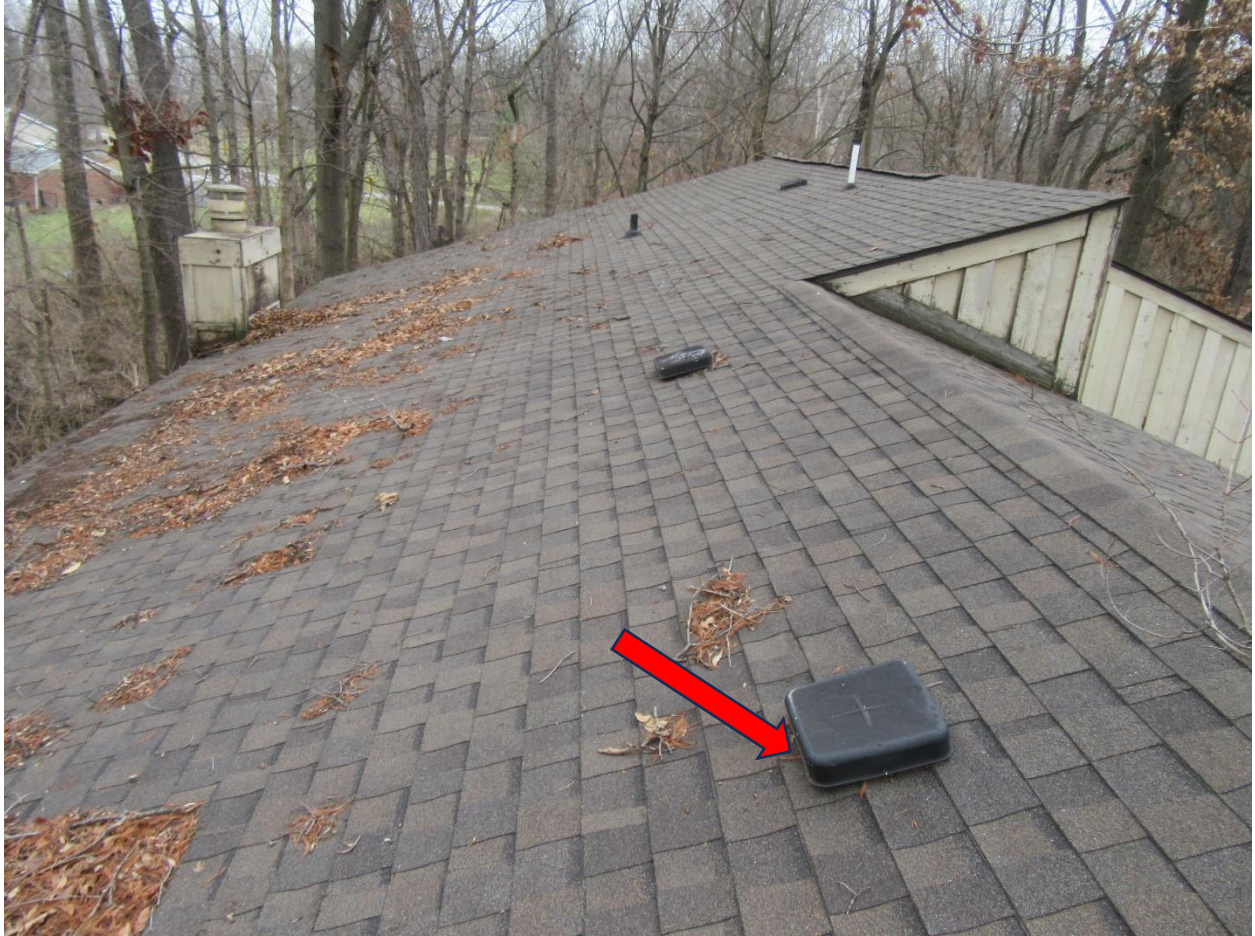
#7 Back side roof view.

Lower edges of the vent flashings are not proper extended out on the shingles. I am unsure if the vents are properly installed.

\*The roof vents should be monitored during a heavy rain.

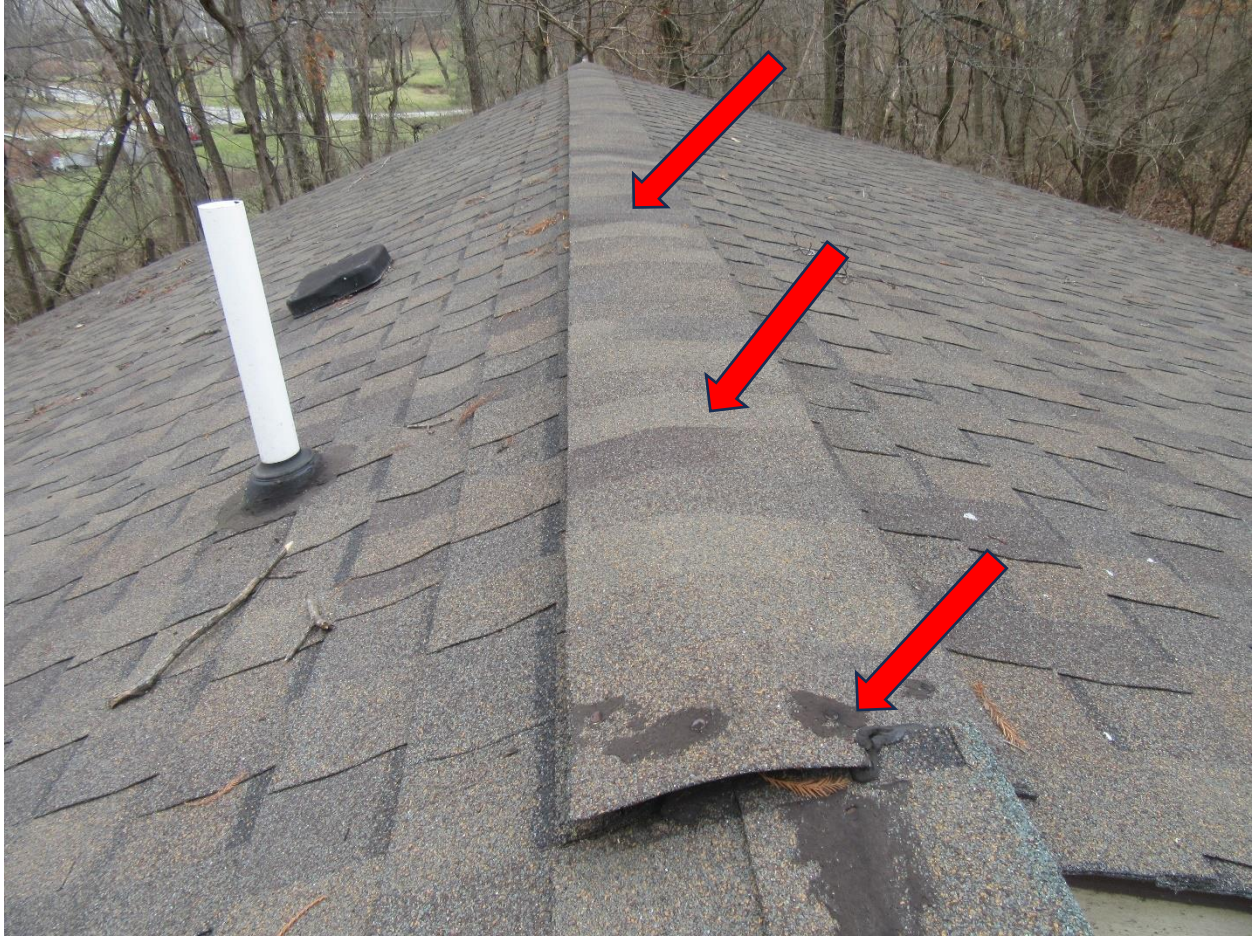
#11 The ridge vents and cap shingles are marginally installed. The ridge cap shingles are too flat. They should be mounded up to properly divert water. Flat vents can lead to leak issues.

\*Tar has been marginally installed on the end. I recommend a qualified roofing contractor evaluate the ridge vents and make repairs or replacements as needed.

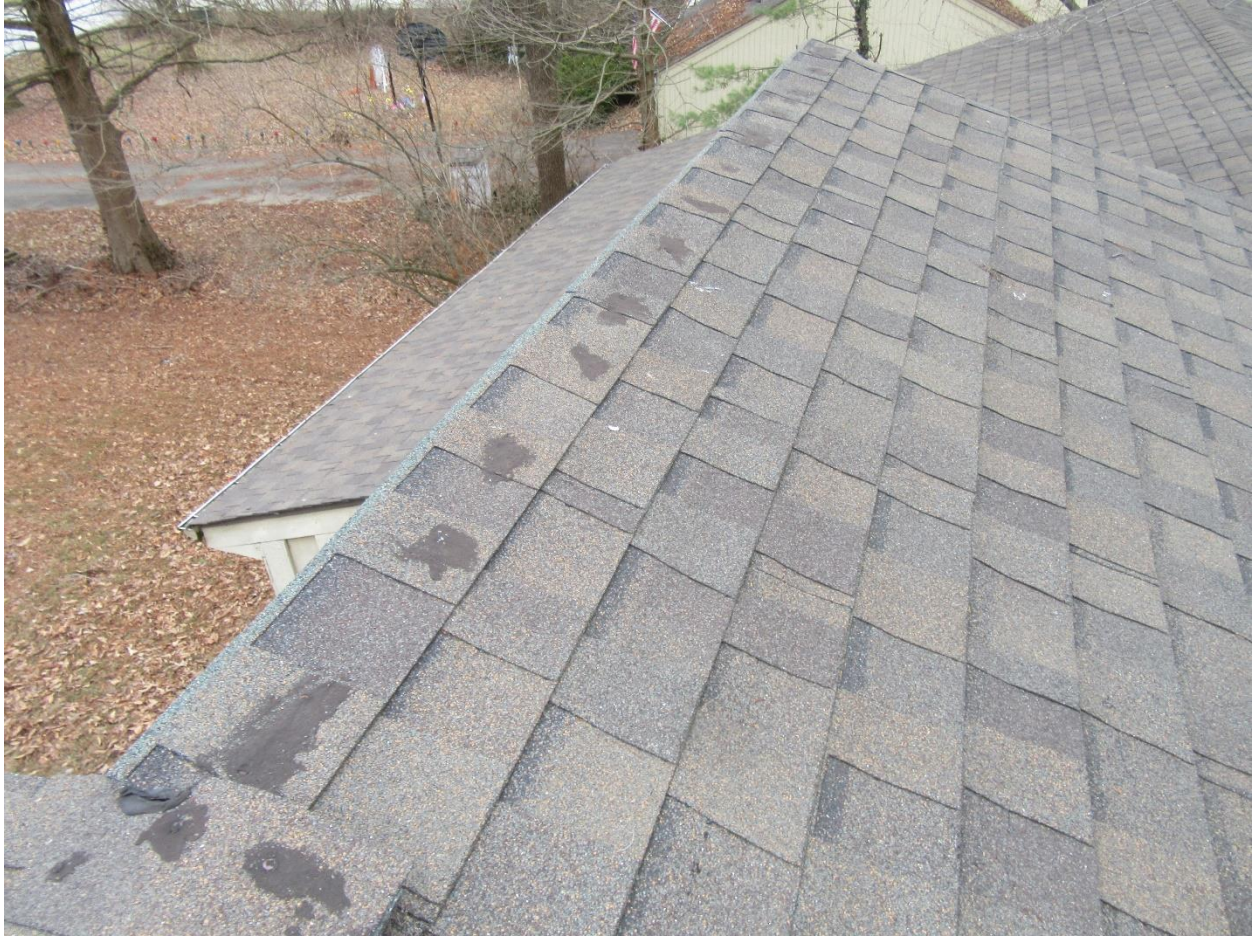
#12 Marginally applied tar on the top shingle row. Most of the tar application should not cause leak issues.

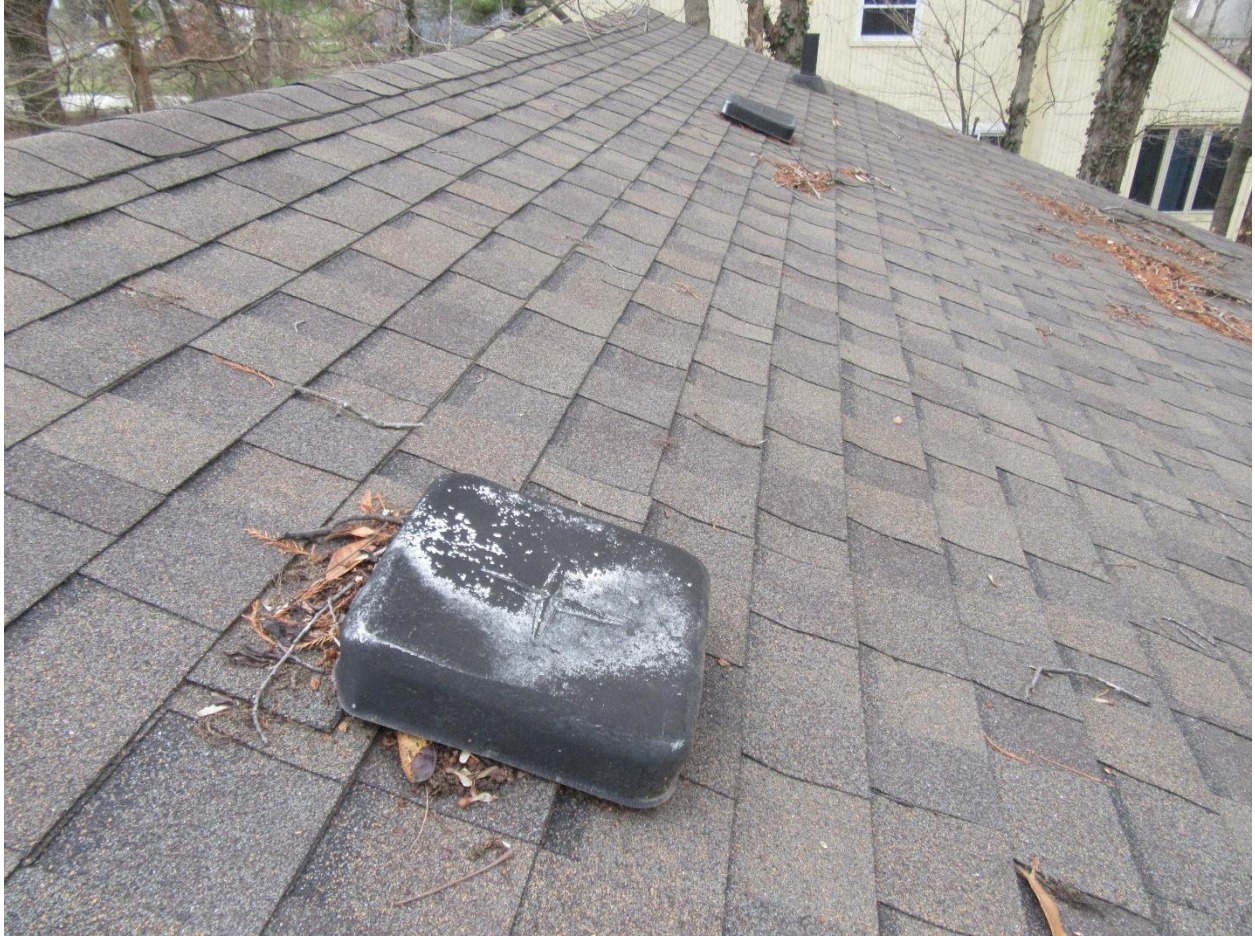
#13 Close-up view of one of the vents.  
(See comments in photo #7)

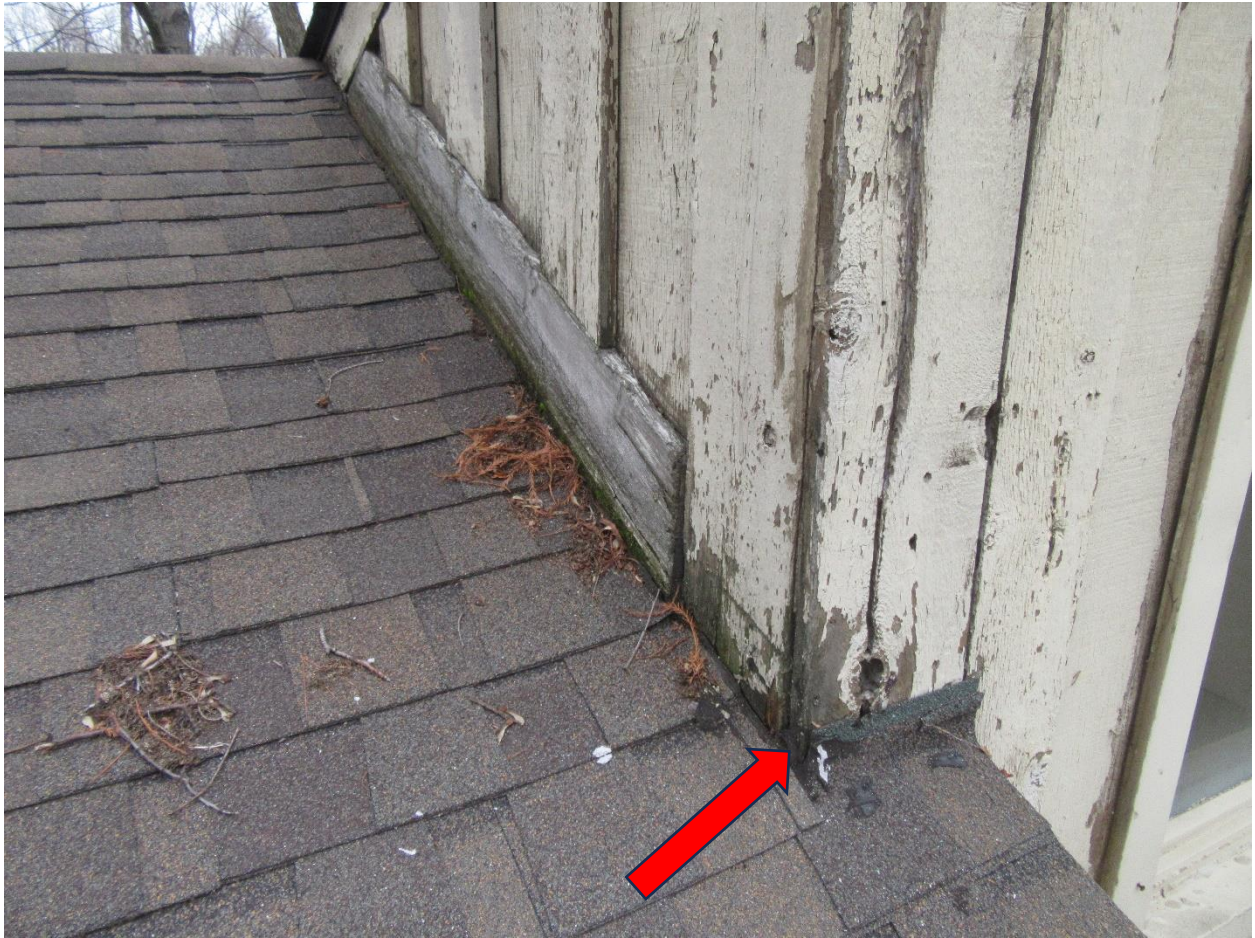
\*Wood siding on the wall on the front side of the house has damage, and the shingles appear to have some damage. There is a chance of leak issues developing here. (See photo #14)  
A qualified contractor should replace the damaged siding and make shingle and flashing repairs as needed.

#14 Poor condition of the wood siding on the front side. I am unsure if there is proper wall flashing where the shingles meet the wall. This is an area of concern and a potential leak issue.

\*I recommend a qualified roofing contractor evaluate and make repairs as needed. Damaged wood siding should be replaced and a proper evaluation of the wall flashing should be made when the siding is replaced.

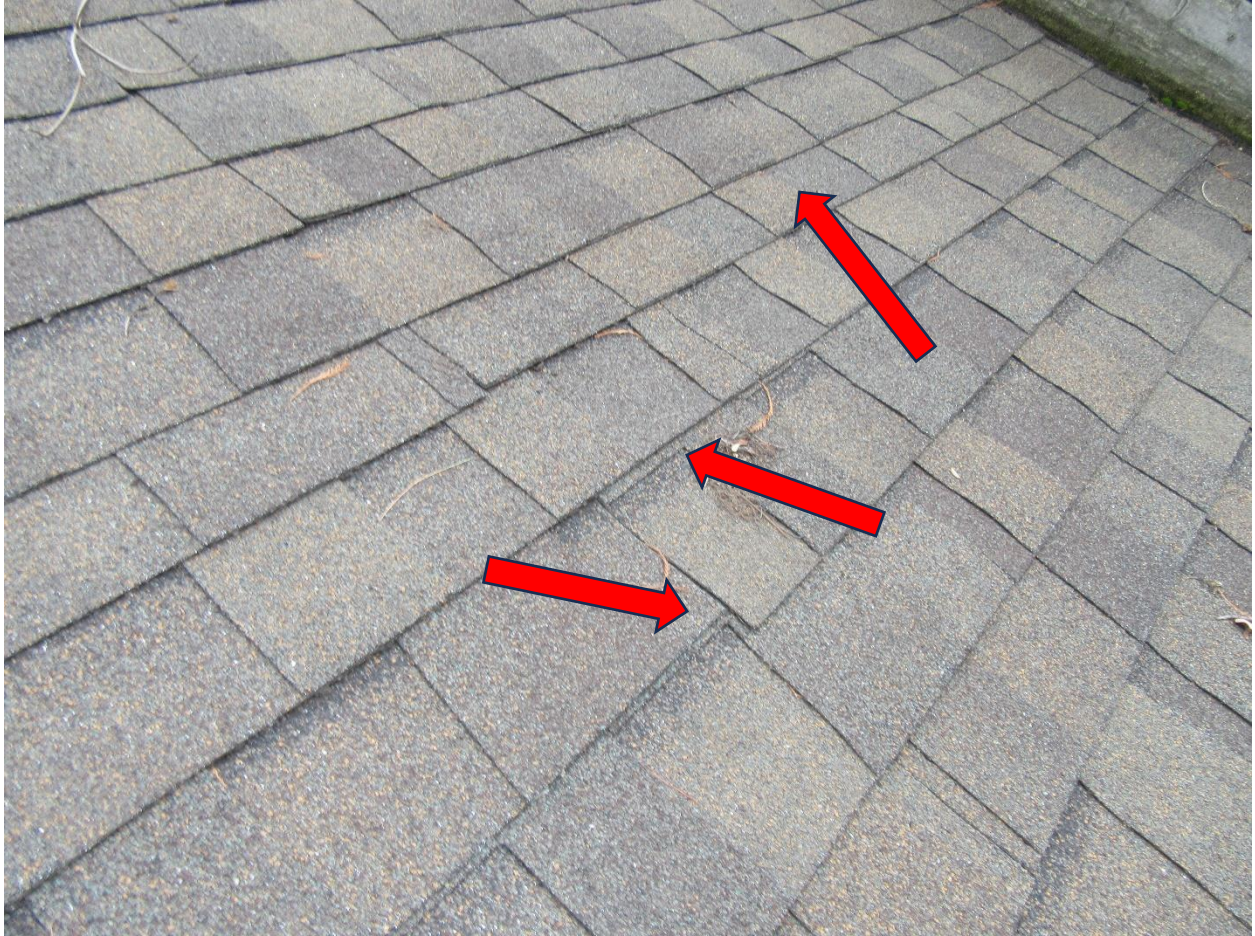
#15 Marginal quality shingle installation. There are several areas where the shingles are uneven and are stretched too far apart. A few shingles are not lined up properly.

Some rows are crowded down too narrowly.

I do not believe these areas are prone to leak issues, but they should be monitored.

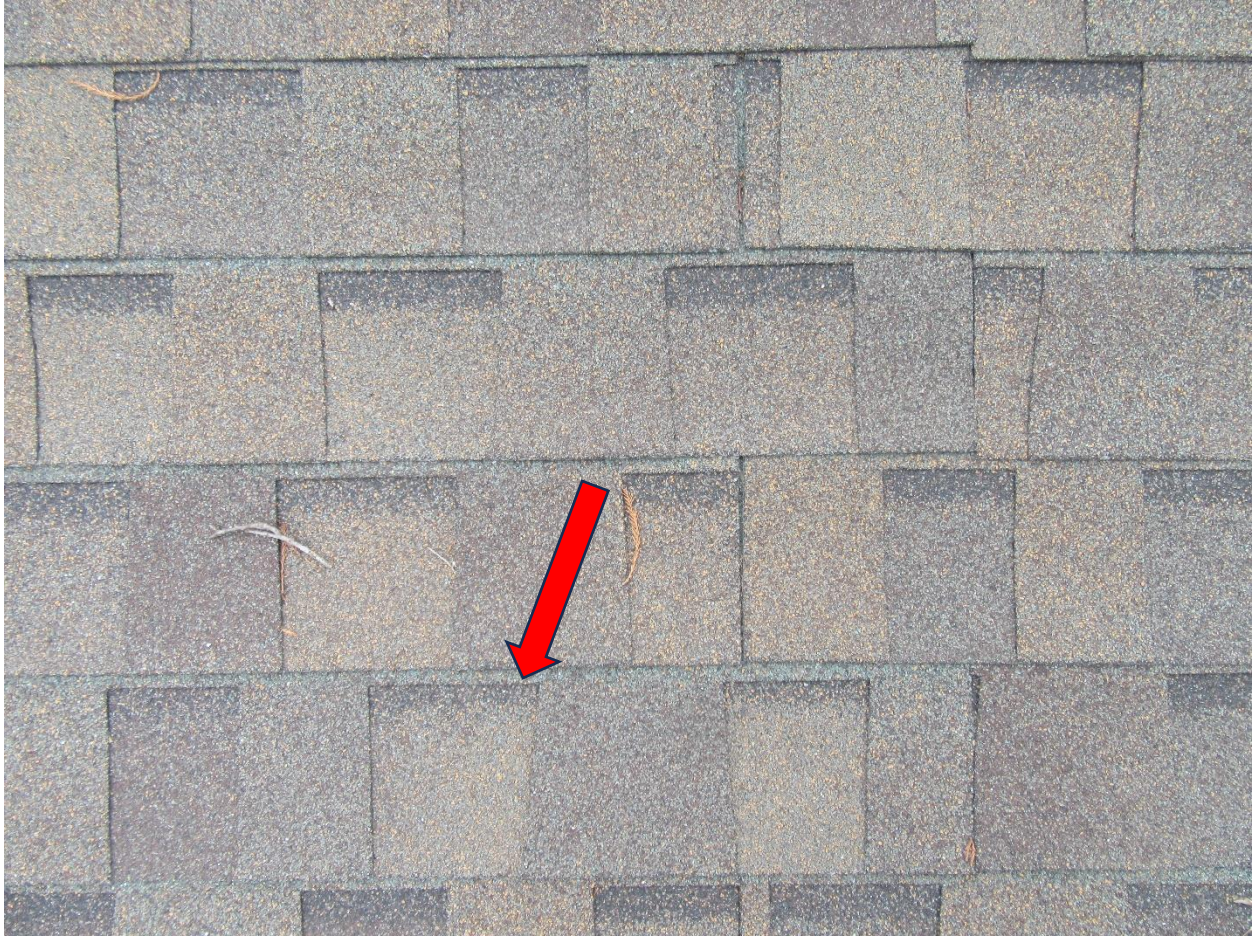
#16 More of the shingle rows that are stretched too wide.  
The area where an arrow is pointing should not be exposed.

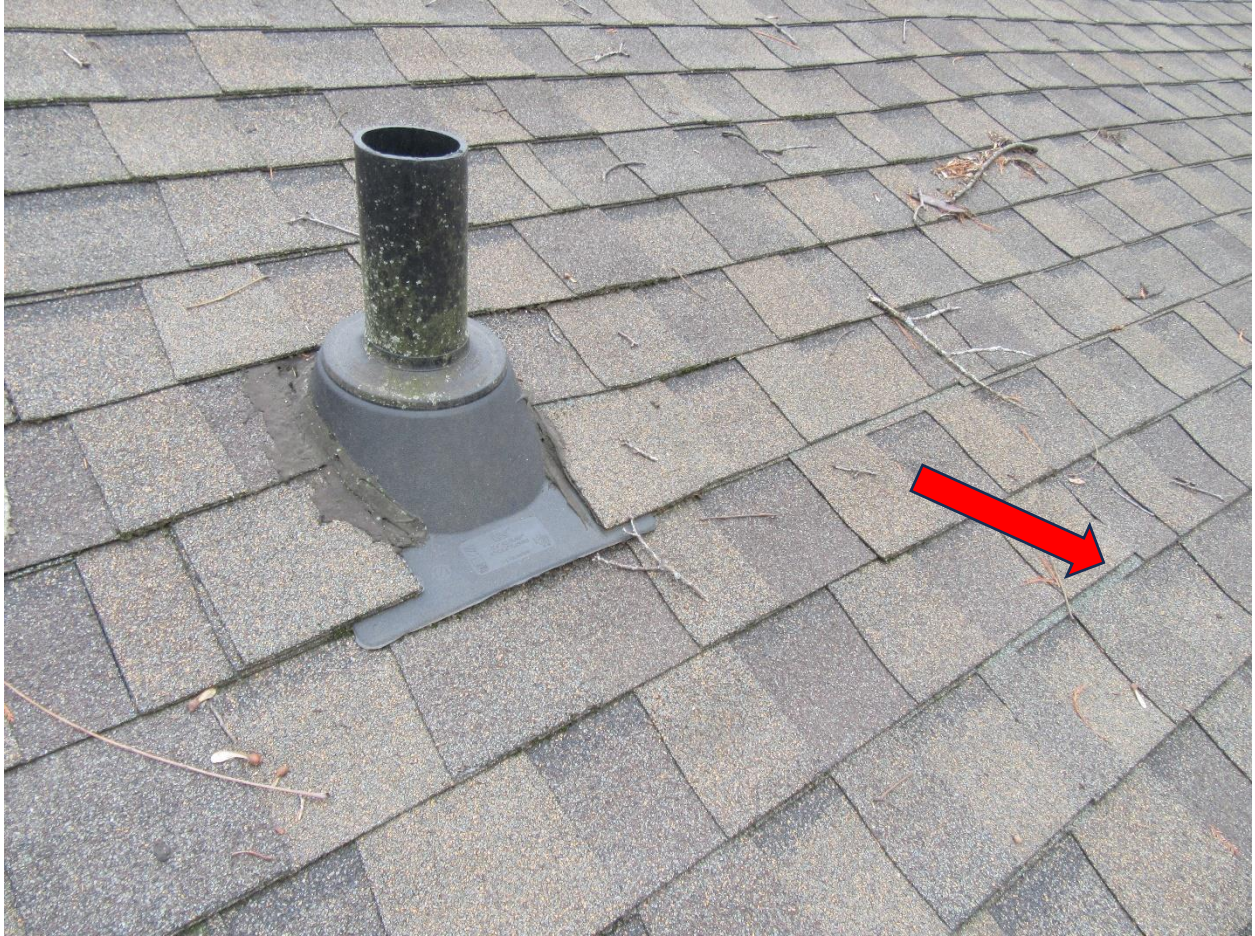
#17 Marginal quality shingle installation on part of the back side. Some rows are uneven.

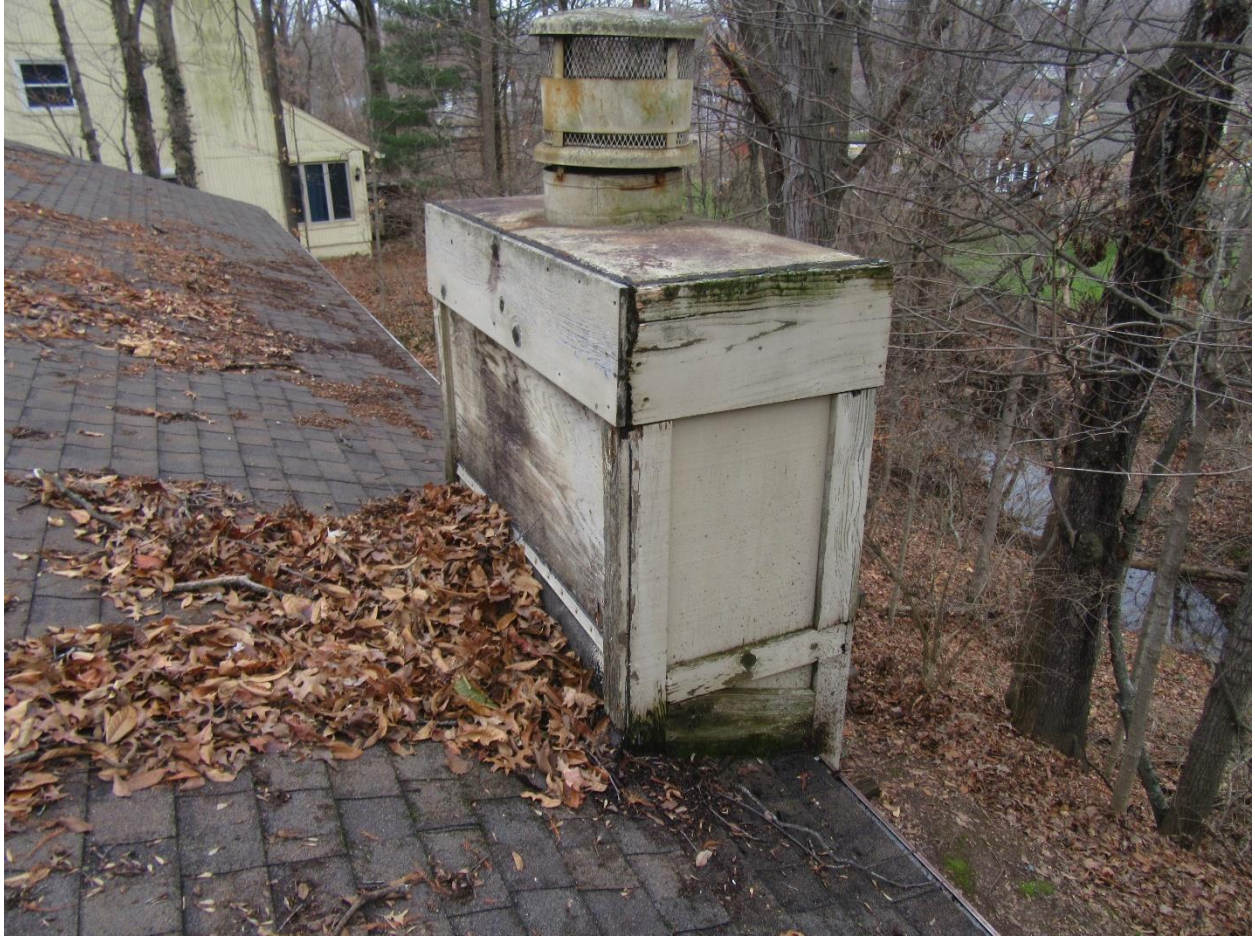
\*The chimney is in poor condition and is missing proper shingle flashing. Ideally, a sloped structure referred to as a “Cricket” or a “Hogsback” should be constructed above the chimney to divert water away from the chimney. This will require a qualified contractor. Since the wood siding on the chimney is in poor condition, there is a possibility of leak issues. The chimney will require a lot of repairs. Damaged wood siding needs to be replaced. Shingles and flashing should be replaced around the chimney when the “Cricket” is constructed.

#18 Chimney view. The leaves prevented a proper inspection. Chimney wood siding is in very poor condition and will require replacement.

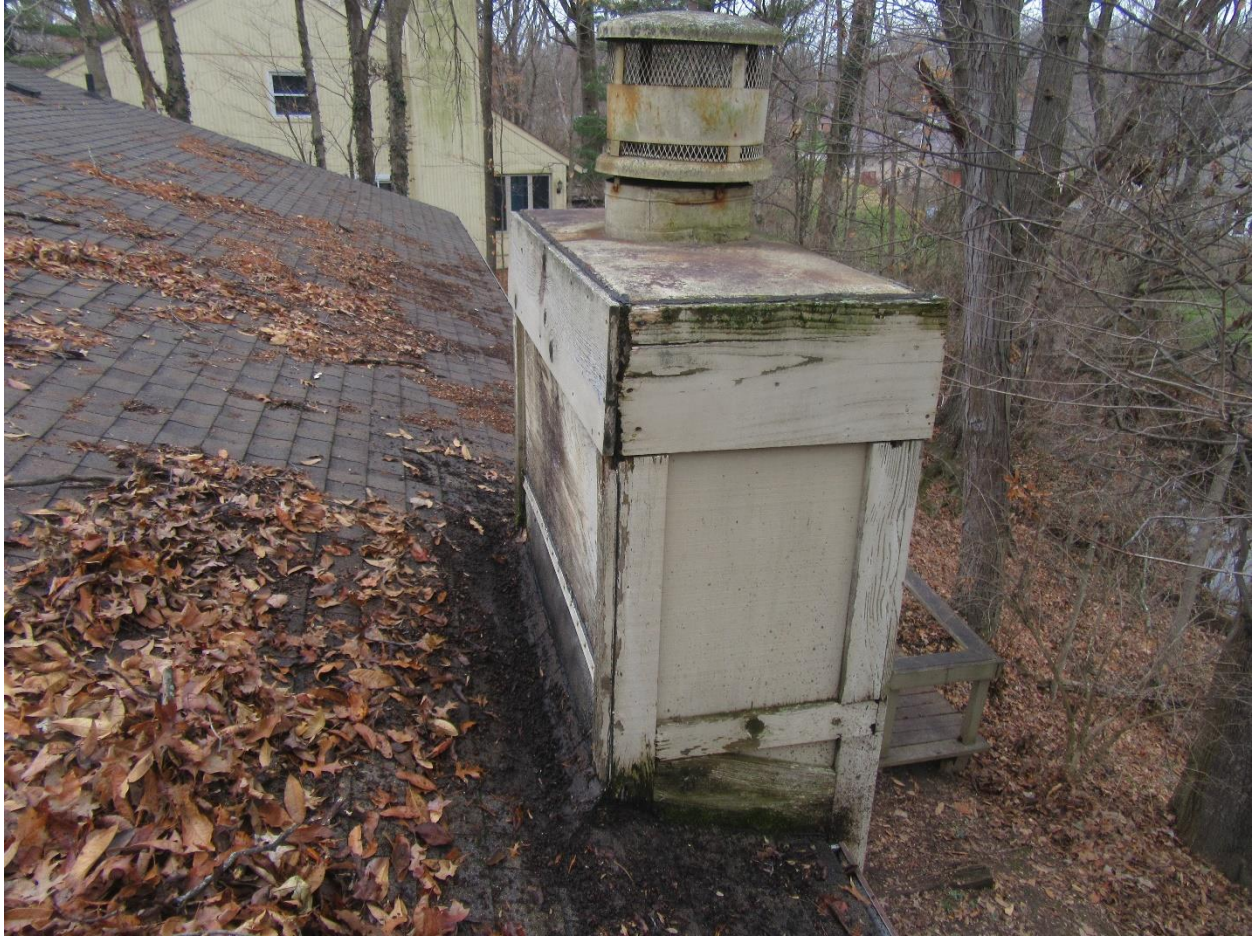
#19 I moved some of the leaves to reveal the poor conditions.

Chimney is missing a sloped structure above referred to as a “Cricket” or a “Hogsback”. Water cannot properly drain away from the chimney in the current condition. The shingles are deteriorating. There does not appear to be proper flashing where the shingles meet the chimney.

\*I recommend a qualified contractor construct a proper “Cricket”, replace the damaged materials, and install proper flashing and replacement shingles.

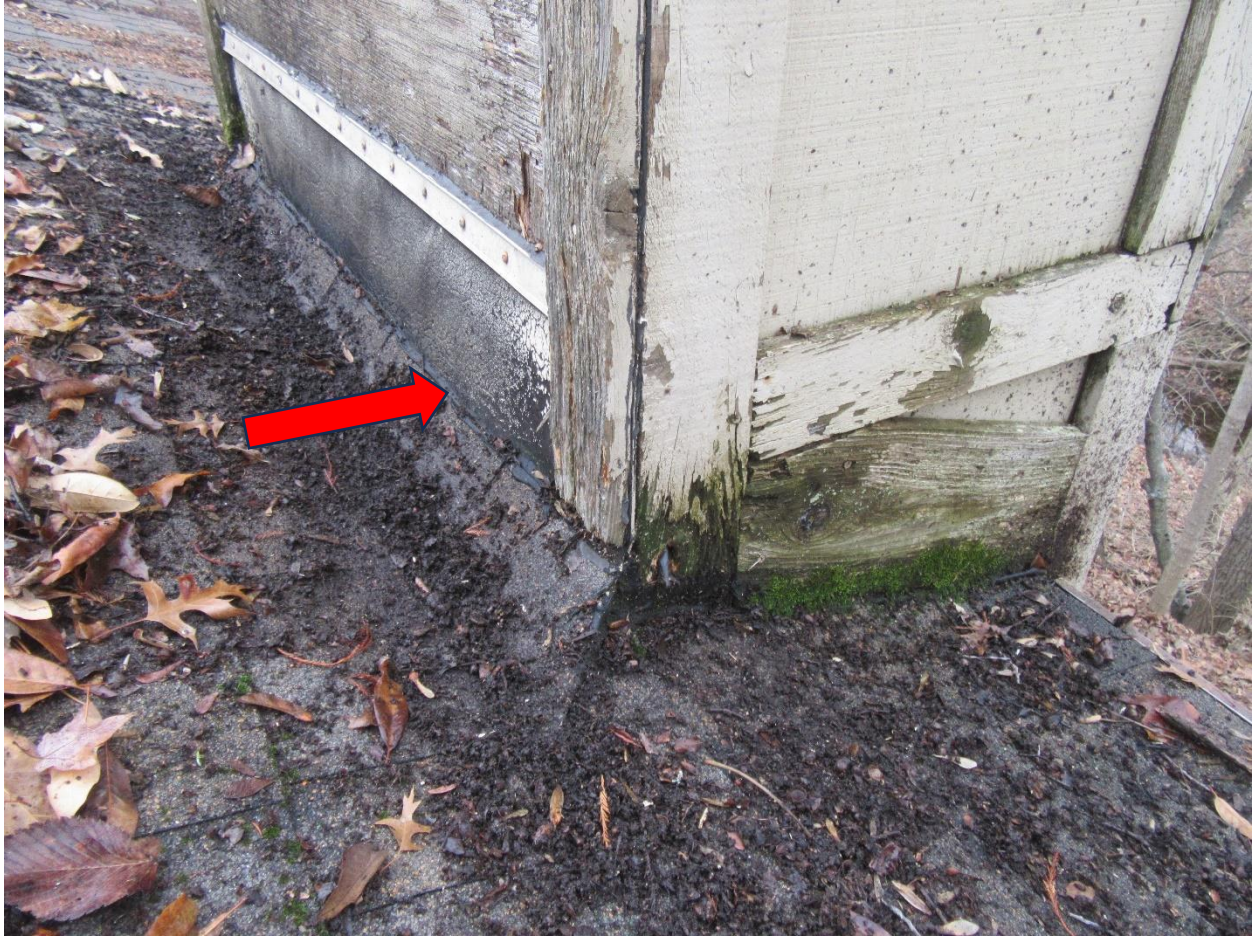
#20 Close-up view of the poor chimney conditions.

Caulking or tar has been applied. This is not a proper application and leak issues may develop.

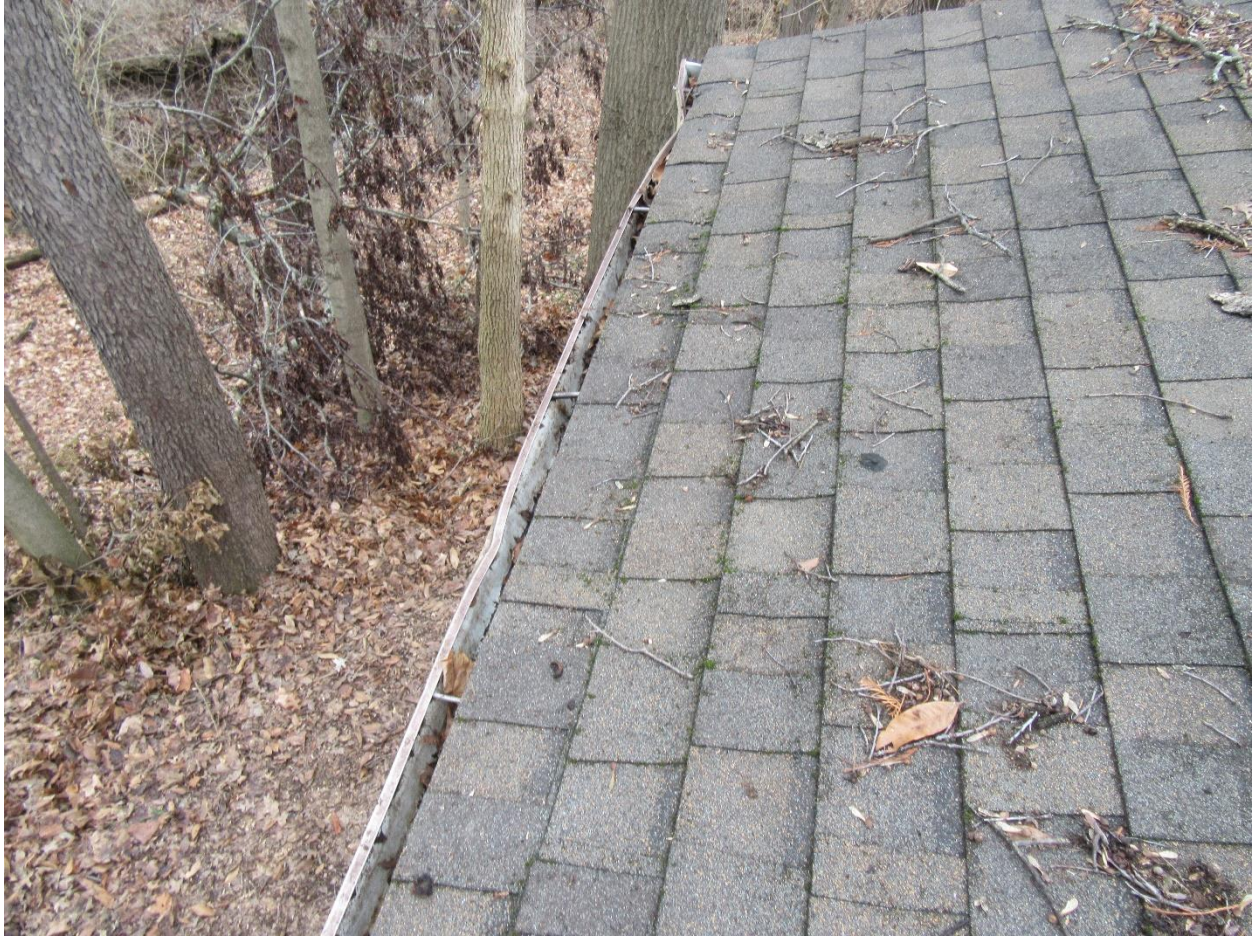
#22 Some of the guttering is damaged and in need of repairs. Gutters will need to be cleaned.

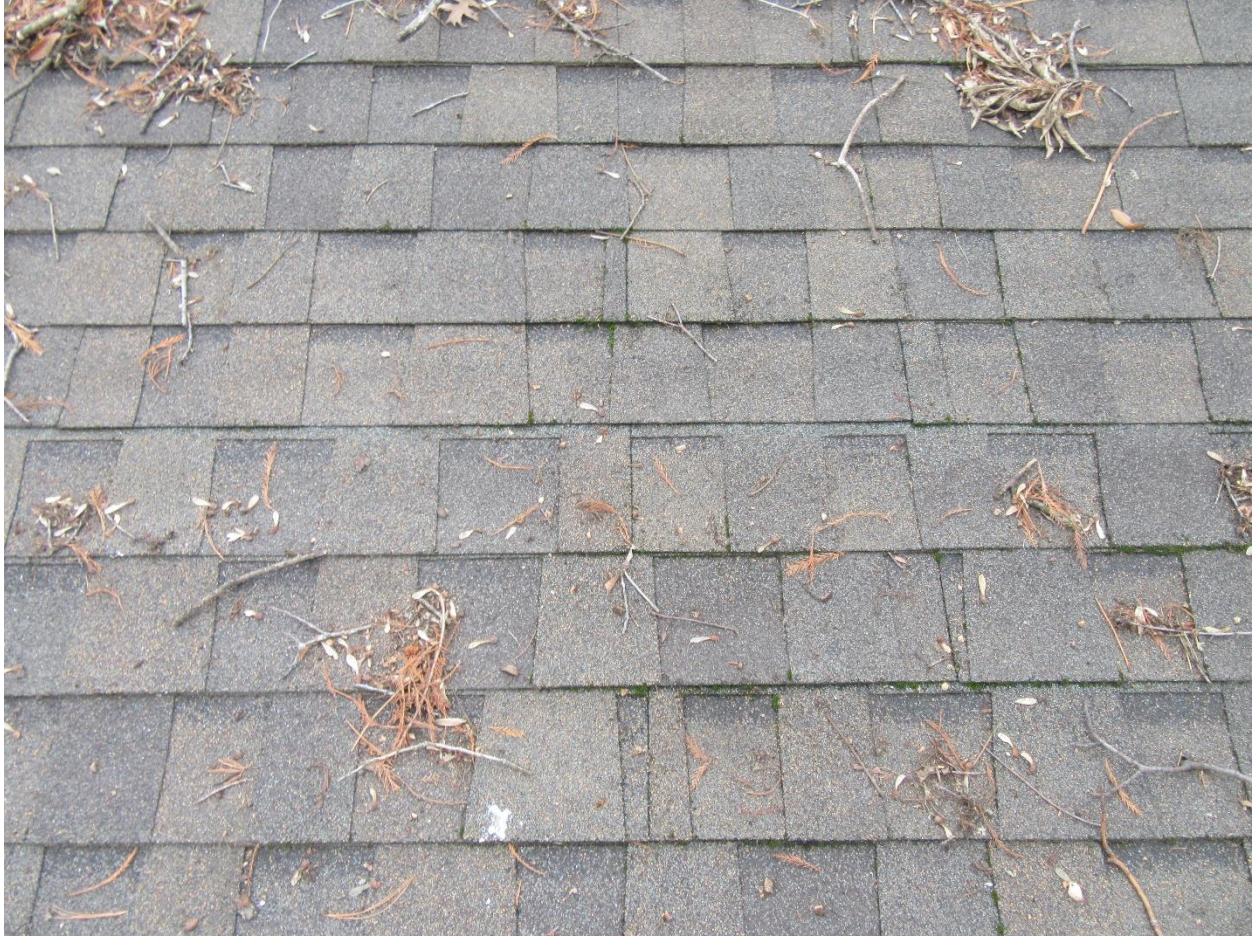
#24 Partial back side view where the shingles are marginally installed.

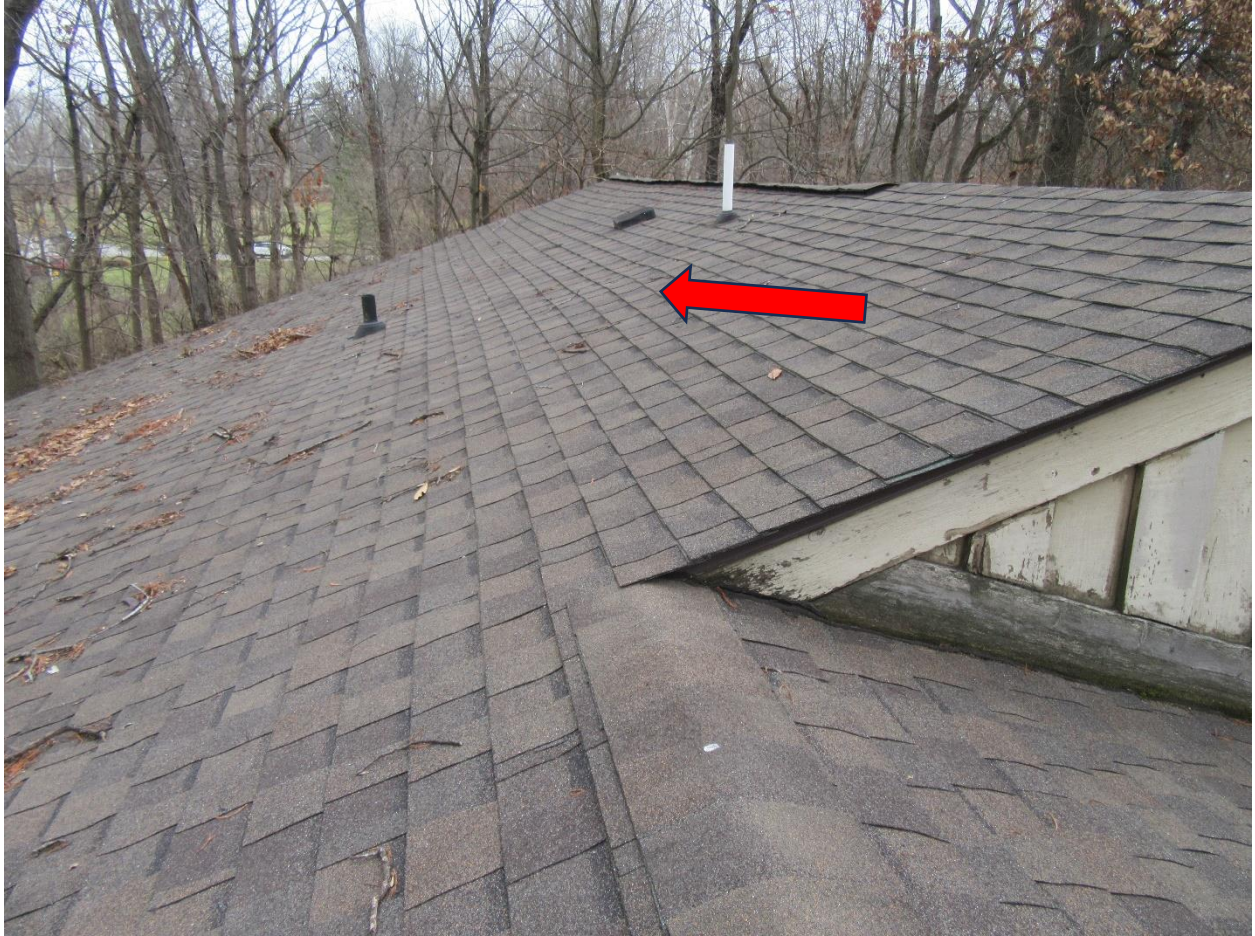
#26 Partial back side view reveals the slightly crooked shingle rows and the slightly uneven roof structure.

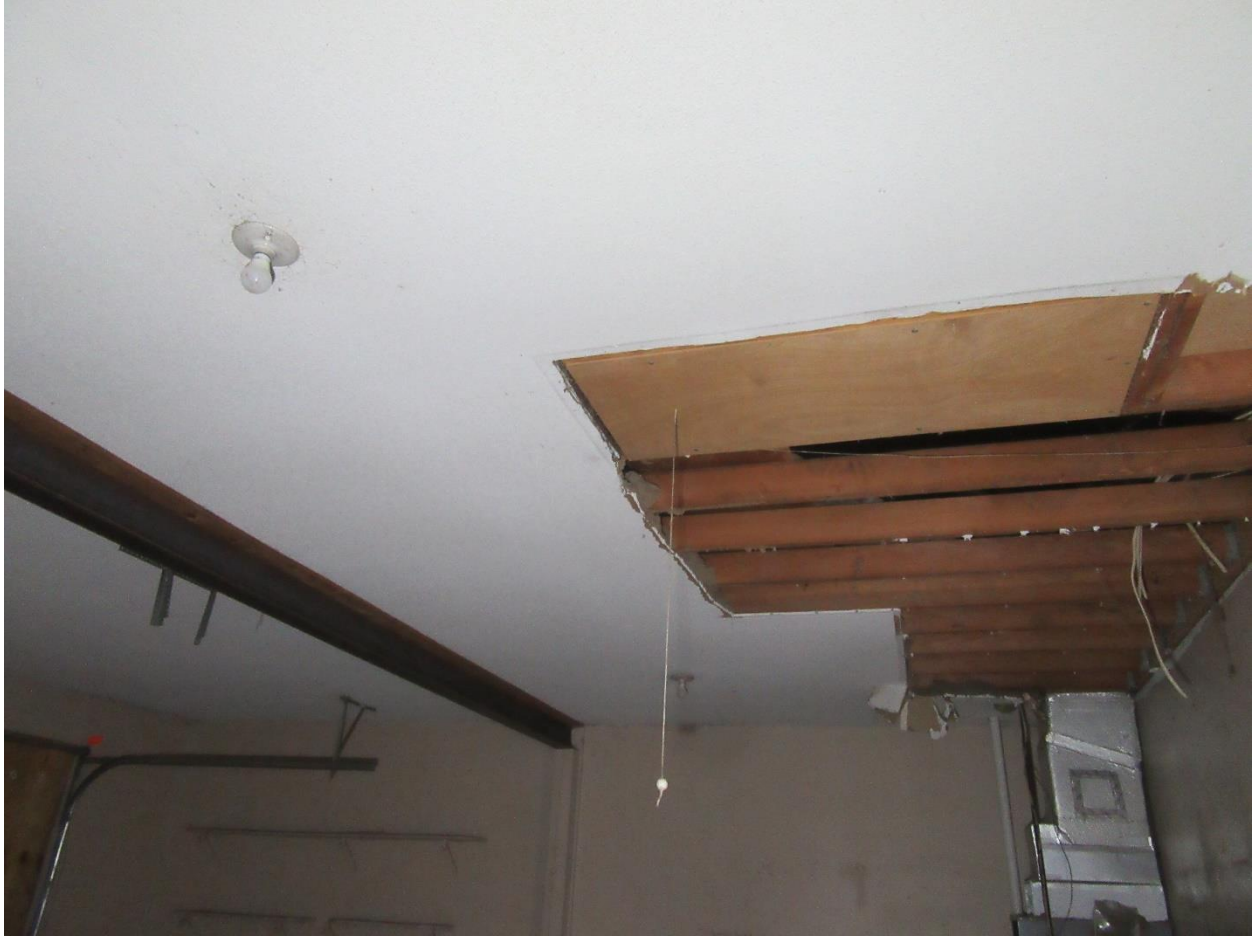
#38 Partial garage ceiling view.

I am unsure why part of the drywall has been removed. There is a chance of roof leak issues. I do not know if the damage is recent or older.

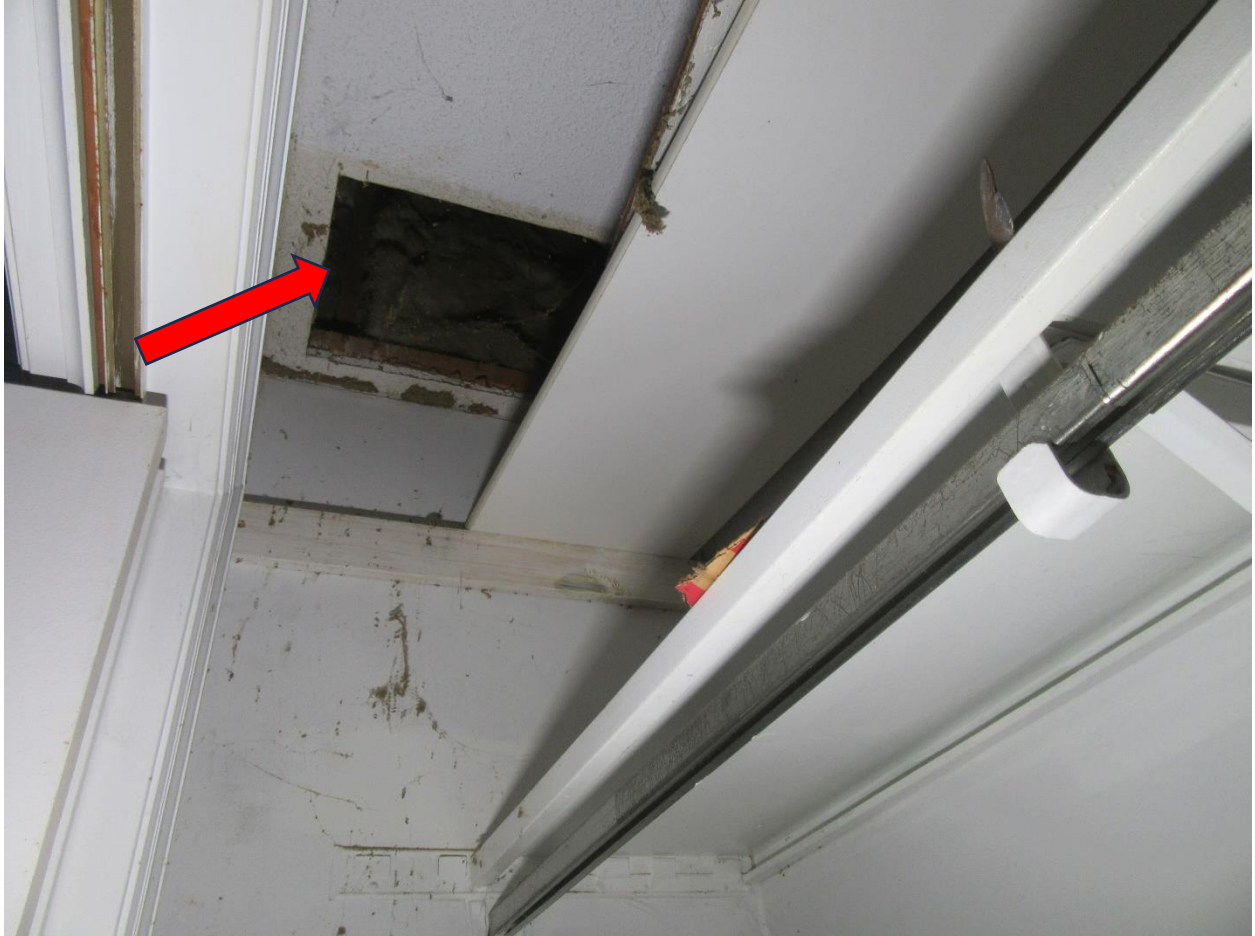
#40 I was unable to safely access the attic area due to the closet shelving and a very small opening. Opening is only 10" wide.

The opening is for the attic space on the west end of the house. The entire house does not have attic space.

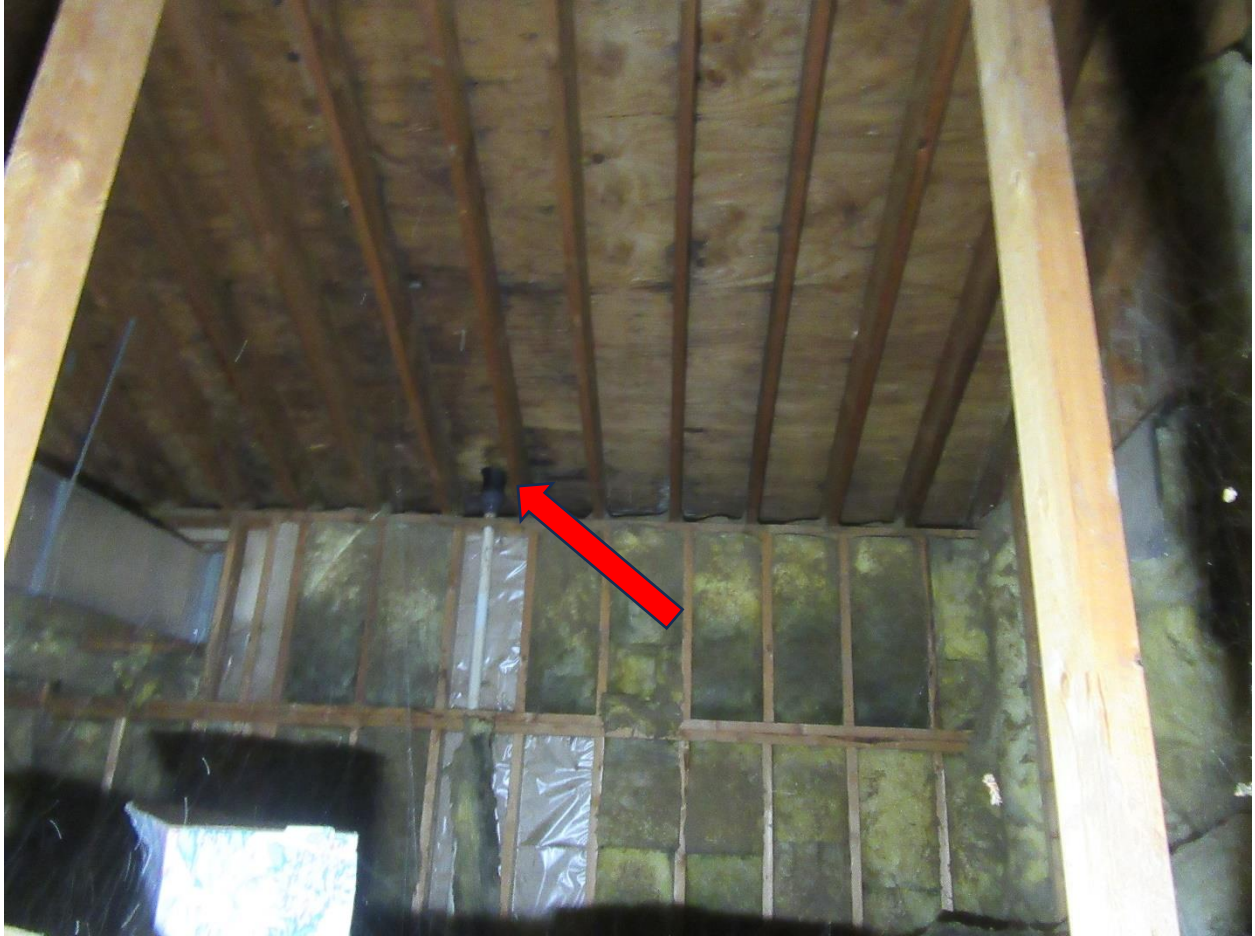
\*I did see stains on the underside of the roof structure in the attic area above the garage and kitchen. (See photos #46, 47). Stains appear to indicate leak issues at some point in time. I was unable to determine if there is a current leak issue. My inspection of the roof did not appear to reveal an obvious leak issue but there are a few areas of concern.

#46 Partial attic view above the kitchen area.

Stains on the roof structure may indicate leak issues at some point in time.
