#1 7201 South Kingswood Street Terre Haute, IN 47802

Roof Inspection performed by Mark Walcott Roofing Contractor  
263 State Road 135 South Nashville, IN 47448 Ph: 812-322-6532  
1/1/2024 Weather: Overcast, 35 degrees, Damp conditions.

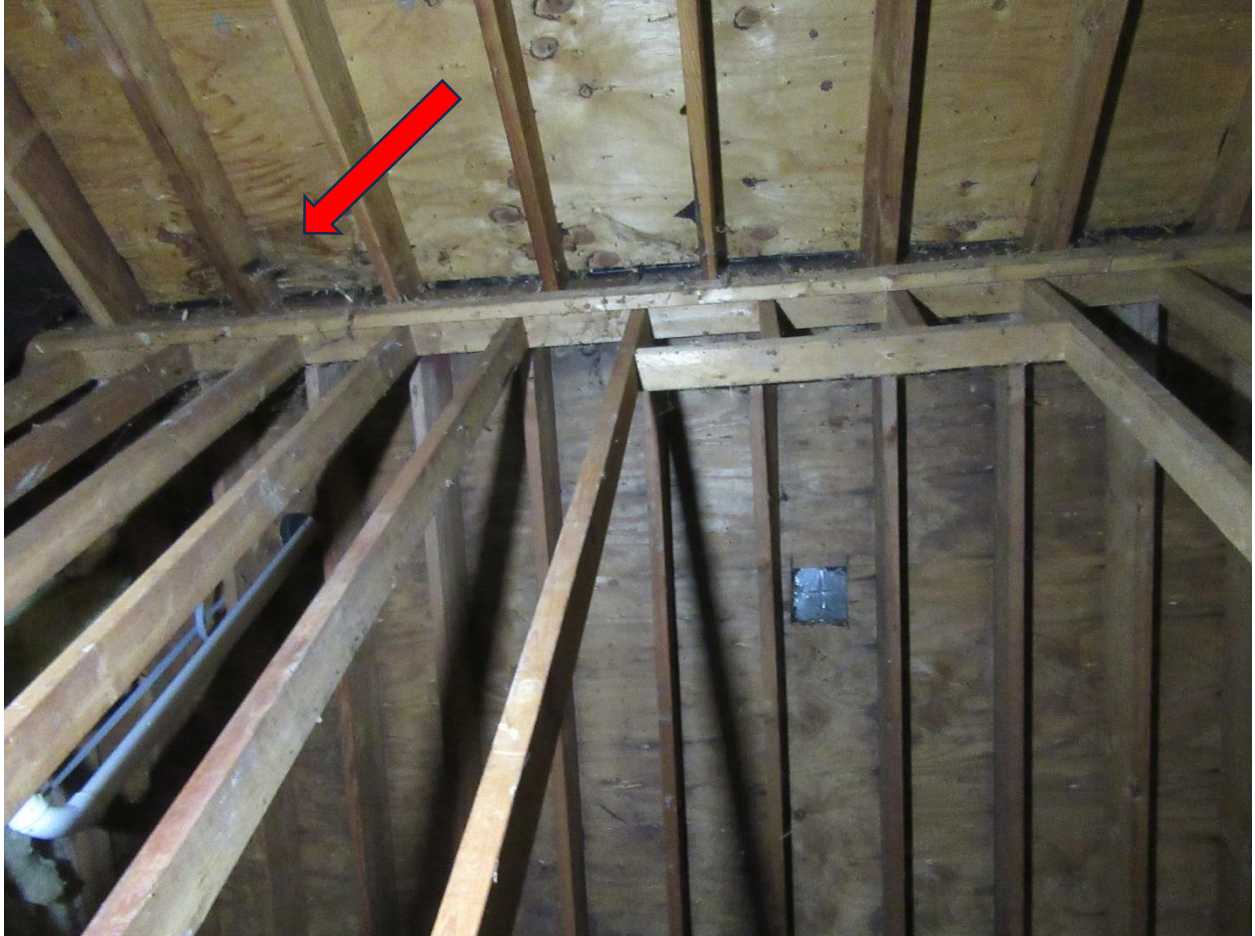
\*I did see stains on the underside of the roof structure in the attic area above the garage and kitchen. (See photos #46, 47). Stains appear to indicate leak issues at some point in time. I was unable to determine if there is a current leak issue. My inspection of the roof did not appear to reveal an obvious leak issue but there are a few areas of concern.

#47 Partial view above the kitchen/garage attic at the peak area. Stains may indicate leak issues at some point in time. Stains are below the ridge vents at the peak. (See the photo of the improper ridge vent installation)
